NRL/MR/6120--97-7957

# Control of Lead in Drinking Water

13. ABSTRACT ( <i>Maximum 200 words</i> )  This report describes the installation of an NRL-developed epoxy lining in the drinking water distribution system in three buildings. Water was sampled before and after installation of the lining; the sampling data was interpreted after several confounding factors were identified and allowed for. Improper installation of the lining in one of the buildings led to its premature failure, and this was documented and analyzed. The lining is shown to be effective in preventing leaching of lead into drinking water. This technology is recommended as a routine method for excluding lead from drinking water distribution systems in buildings, and guidance for use in establishing contracts to install the lining is provided.

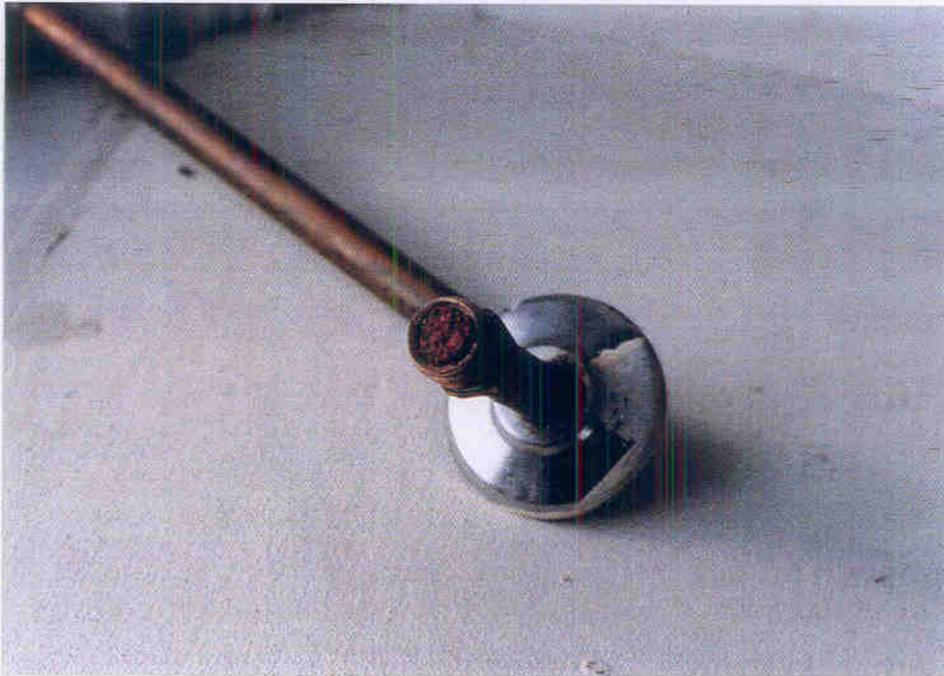
Some of the feed lines to bathroom taps were blocked with debris. Figure 3 shows the hot water line just behind the tap in room 214; this debris was packed hard and more than 3/4" deep.

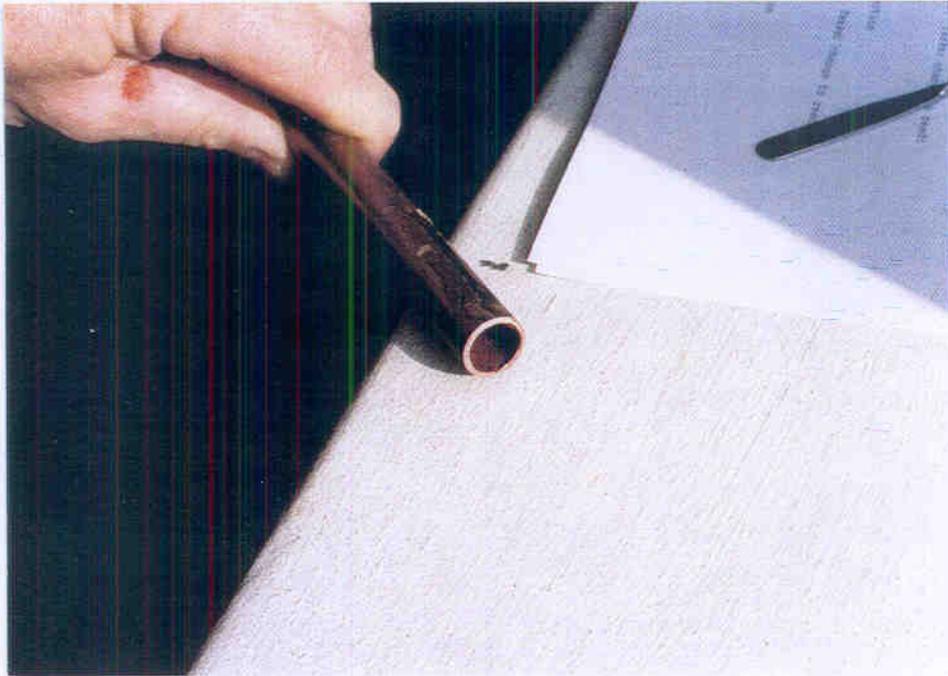
Figure  
4

Paint in the cold water riser to room 214 was rippled, indicating that it sagged before drying; thickness is reasonable but the paint has entrained grit which makes it rough (Figure 4). Where this line became horizontal and entered the main, the coating was thicker on the bottom of the main (Figure 5).

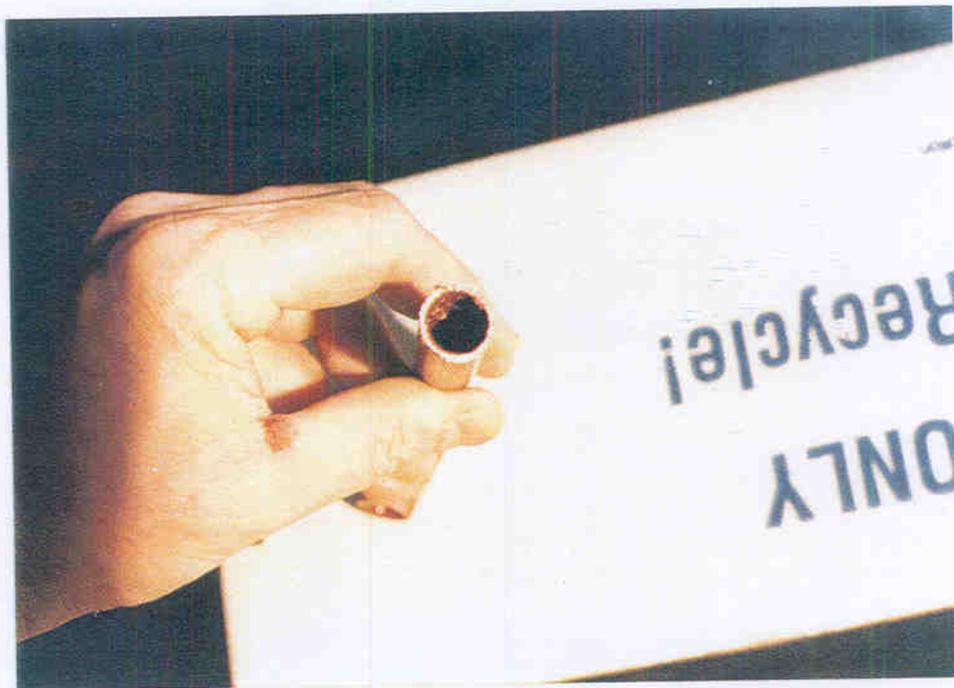
Figure  
6

The cold water line to room 211 showed proper thickness and good adhesion, but contained much entrained grit (Figure 6). Some of the pipes, such as the cold water feed in room 210, contained excessively thick coating or no coating at all. In the cold water line to room 206, just behind the tap the coating is excessively thick and porous (Figure 7),

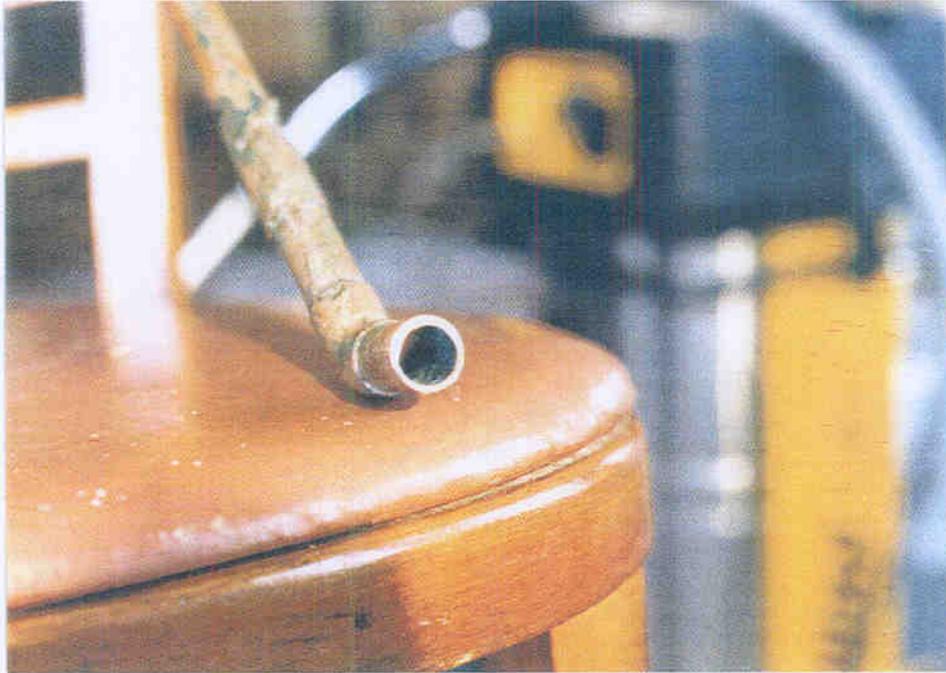
Figure  
8

but 24 inches toward the main there is no coating at all (Figure 8). The cold water line (Figure 9) to the ladies room near the first-floor lobby and to room 207 was at the upper limit of thickness on the bottom and very rippled.

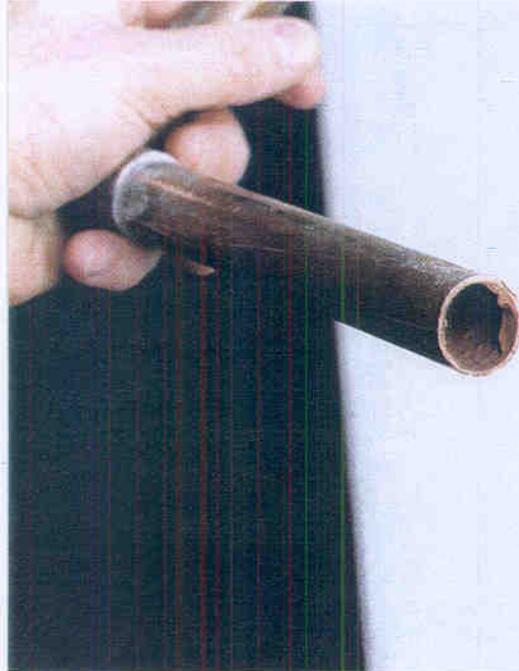
Figure  
10

The hot water line leading to laundry on the first floor between room 107 and the booking office showed good adhesion, but the paint is excessively thick and severely rippled (Figure 10). The lining in the hot water pipe to room 106 (Figure 11) was at the maximum permissible thickness and showed ripples, good adhesion, and some evidence of grit in the paint.

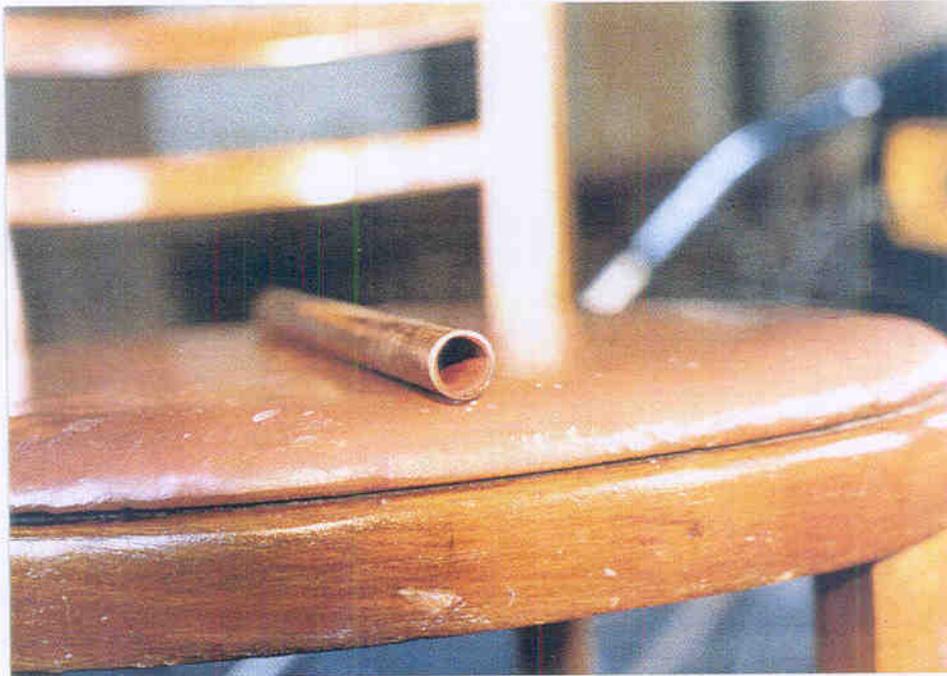
Figure  
12

The lining in the cold water feed to room 105 (Figure 12) was excellent, showing proper thickness, good adhesion, and no contamination. Lining in the hot water line into room 101 was hard and smooth, adhered well, but was slightly thick on the bottom of the pipe nearest the tap (Figure 13).

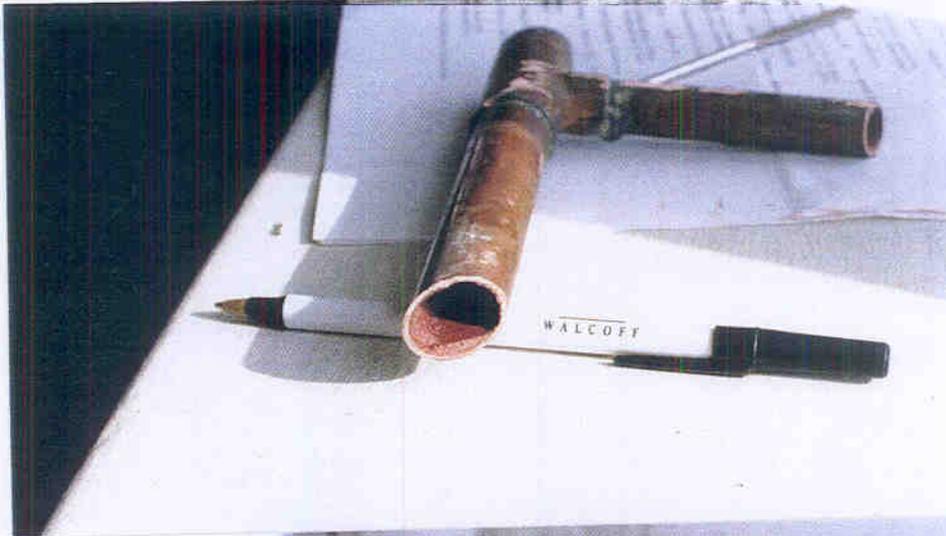
Figure  
14

Workmanship in the cold water main is good at the north end but very poor at the south end. At the north end, the lining is generally smooth and glossy, with light rippling. Adhesion of the paint seems satisfactory. The paint is thicker on the bottom of the main at the north end of the building (Figure 14), but not so thick as to obstruct flow.

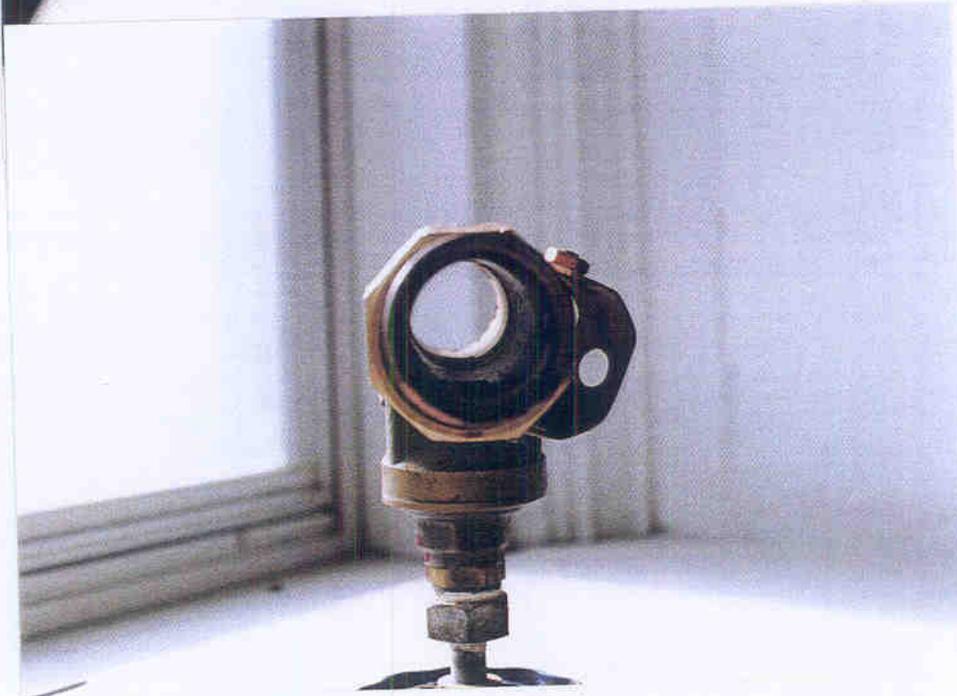
Figure 15 shows a valve and adjoining piping from the cold water main at the north end. The valve is operable but must pierce and crack paint in order to close. The coating is generally smooth, with light rippling but no blisters. Adhesion of paint seems satisfactory. Paint has a matte finish instead of the normal gloss.

All valves were painted, and most were inoperable (see Figures 15, 17 and 20 above). The contract explicitly required valves to be removed from the lines before painting.

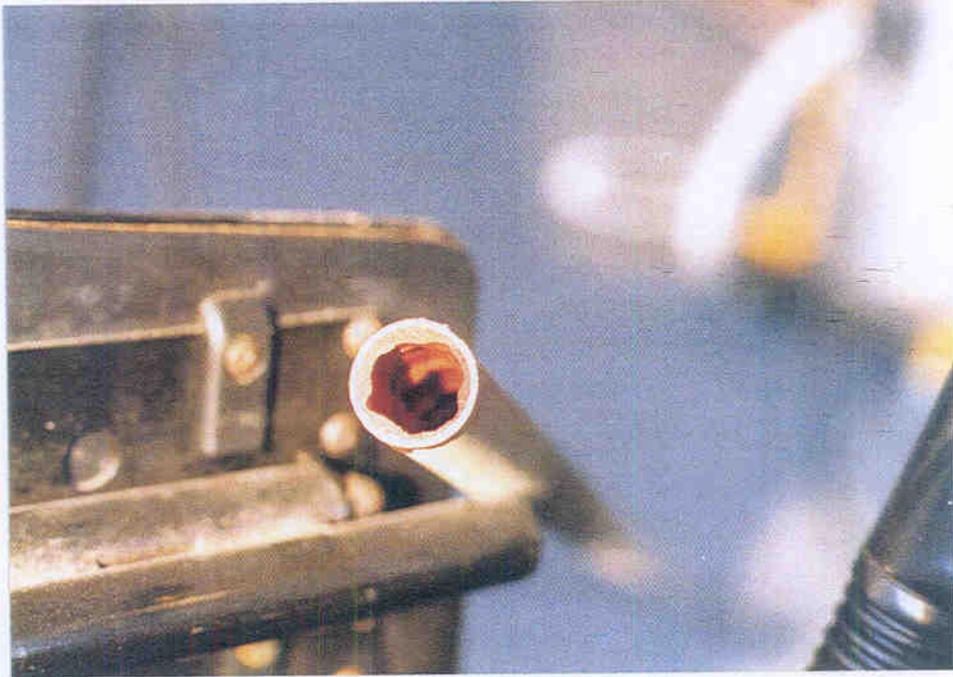
Figure  
16

At the south end of the building, the paint is excessively thick and rippled (Figure 16). A valve in this line is painted open and cannot be operated (Figure 17).

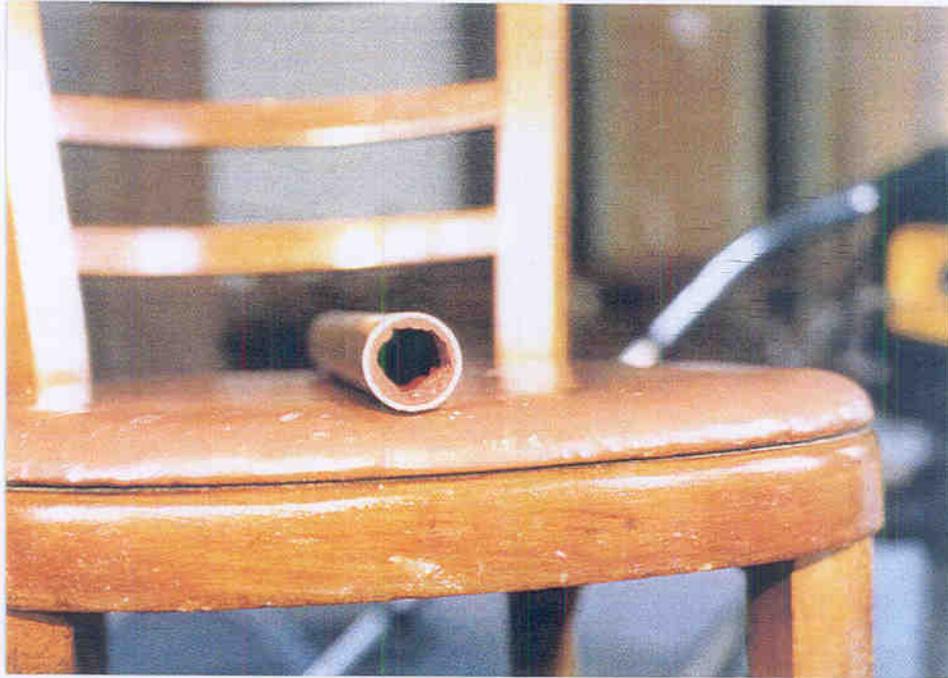
Figure  
18

At the far south end of the building, the lining is excessively thick at one point, but stops abruptly leaving uncoated pipe. In a section of 1" cold water main from far south end of building, the paint is excessively thick at one end (Figure 18) but there is no paint at all at the other end (Figure 19). The roughness of the pipe surface at the uncoated end is very light on the bottom and sides, but there is no roughness at all on the top 60° of the pipe.

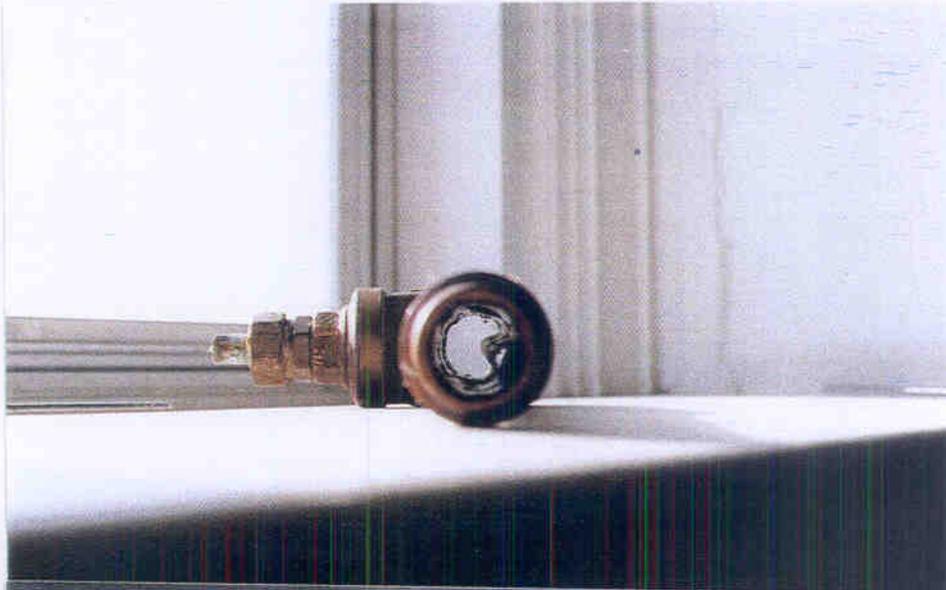
Figure 20 shows a section including a valve from the hot water main at the north end of the building. The thickness of paint in the pipe is acceptable, but the valve is painted open. A single blister about 8" long has formed at the top of the pipe. The interior metal surface of pipe is very smooth; there is no surface roughness at all.

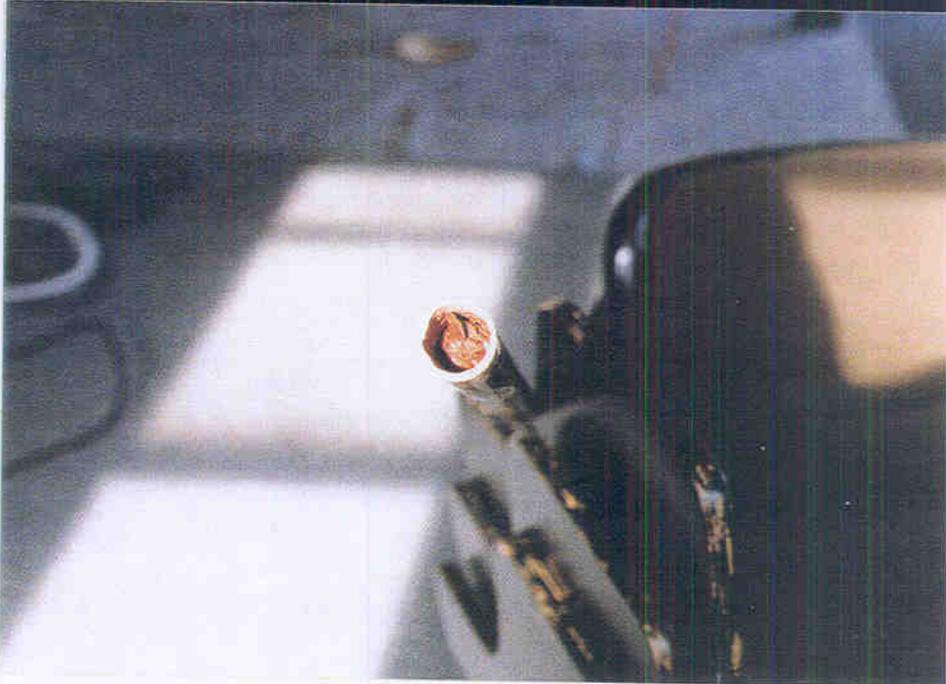
Figure 21 shows the end of a 7-1/2-foot section of 1" hot water pipe from north end of building; the pipe is completely blocked. Paint had lost adhesion at top of pipe and been wrinkled and curled by water flow until it blocked the pipe.

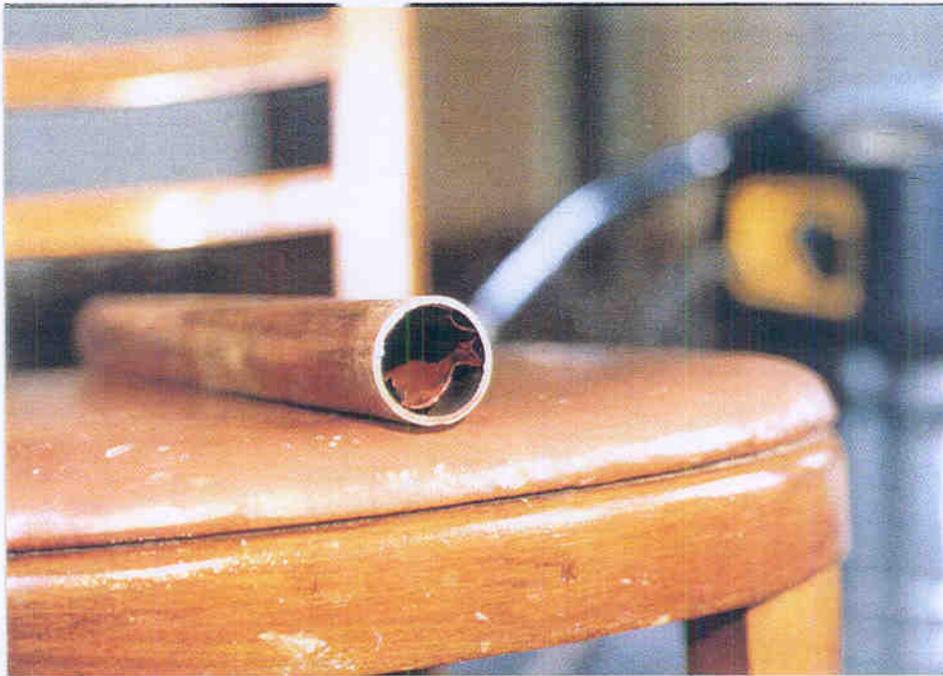
Figure 22 shows a section of pipe from the south end of the building. Adhesion to the bottom of the pipe is satisfactory, but paint on the sides and top of the pipe has lost adhesion to the metal and moved into the center of the pipe, where it may be broken loose by flowing water.

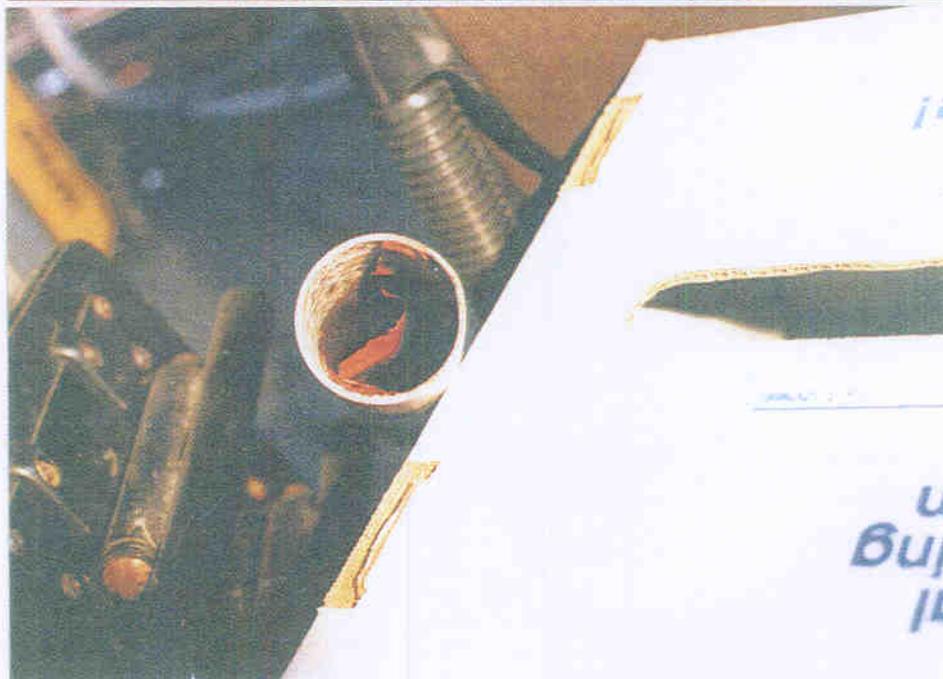
Figure 23 shows delamination of paint, leaving bare metal and flakes partially obstructing flow in hot water 2" pipe from ceiling in main hallway at south end of the building. The mottled black spots on the metal indicate that hot work has been done close to this site.

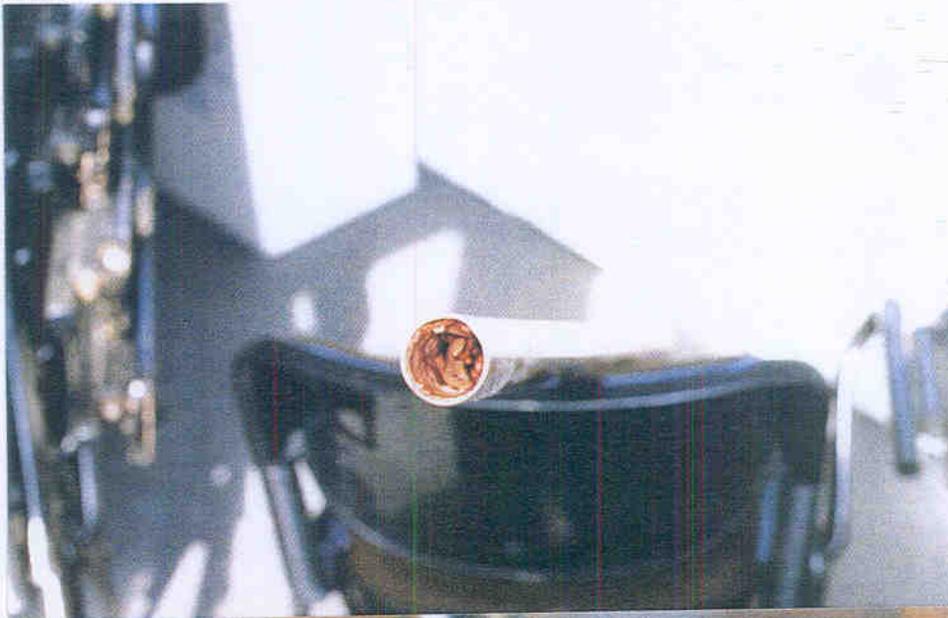
Figure 24 shows the 1 1/4" hot water recirculating line from the ceiling of the first floor center hallway. The paint is massively lumpy. Lumps are porous paint, they are not blisters, the pipe is not blocked. When the adhesion of the lining is tested with a knife, all adhesion is lost at the top of the pipe, but the bottom paint adheres well.

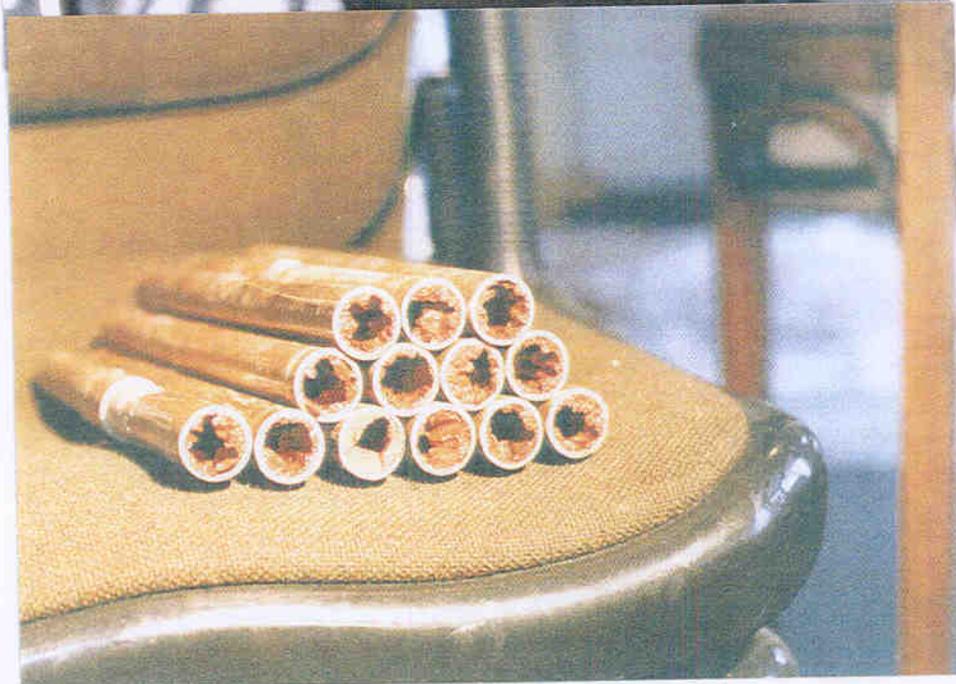
Figure  
25

A 13-foot section of 3/4" hot water recirculating line from the far south end of the building was nearly obstructed by excessively thick paint. A pipe cutter was used to cut this pipe into 13 1-foot segments, and these are shown in Figure 25. The lining is not solid paint but is porous.

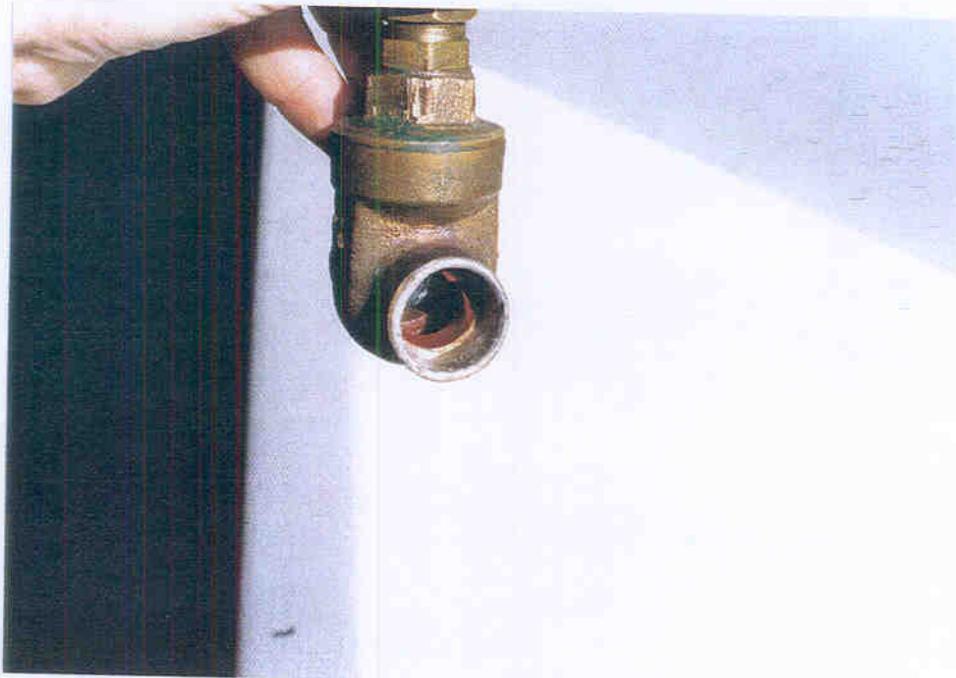
Figure 26 shows a valve from 3/4" hot water recirculating line which was not removed during painting. Paint covers the seat of the valve and prevents the valve from closing.

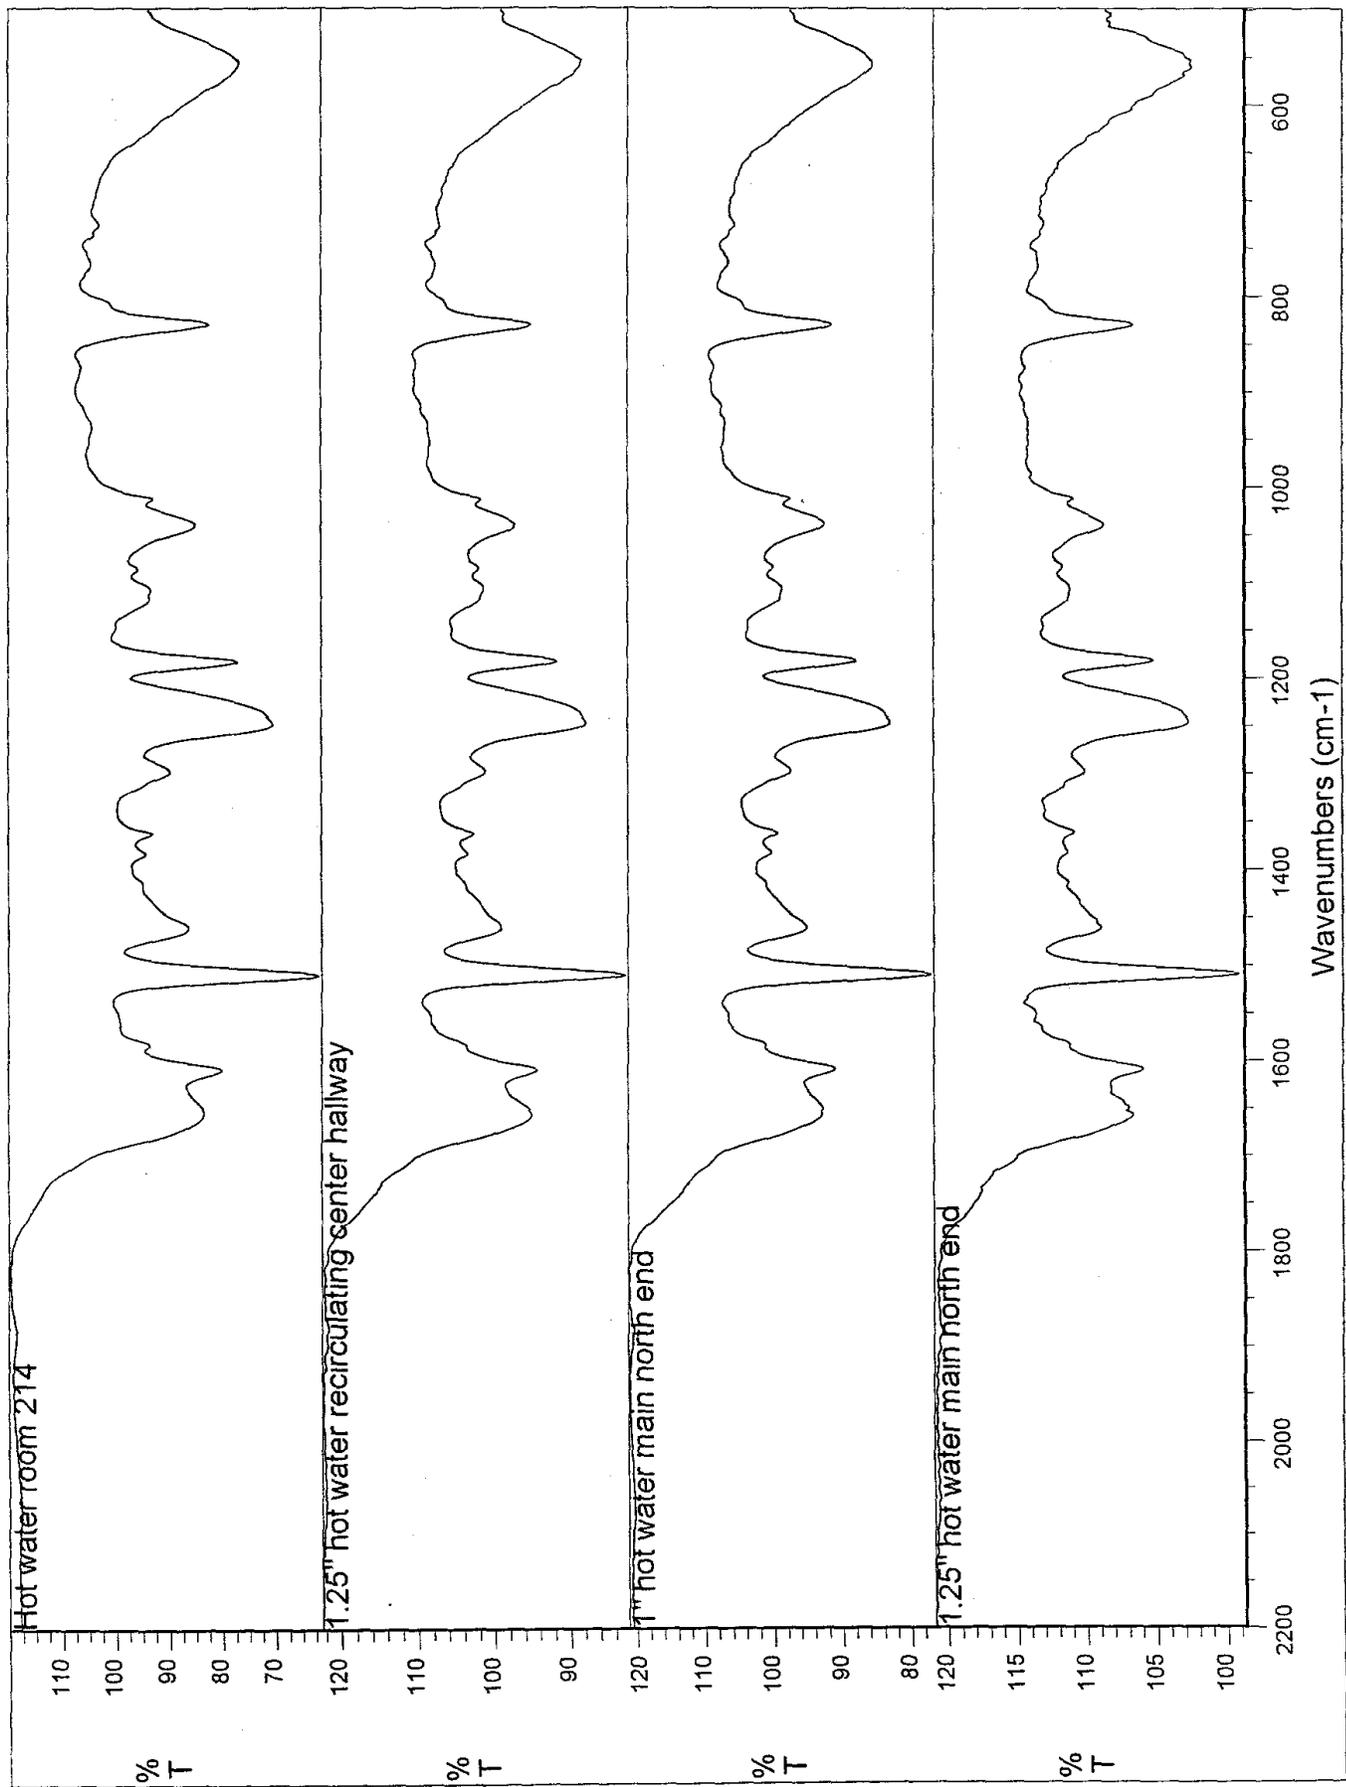
*Manufacture and mixing of the lining.* Infrared spectra of paint flakes were used to determine if the paint was manufactured properly and mixed properly. Figure 27 shows spectra of lining from four places in the building. The position and intensity of the peaks shows that the paint was properly manufactured and mixed.
