Final Report

ENERGY REDUCTION USING EPOXY COATINGS FOR SEALING LEAKING COMPRESSED AIR SYSTEMS

**Energy and Water Project
EW 201517**

Naval Facilities Engineering and Expeditionary Warfare Center

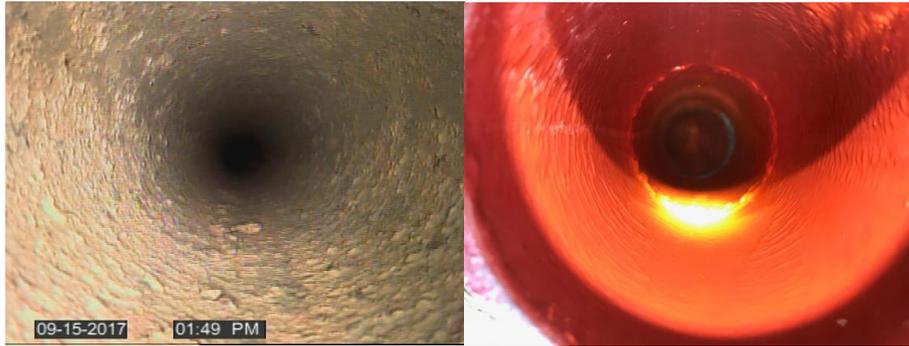
Figure 2: Uncoated Pipe and Epoxy Coated Pipe at NBVC CED, Port Hueneme, CA

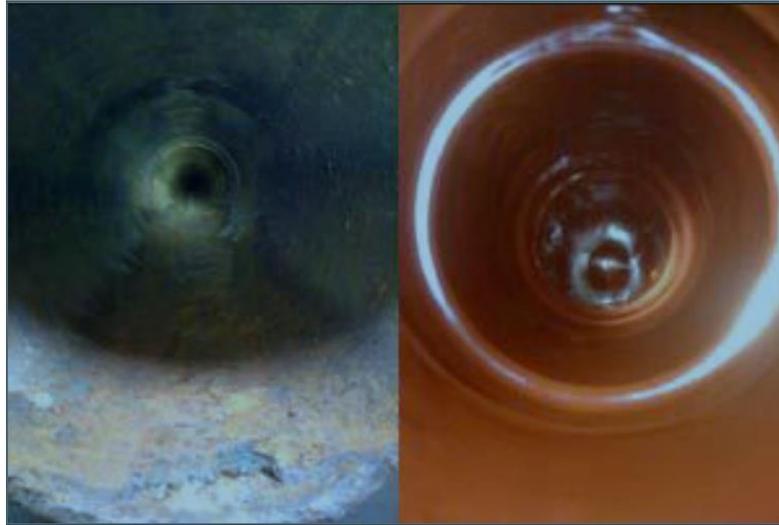
Figure 1. Uncoated and Epoxy Coated Pipe at NAS North Island, California

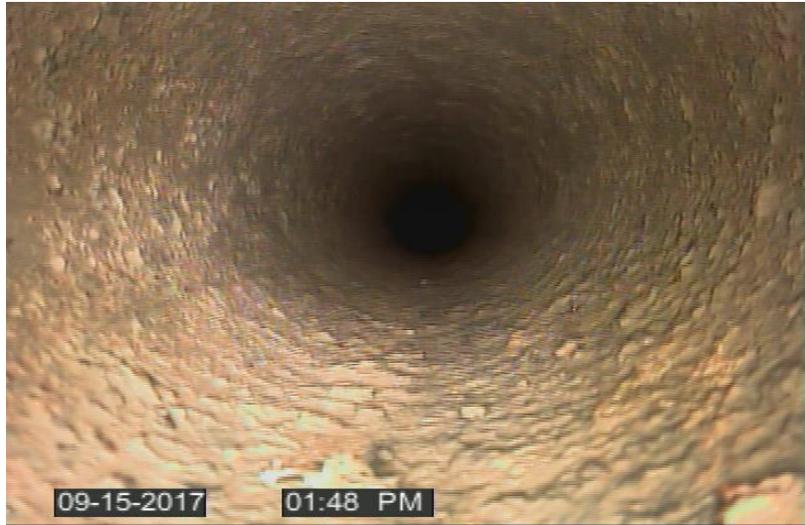
Due to its age and proximity to the Pacific Ocean, (air moisture and high ground water table) much of the CED facility is in fair condition, showing considerable signs of paint wear and external corrosion. The receiver tank located near building 814 originally installed in 1952 has external rust and is in need of fresh coat of paint as shown in Figure 3. The above ground adjoining pipeline (abandoned) has also considerable external rust but appears to be serviceable. The underground pipelines connecting buildings 813, 814 and 815 are thought to be the same age as the receiver tank and are not accessible without digging. The condition of the inside of the underground lines could not be effectively ascertained in some cases due to its construction with multiple elbows and length limitations of the cameras. Where camera inspection was possible the pipeline mostly appeared to be a relatively good shape with the exception of the 1-1/2-inch pipe from 814 to 815. This pipeline had a fair amount of tuberculation. See Figures 4 and 5.

Figure 4. Inside view of 1-1/2 inch diameter pipeline prior to epoxy coating

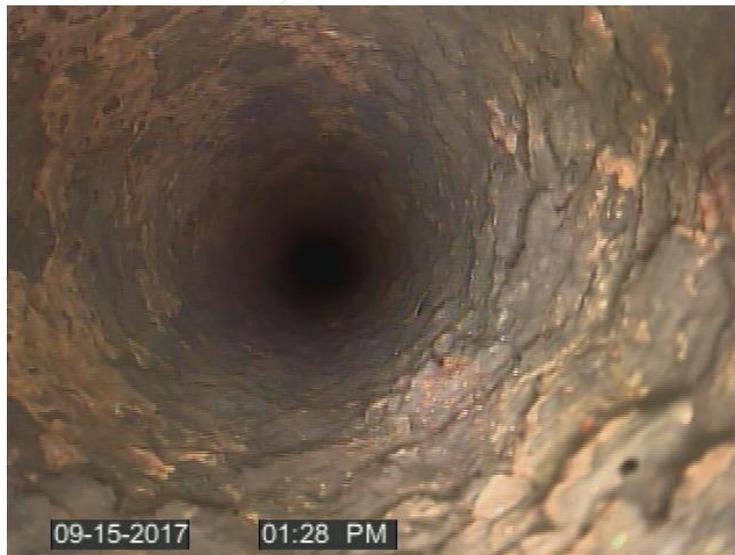
Figure 5. Inside view of 1-1/2-inch diameter pipeline showing severe corrosion

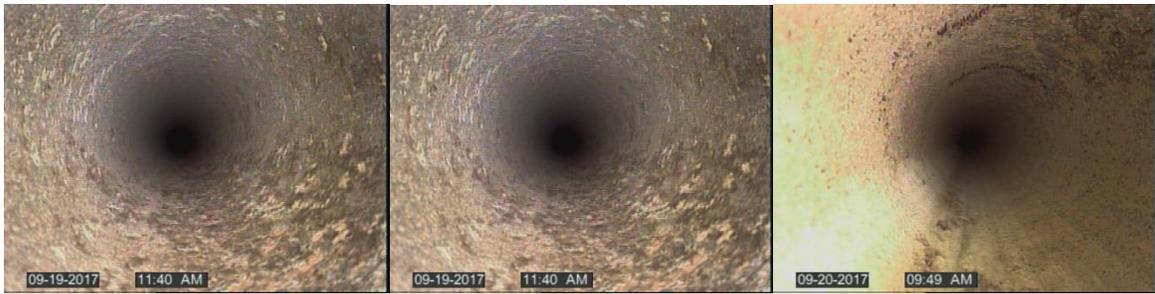
Figures 8 and 9 show pictures of the inlet and outlet ends for the 1-1/2-inch diameter and 4-inch diameter underground pipelines, respectively, post-blasting with the abrasive garnet. The pictures demonstrate that the inlet and outlet ends of the pipelines were mostly clean. In the case of the 1-1/2-inch diameter pipeline there was pipe pigmentation in some of the pictures. This may be due to the removal of heavy scale, rust and possibly corrosion from the inner wall surface. Nonetheless, the images show that the pipe's ends were clean and free of debris. Therefore, both underground pipelines exhibit good general appearance and pass point one of the present performance objective.

Figure 8. 1-1/2-inch Underground Pipeline Inlet and Outlet Ends after Abrasive Garnet

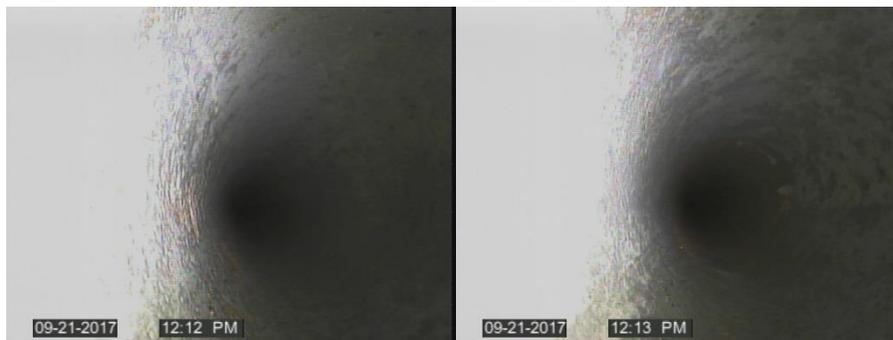
Figure 9. 4-inch Underground Pipeline Inlet and Outlet Ends after Abrasive Garnet

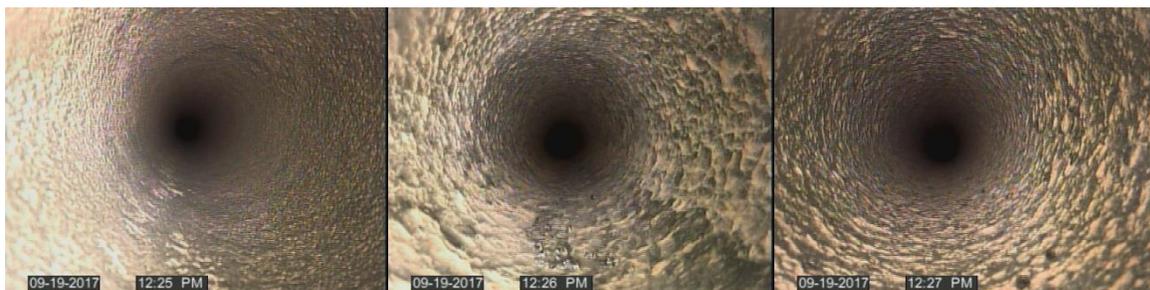
Figures 10 and 11 display the interior of the 1-1/2-inch diameter and 4-inch diameter underground pipelines, respectively, after the application of the abrasive garnet. The pictures of the 4-inch diameter pipeline show its interior to be extremely clean and free of debris. Hence, this pipeline passed the second point of performance criteria regarding pipe cleanliness and preparation. Conversely, the interior images of the 1-1/2-inch diameter underground pipeline depict a clean interior free of debris but with some regions of the pipe showing significant surface roughness. The latter may have the potential to compromise the epoxy coating as extreme surface roughness may interfere with the formation of a smooth and homogenous epoxy coating along the pipe. It is believed that the extreme surface roughness was the result of moderate to severe pipe corrosion resulting from pin-holes or fractures on the pipe wall allowing contact with water. The 1-1/2-inch diameter underground pipeline did not pass the second point of the present performance criteria.

Figure 10. Interior of 1-1/2-inch Underground Pipeline after Abrasive Garnet

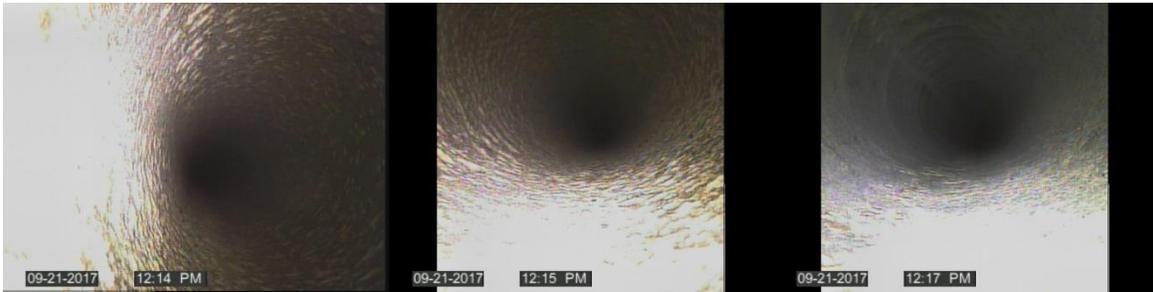
Figure 11. Interior of 4-inch Underground Pipeline after Abrasive Garnet

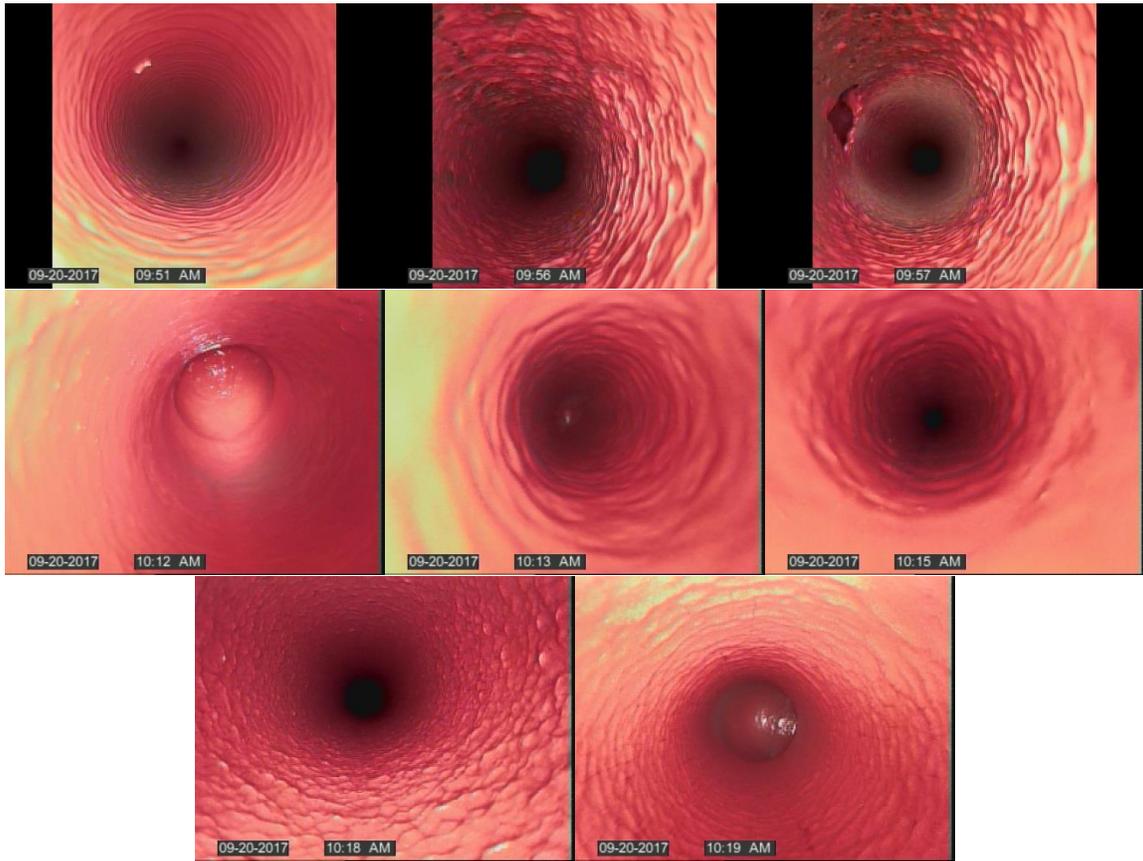
Figure 14. Inside Camera Shots of 1-1/2-inch Diameter Pipeline One Day after First Epoxy Coating

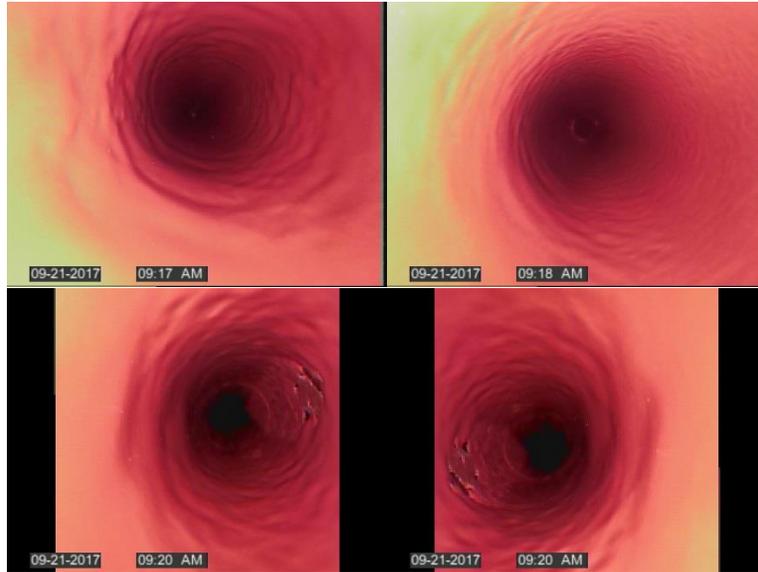
Figure 15. Inside Camera Shots of 1-1/2-inch Diameter Pipeline One Day after Second Epoxy Coating

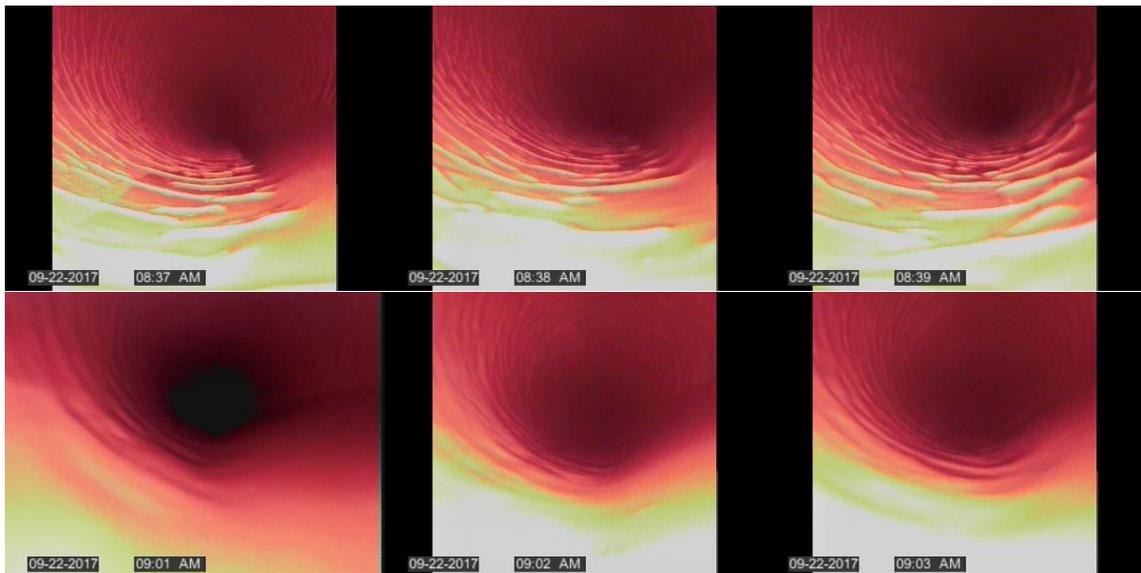
the thickness and uniformity criteria due to substantial corrosion in the pipe. Camera inspection of the 4” diameter pipeline showed negligible pooling within the pipe.

Figure 16. Inside Camera Shots of 4-inch Diameter Pipeline One Day after Epoxy Coating

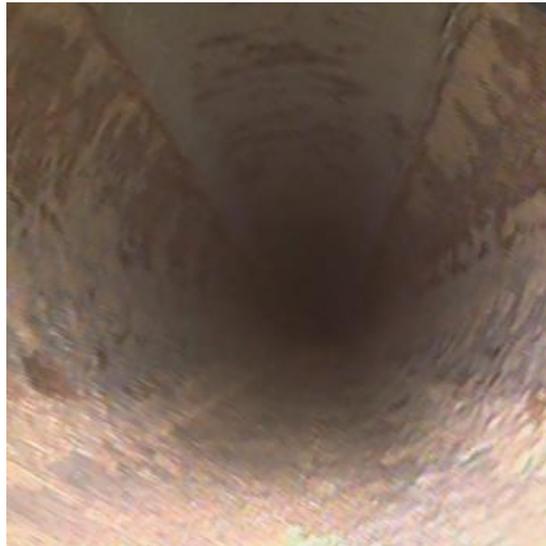
EXWC did extensive research and found one special camera that could be inserted into the 1 ½" diameter pipe; the only shortcoming was that the camera's cable had a range of 60 feet. The subject 1 ½" diameter pipeline was inspected with this camera to evaluate the conditions and check for holes/breaches. Again, due to the relatively small diameter of the pipe and the use of short sweep elbows (typical in compressed air systems), the camera's head was not able to advance through about 40% of the pipeline's length. As for the remaining 60%, no holes were found but there were areas encountered that had moderate to high levels of corrosion; this corrosion is typical to steel point submerged in water Figures 2D and 3D display the interior pipe condition.

Figure D2. Photo of inner pipe near one leak point and prior to epoxy application (35' from camera's insertion point).

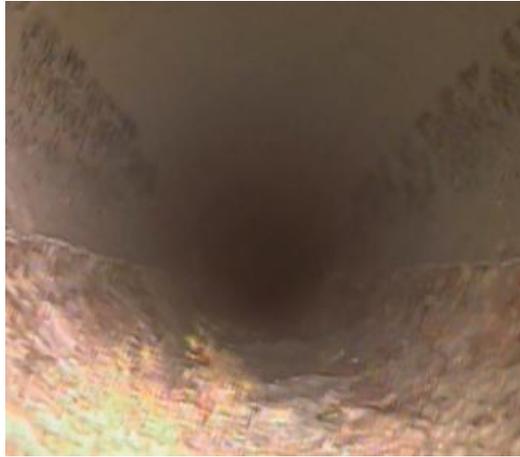
Figure D3. Photo of inner pipe near another leak point and prior to epoxy application (40' from camera's insertion point).

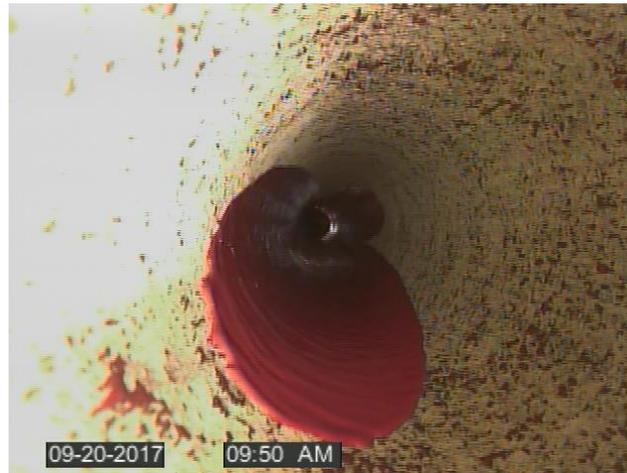
Figure D4. Photo of pipe's end near Building 814 that should have been fully coated after applying initial amount of epoxy.

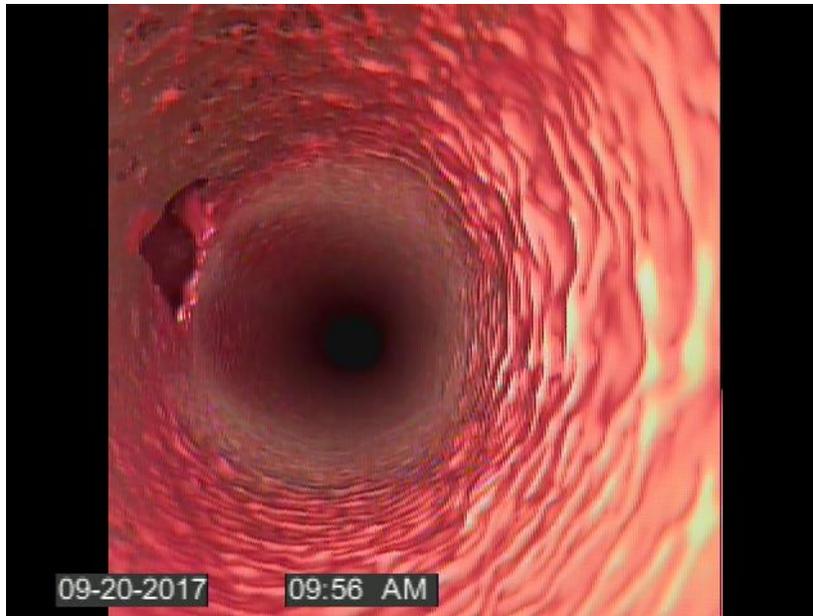
EXWC technician used a pipeline camera to pinpoint the location of two leak points. Two major holes were found with the camera. Figure D6 shows the holes, which were situated at approximately 35 and 40 feet from the entrance point located in Building 814.

Figure D6. Photo of inner pipe after application of epoxy and near leak point at 40’.

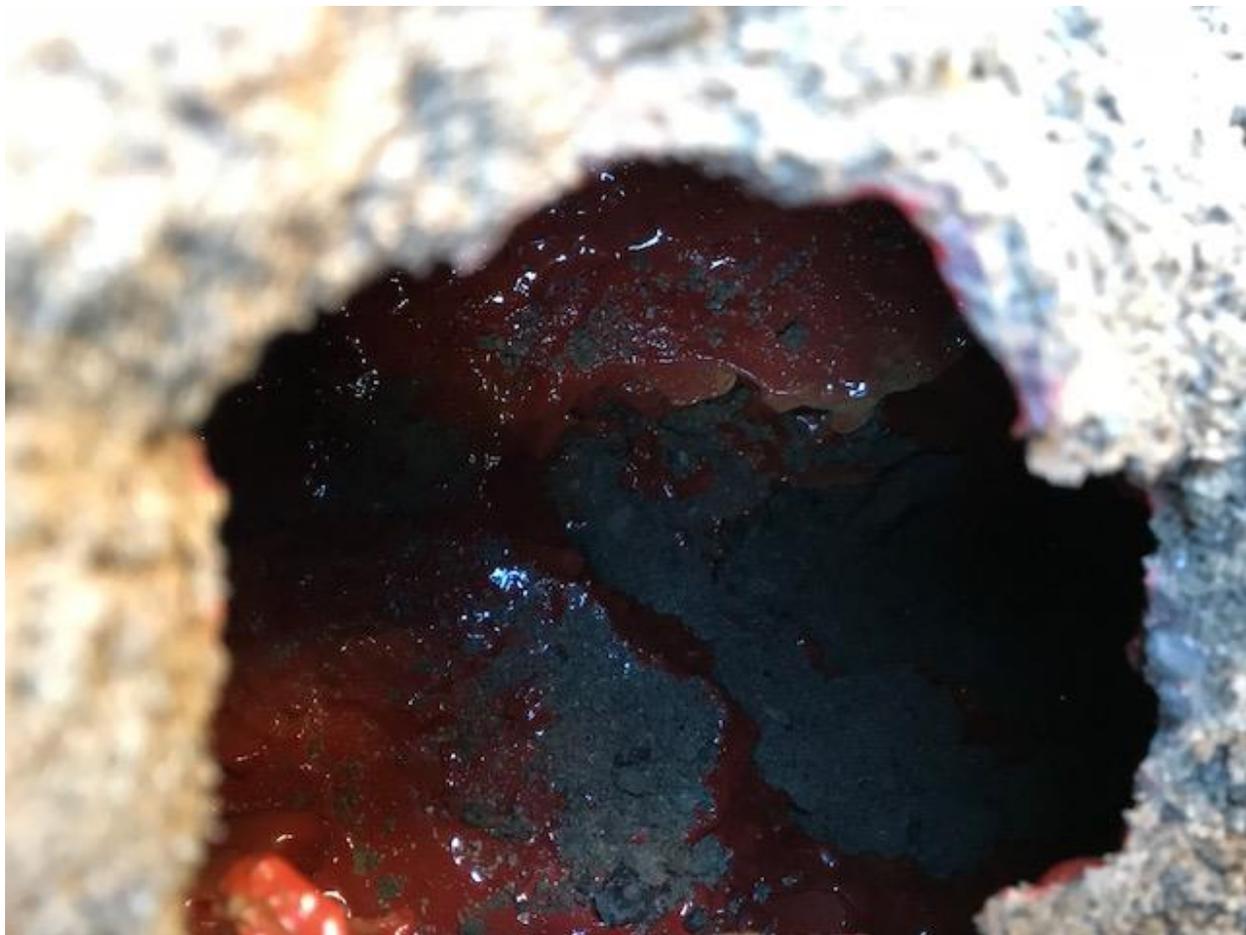
Removing the soil surrounding the air passage led to the discovery of a large void in the earth above the pipeline. Figure D7 display the hole, which was estimated to be slightly larger than a cubic foot in volume. Presumably, this void was created from years of leaking compressed air which slowly stripped the soil surrounding the pipeline and pushed it through soil cracks and fissures induced by pressure as well as above ground road activity. Engineers noted that the void's outer shell was fully coated with epoxy ranging from 1/16" to 1/2" thick and wondered if it may have been better to use ground penetrating radar (GPR) to identify the exact location of the pipeline. Using GPR may have detected the presence of the voids and major breaches which could have been used to better select pipe repair/replacement procedures.

Figure D7. Void region in the soil above the pipeline.

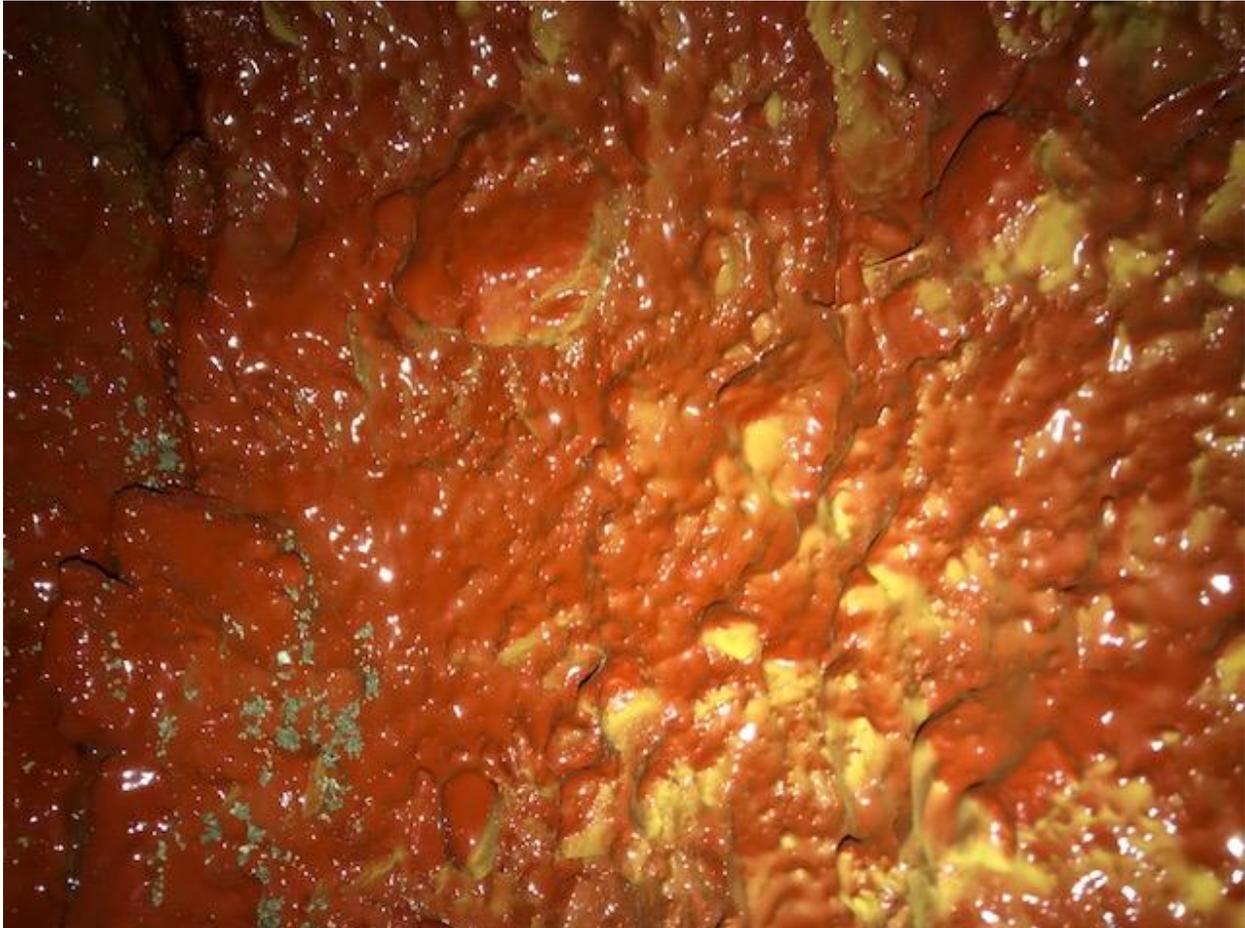
Figure D8 shows the inner walls of the void were coated in large amounts of epoxy resin that had to be chipped away or broken when digging into the void. The amount of the epoxy deposited in this void seemed to be much more than the quantity originally estimated to coat the entire length of the pipeline (i.e., beginning to end). The coating was paper thin in some areas and inches thick in others. The coating seeped into pores and fissures in the dirt and between rocks to form a solid matrix of dirt, rocks, and resin in the thickest areas.

Figure D8. Hardened epoxy coating on the inner side walls of the void.

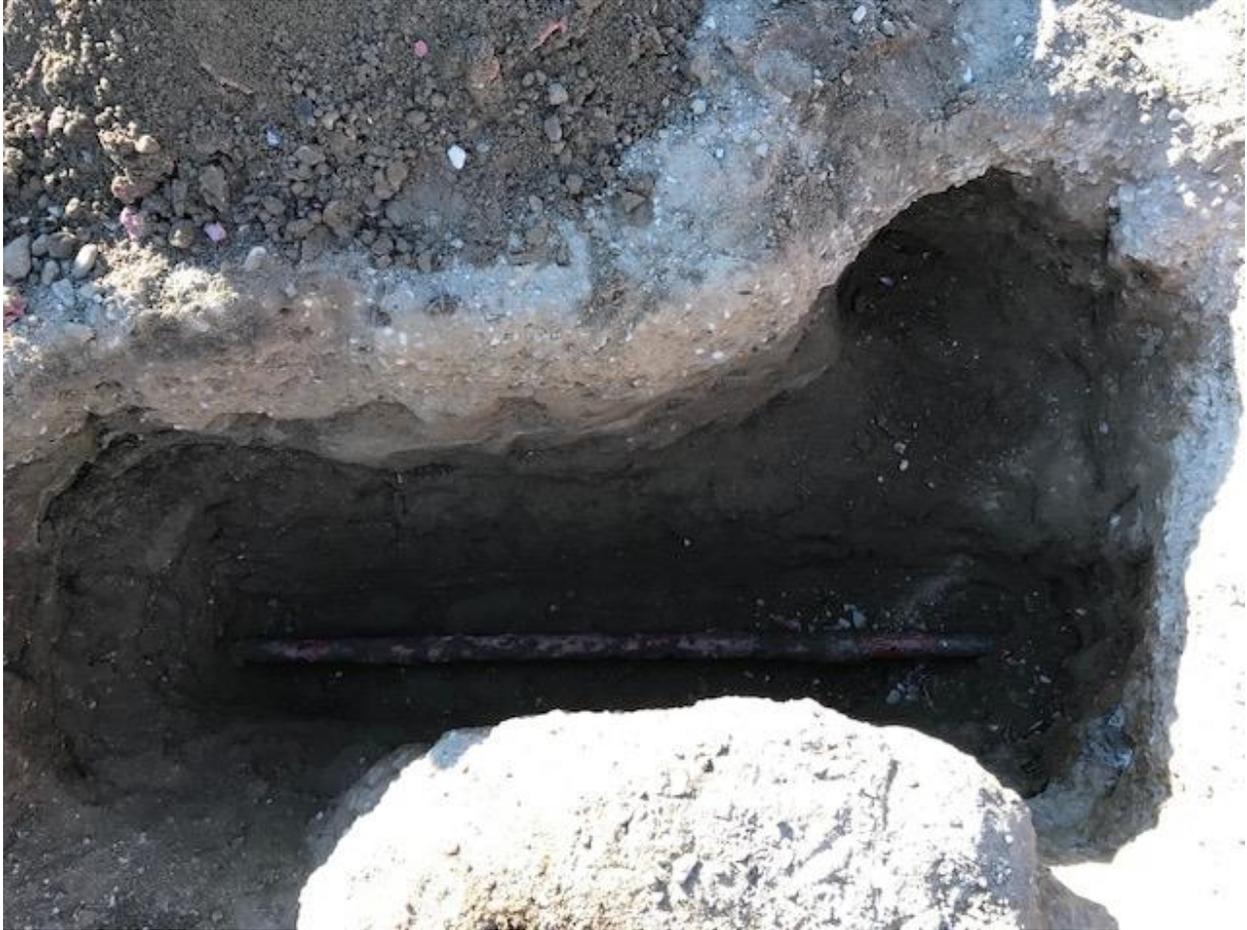
After digging out the void, the underground pipeline was discovered directly underneath. Figure D9 displays the exposed pipeline with the void and the associated leak located on the left.

Figure D9. Exposed length of underground pipeline within the 7'x7' area.

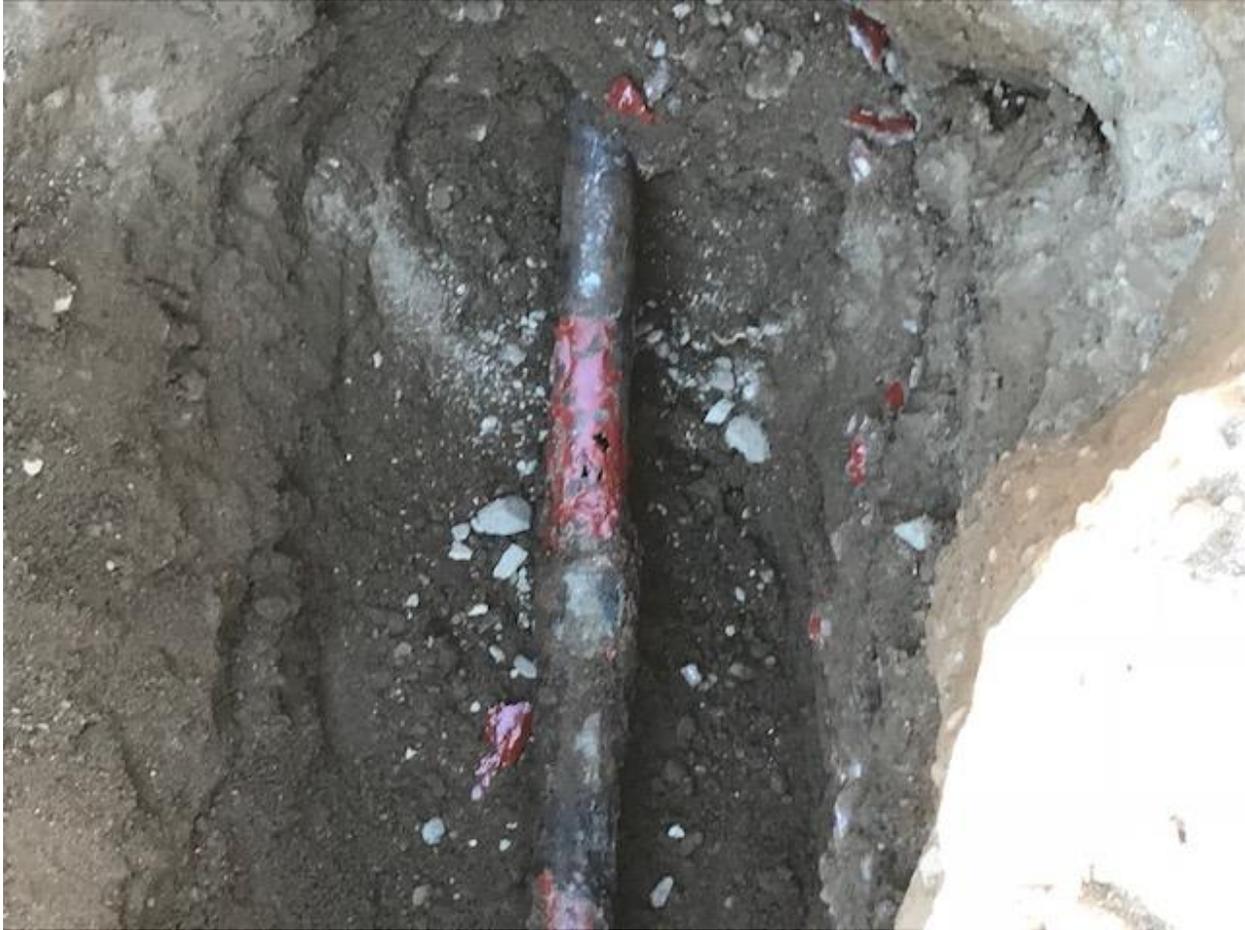
The pipeline had originally been wrapped in a protective material. However, this material was significantly deteriorated in the uncovered area. The wrap had become rough, hard, and extremely brittle. Figure D10 shows the condition of the pipeline with protective wrap. In some sections of the pipe it was difficult to differentiate the wrapping material from corrosion. Nonetheless, corrosion was prevalent on the pipe in particular in the areas surrounding the holes responsible for the leaks. In addition, loss in pipe wall thickness was exhibited around the holes. Sections of pipe around the holes were only a few millimeters thick. Both holes were located in the 12 o'clock position. The cause for the accelerated corrosion is unknown but it is suspected that previous construction/excavation in the area directly above the underground pipeline may have compromised its integrity.

Figure D10. The picture shows one the leaks that formed as a result of heavy corrosion.

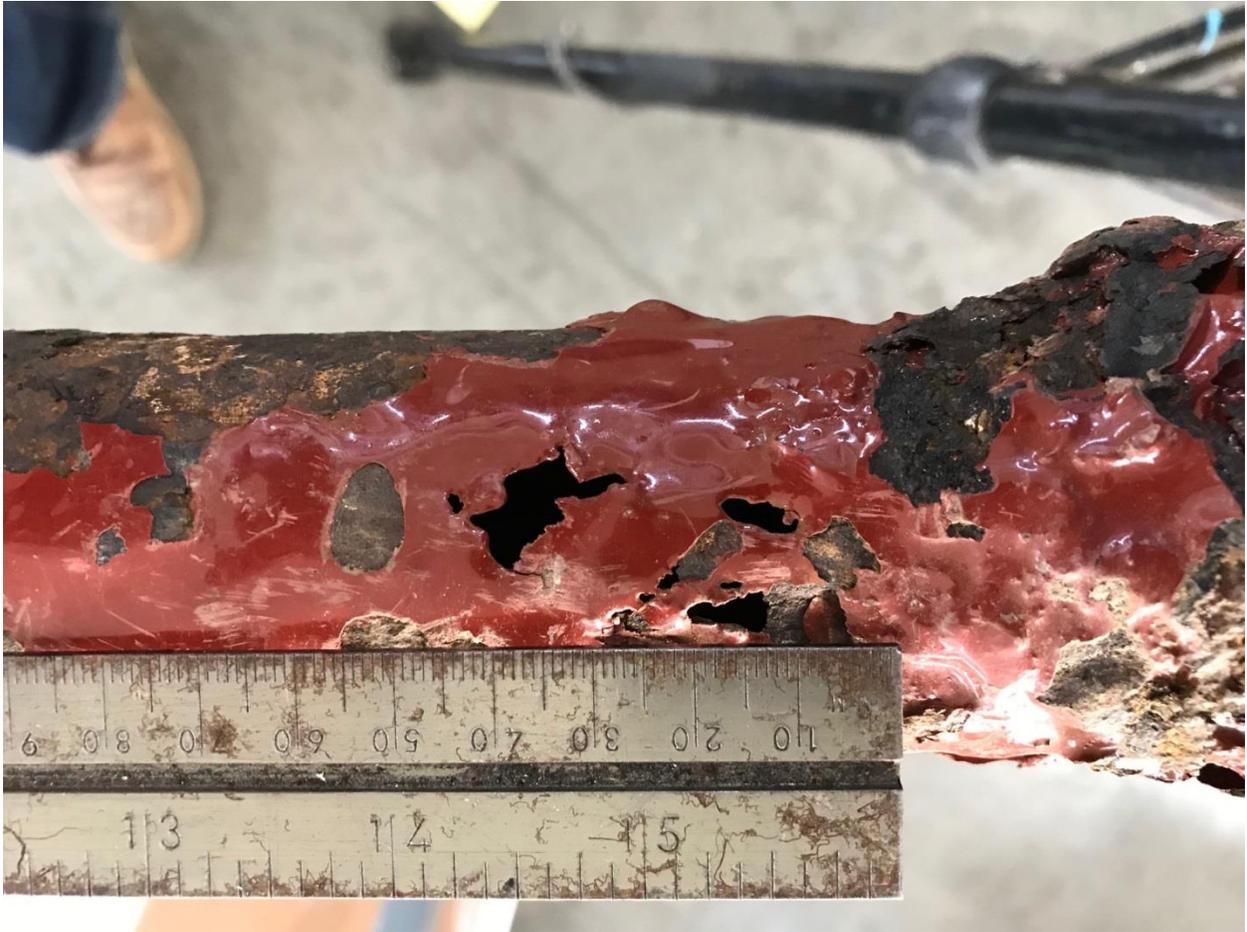
Figure D16. First-hole located in section A at the 12 o'clock position.

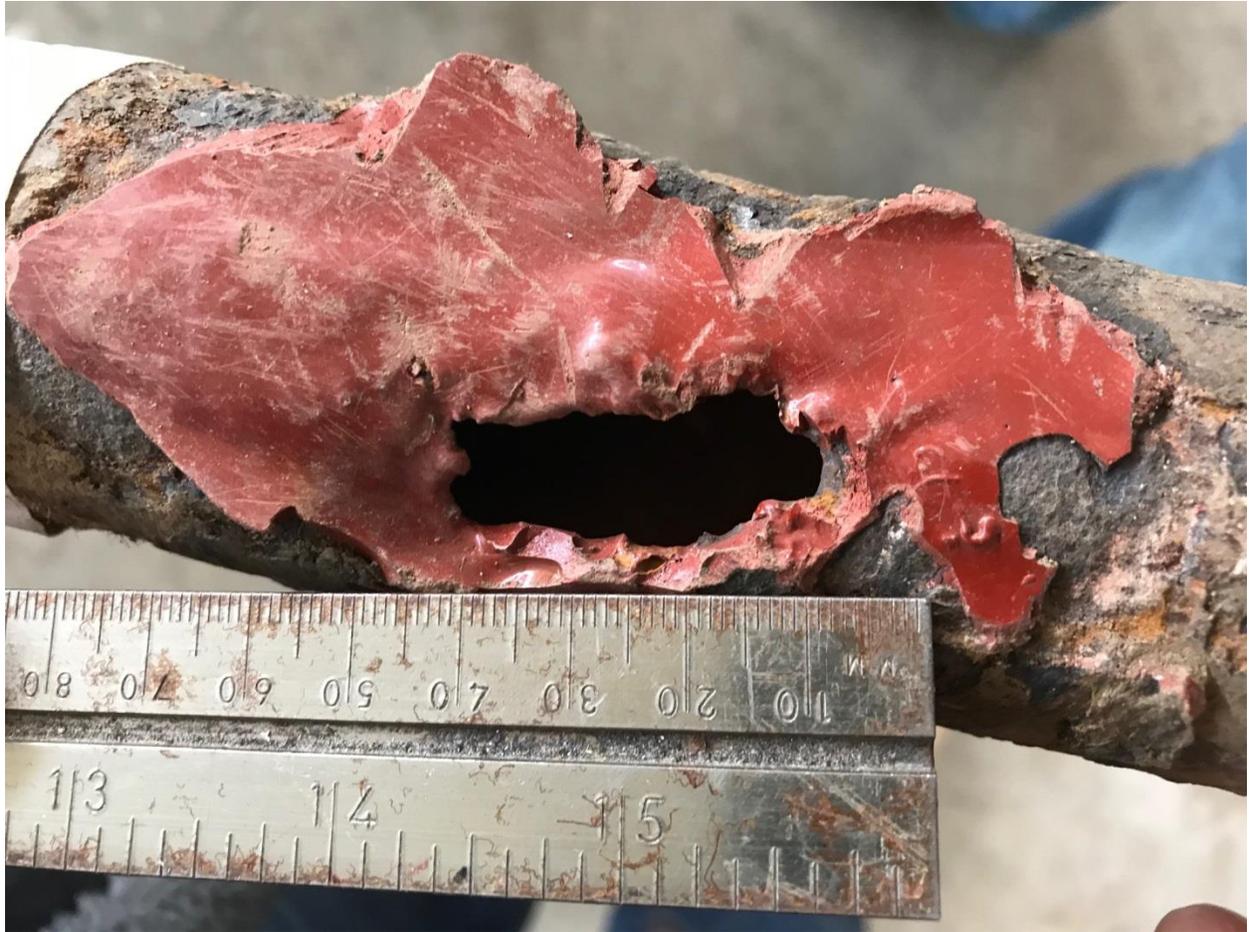
Figure D17. Second-hole located in section E at the 12 o'clock position.

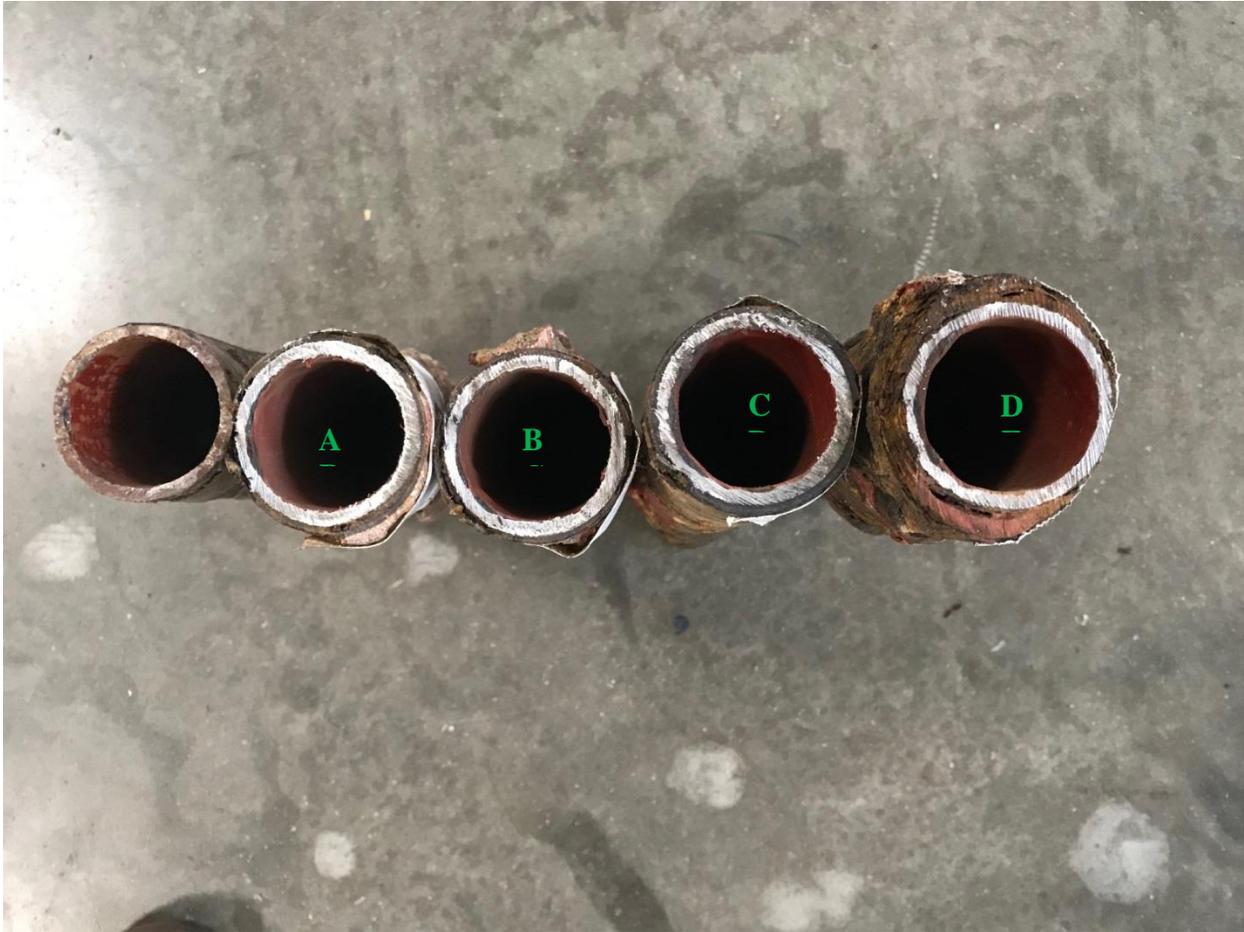
Figure D18. Visual inspection of pipe thickness at each cut.
