ESTCP Cost and Performance Report

(EW-200813)

BUILDING INTEGRATED PHOTOVOLTAIC (PV) ROOFS FOR SUSTAINABILITY AND ENERGY EFFICIENCY

April 2013

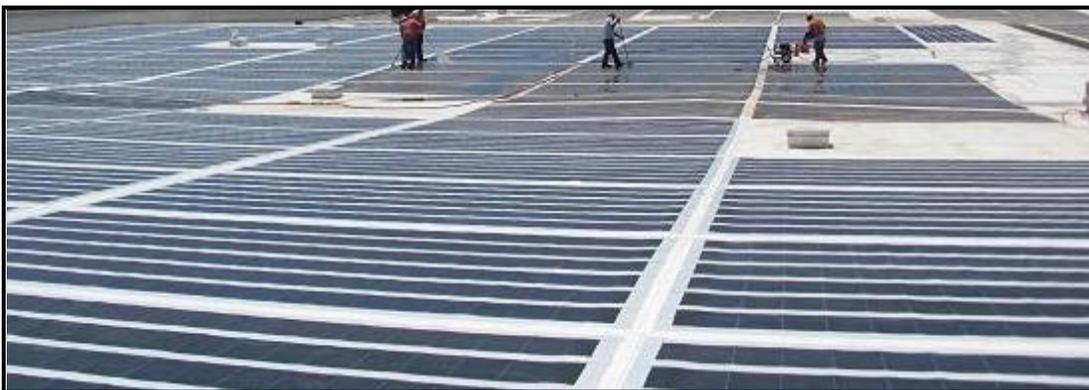
Figure 5. Luke AFB BIPV roof being cleaned during adhesive-failure fix.

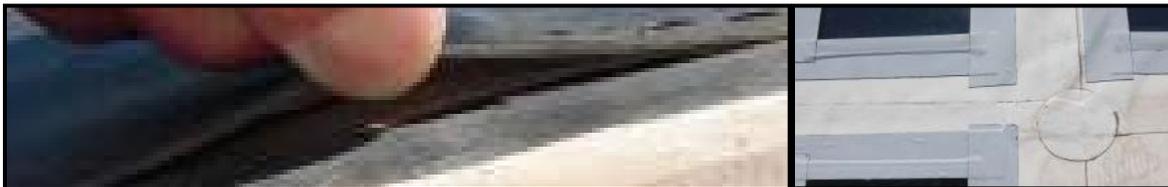
The left photo in Figure 13 shows the bond failure between the PV and PVC carrier sheet. Since the PVC carrier sheet may still provide for a water tight roof assembly, problems experienced by the PV modules may not impact ROOFER scoring. In response to the bond failure, the PV manufacturer taped the frame around the PV to the adjacent PVC membrane in an attempt repair the problem in May 2010 (Figure 13, right). Unfortunately, some of the tape deteriorated less than six months after it was applied. The deteriorated tape exposed adhesive residue, which collected dirt and reduced the overall reflectivity. Figure 14 shows some of the tape deterioration along with soiling of the PV modules. The significant soiling was a result of the low-slope surface, which does not allow for all the water to completely leave the area and causes any dirt trapped by the water to settle on the roof after the water evaporates. The soiling on the PV modules will reduce the overall roof reflectivity and the energy output of the PV system.

Figure 13. Bonding failure (left) and tape solution (right) between PVL and PVC at Site I (Luke AFB).

Site I (Luke AFB) was the only site out of the three where maintenance and repair was performed. The PV bonding failure resulted in the May 2010 tape fix shown in Figure 14. While the bonding failure did not occur throughout the PV system, the PVL manufacturer applied the tape solution on the entire PV system as a preventive measure. However, as can be seen in the photograph, some of the tape deteriorated later that year, so the tape needed to be reapplied. In addition, Site I (Luke AFB) required the replacement of one BIPV panel (i.e., an entire set of PVLs bonded to one carrier PVC sheet) because at least two of the PVLs were corroding due to water penetrating the encapsulation.

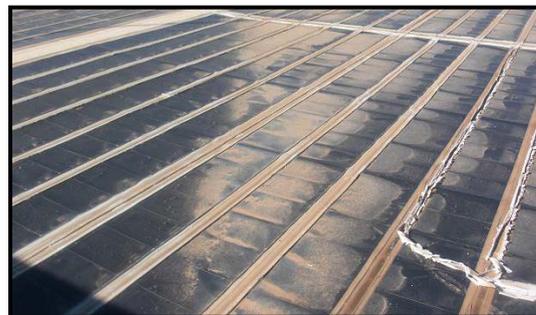
Figure 14. Tape deterioration and soiling of the PV system at Site I (Luke AFB).

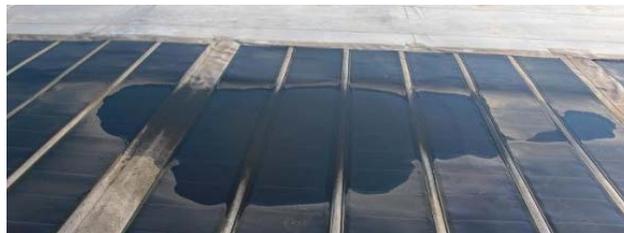
Figure 17. Site II (NAS Patuxent River) water ponding.

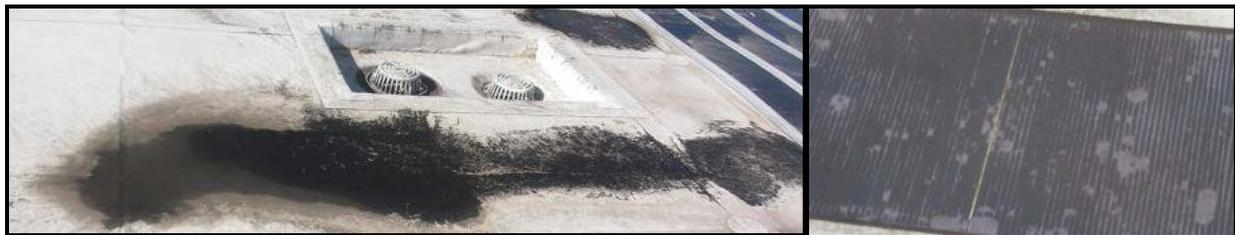
Qualitative inspections of other BIPV roofs similar to those in this study were made. This type of BIPV roof endured well in some areas and some of the notable deficiencies were due to poor construction and practices. In one location, the tape solution prevented water drainage. That same system also experienced significant mold growth due to its tropical environment. Another system experienced localized mold growth due to water ponding (Figure 21, left). The right photo in Figure 21 shows discoloration indicating that the encapsulation of the PV laminate has been compromised. This occurred only in areas where there was significant water ponding, but it is possible that the damage was actually due to snow build-up and the exposure of the encapsulation to freezing temperatures. Interestingly, the tape solution appeared to be unaffected.

Figure 21. Severe, localized mold growth due to water ponding (left) and PV delamination (right).

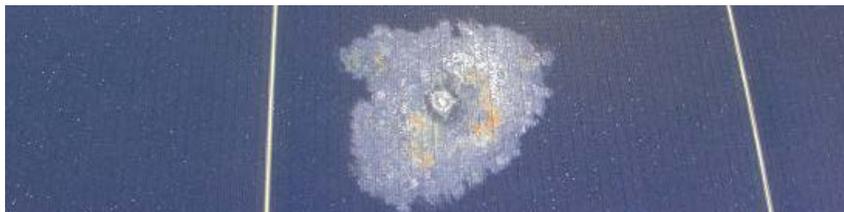
Site II (NAS Patuxent River) did require some maintenance due to a pin-size hole in the PV, but there was difficulty in finding local personnel to perform the maintenance due to the need to operate a small flame to patch the hole (Figure 23). Corrosion is expected to spread to the rest of the cell. Fortunately, the PVL includes bypass diodes connected across each cell, which allows the rest of the cells in the PVL to continue to produce power. The mold growth that was shown earlier is also a concern, but as it was stated earlier, an attempt to remove the mold will likely cause more damage to the roof. The only way to stop additional mold growth is to keep the roof dry, which is impractical, so the only remaining practical course of action is to ensure that the roof remains water tight, such as by surveying the roof every one-to-two years, and replacing the roof at its end of life. The tape solution was not applied to this site due to the lack of the PV bonding problem and the desire to study the BIPV roof as it was originally designed.

Figure 23. Corrosion of PV material due to a pin-size hole at Site II (NAS Patuxent River).
