Portable Cold Spray Repair  
ASETS Defense Workshop  
August 21-23, 2018  
Denver, CO

Timothy J. Eden, Ph.D.  
Head of the Materials Processing Division, Applied Research Laboratory  
The Pennsylvania State University  
P:814.865.5880  
email: [tje1@arl.psu.edu](mailto:tje1@arl.psu.edu)

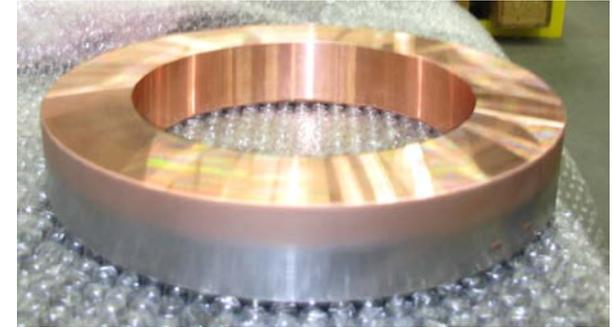
Copper Coated Steel Ring

- Steel housing wears causing vibration in the motor
- Replace copper plating with longer lasting solution
- Machine worn area to remove damage
- Restore surface to original dimension
- Replace Copper Plating
- Develop repair process

- Cu                      8.5 ksi
  - Ni                      >11 ksi
  - NiCr-Cr<sub>3</sub>C<sub>2</sub>        >11 ksi 42 HRC
- Coating Parameters Established
  - Process demonstrated on steel rings
  - Can be machined with conventional tools
  - Coating Final mock-up for UIPI

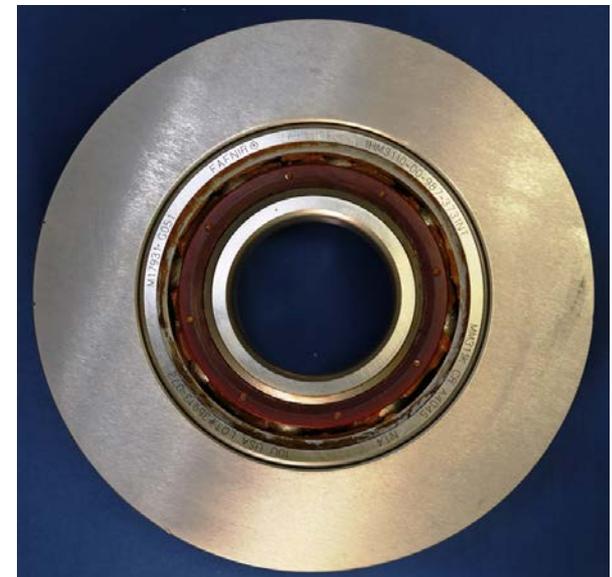
NiCr-Cr<sub>3</sub>C<sub>2</sub> Coated Steel Ring  
with bearing installed

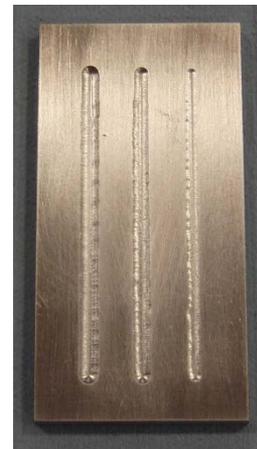
Al-6061  
Substrate

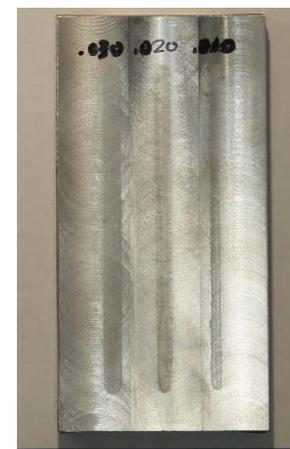
Coated and  
Machined

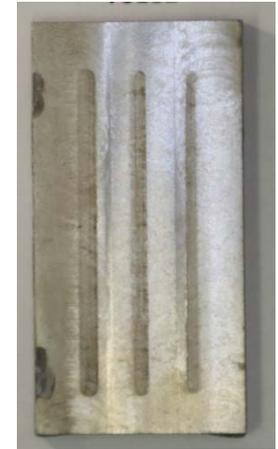
After 689 hrs in  
B117 11

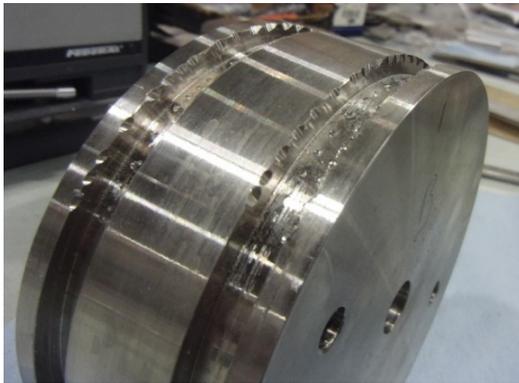
**Damage to simulate  
damage during use**

- **Substrate**
  - 70/30 CuNi
- **Deposition**
  - Nitrogen
  - Inconel-Cr<sub>3</sub>C<sub>2</sub>
  - Cu116-Cr<sub>3</sub>C<sub>2</sub>
- **Testing**
- **Corrosion**
  - Salt Fog
  - Crevice
  - Galvanic Potential
- **Adhesion**

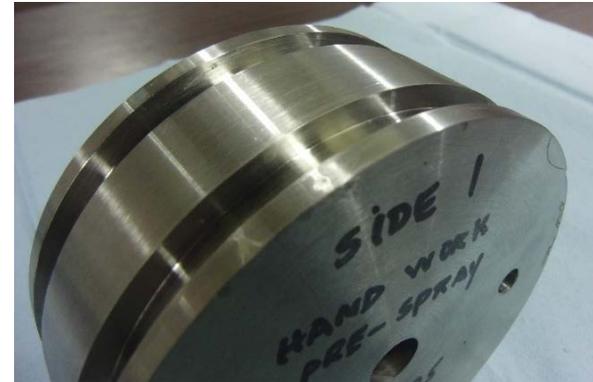
**Sprayed and Machined**

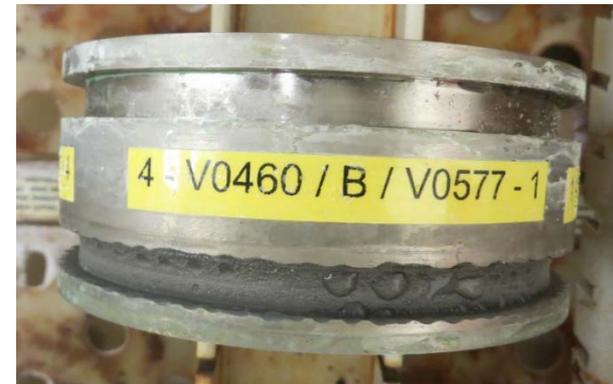
**Upper ringed – repaired  
Lower ringed – not repaired  
100 hrs ASTM B117 Salt Fog**

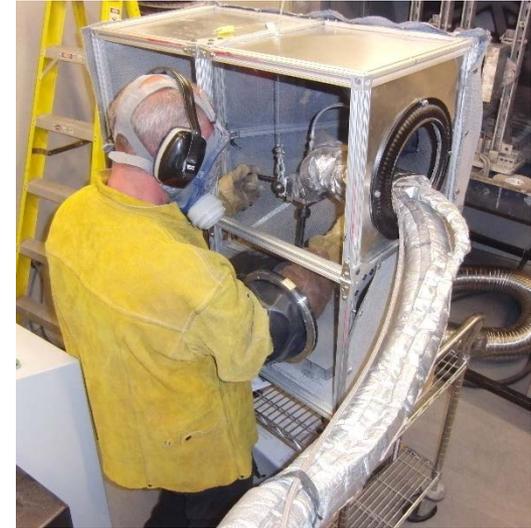
Hand Held Repair using modified grip in the portable glove box

- Sound dampening material
- Flow/temperature testing
- Powder removal vs flowrate
- Work envelope
- Testing for particle containment
- Flexible/reconfigurable

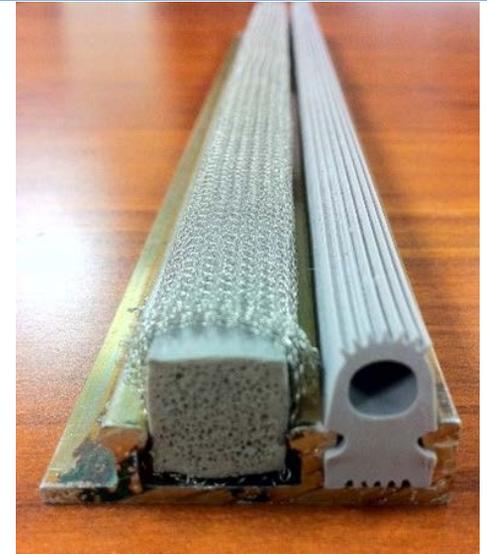
EMI and sealing gaskets

- **Al-6061**
  - He
  - N<sub>2</sub>
- **Robotic and Hand Held Repairs**
- **Find curvature of the door**
- **Machine damaged areas**
  - **Limited material removal**
  - **Blend deep pits**
- **Apply Al-6061**
- **Machine**
- **Blend any areas that need additional material**
- **Apply Al-6061**
- **Machine**
- **Hand Finish**

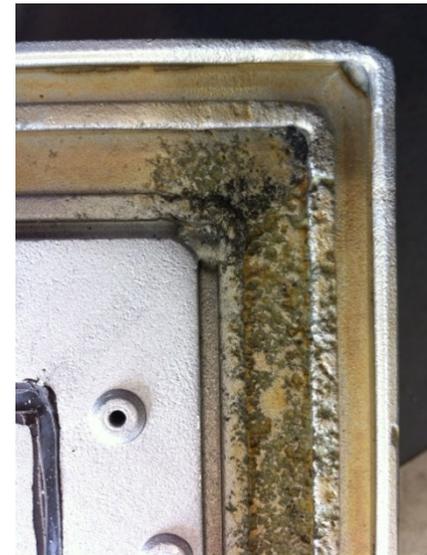
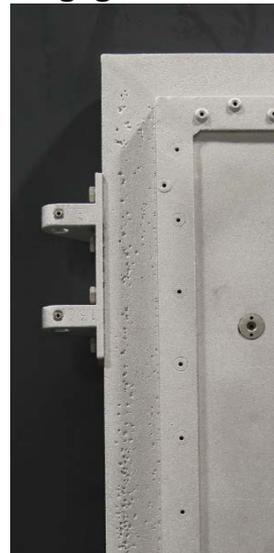
Pitting Corrosion
