# FINAL REPORT

Zinc Bromide Flow Battery Installation  
for Islanding and Backup Power

ESTCP Project EW-201242

SEPTEMBER 2016

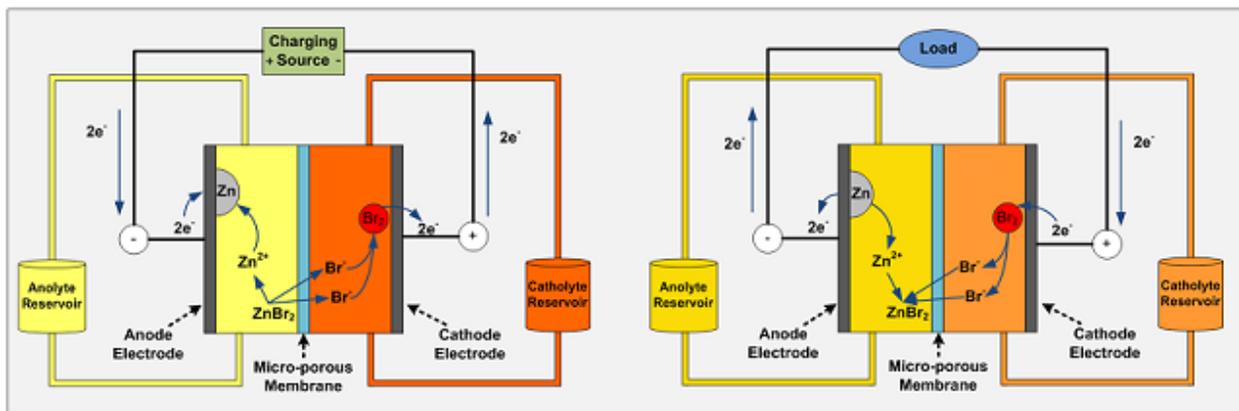
Figure 2-1: Schematic of a traditional Zn/Br cell with two electrolyte flow loops.

The traditional Zn/Br cell design uses carbon coated felt paper as the electrode surface. The cells also have two separate electrolyte tanks for capturing the anolyte and catholyte separately during charge and discharge. These separator membranes and carbon paper often are subject to degradation and contamination and are a common failure mechanism amongst Zn/Br batteries that requires recurring replacement. Traditional Zn/Br needs to be replaced after 1500 cycles which would constitute replacement every 4.1 years if cycled daily.

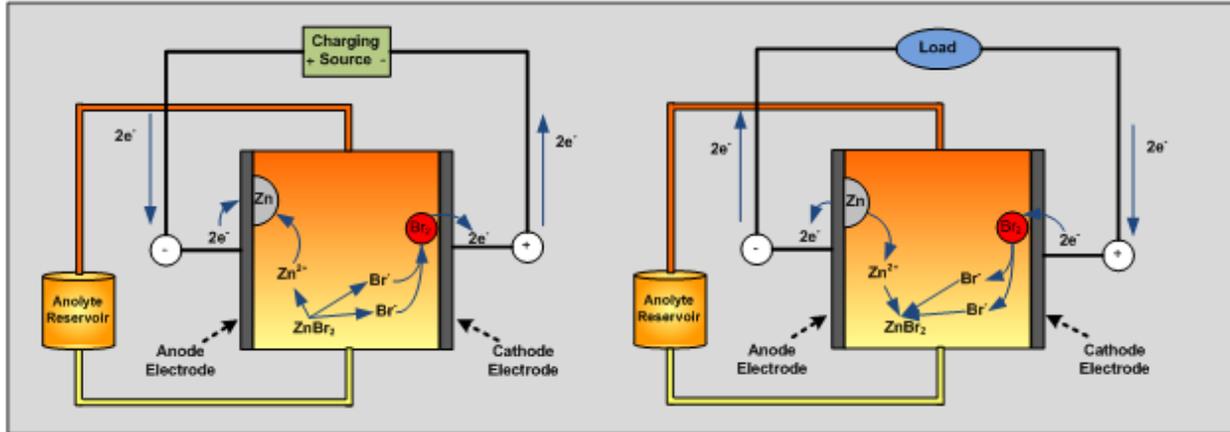
**Figure 2-2: Schematic of Primus' approach to a Zn/Br cell using a solid titanium electrode and a single flow loop of electrolyte.**

Primus Power took a different approach to their Zn/Br cells. Instead of using carbon coated felt paper for their electrodes Primus utilizes an activated solid titanium electrode for its Zn plating surfaces. Using a titanium electrode provides Primus the capability to use a single flow loop of electrolyte as opposed to dual flow loops as well as eliminate the need for an ion exchange membrane, which is an early failure mechanism in tradition Zn/Br cells. This reduces the number of tanks required and pumps for managing the electrolyte (Figure 2-2). The titanium electrodes also provide better energy density when compared to traditional Zn/Br 3.1 kWh/ft<sup>2</sup> vs 1.7 kWh/ft<sup>2</sup>.

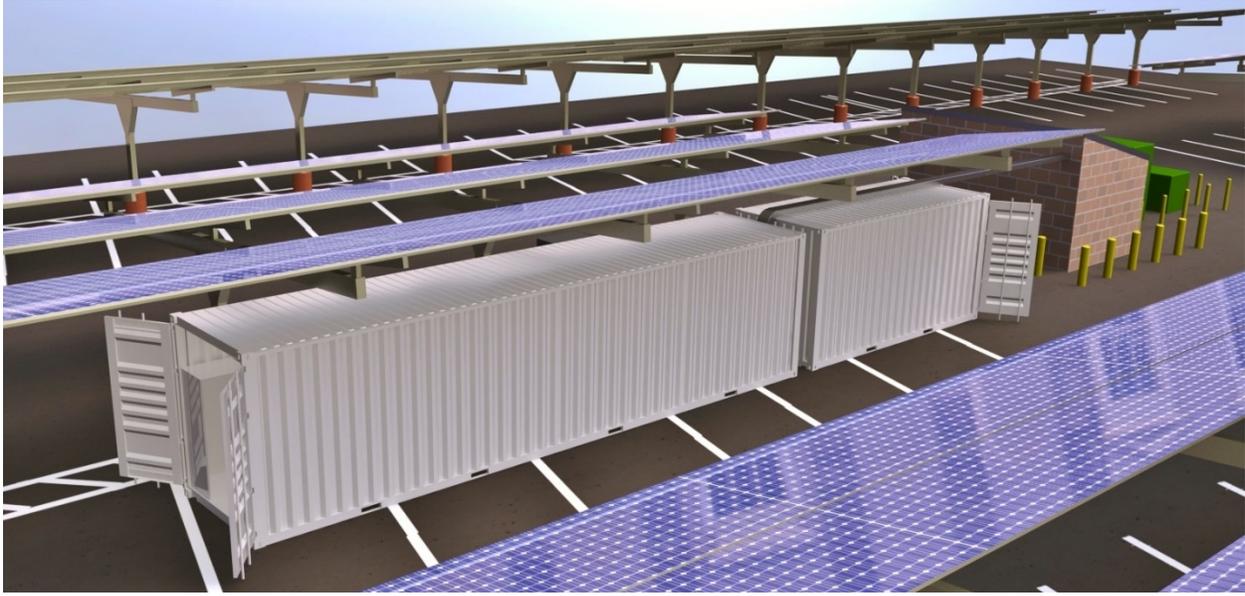
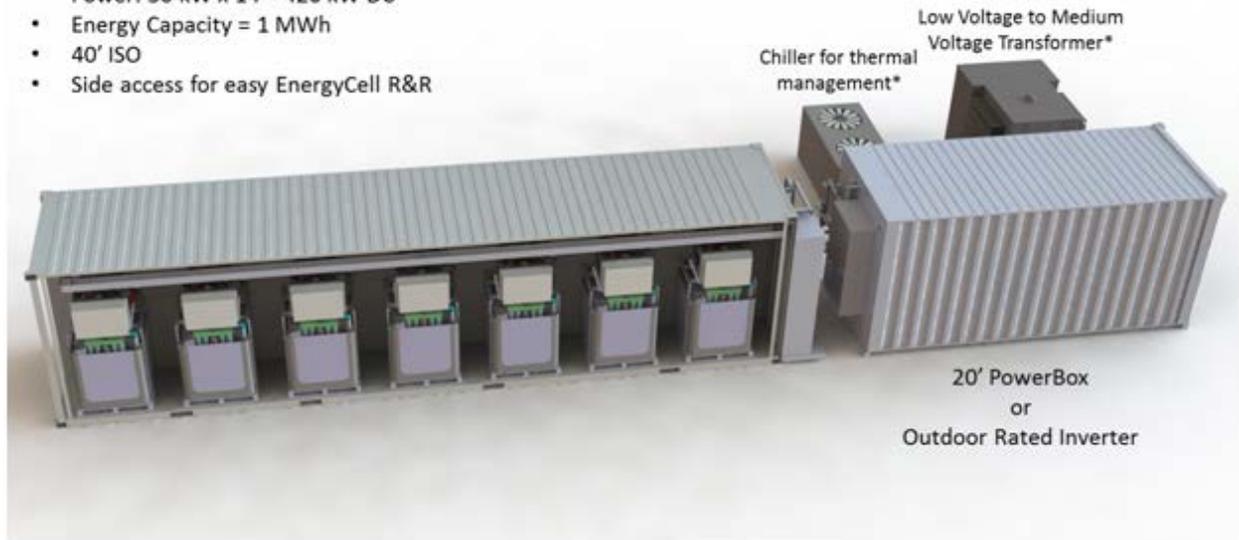
- Power: 30 kW x 14 = 420 kW DC
- Energy Capacity = 1 MWh
- 40' ISO
- Side access for easy EnergyCell R&R

**Figure 2-4: Illustration of Primus EnergyPod system complete with Zn/Br cells, power electronics, and thermal management.**

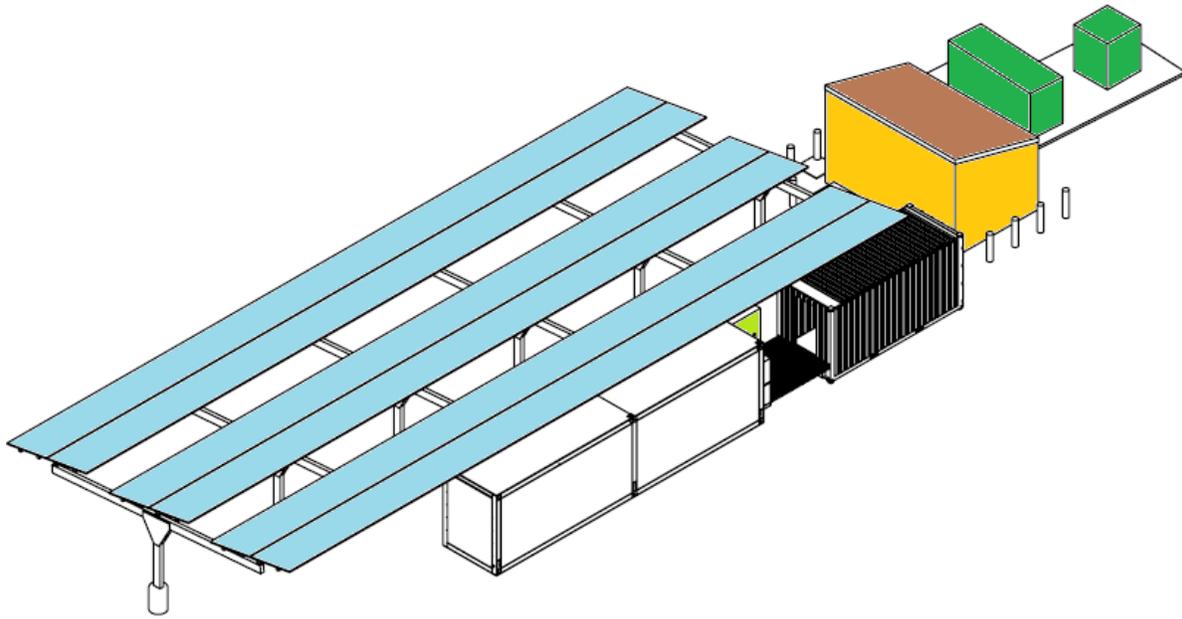
**Figure 2-5: Isometric view of the construction plans.**

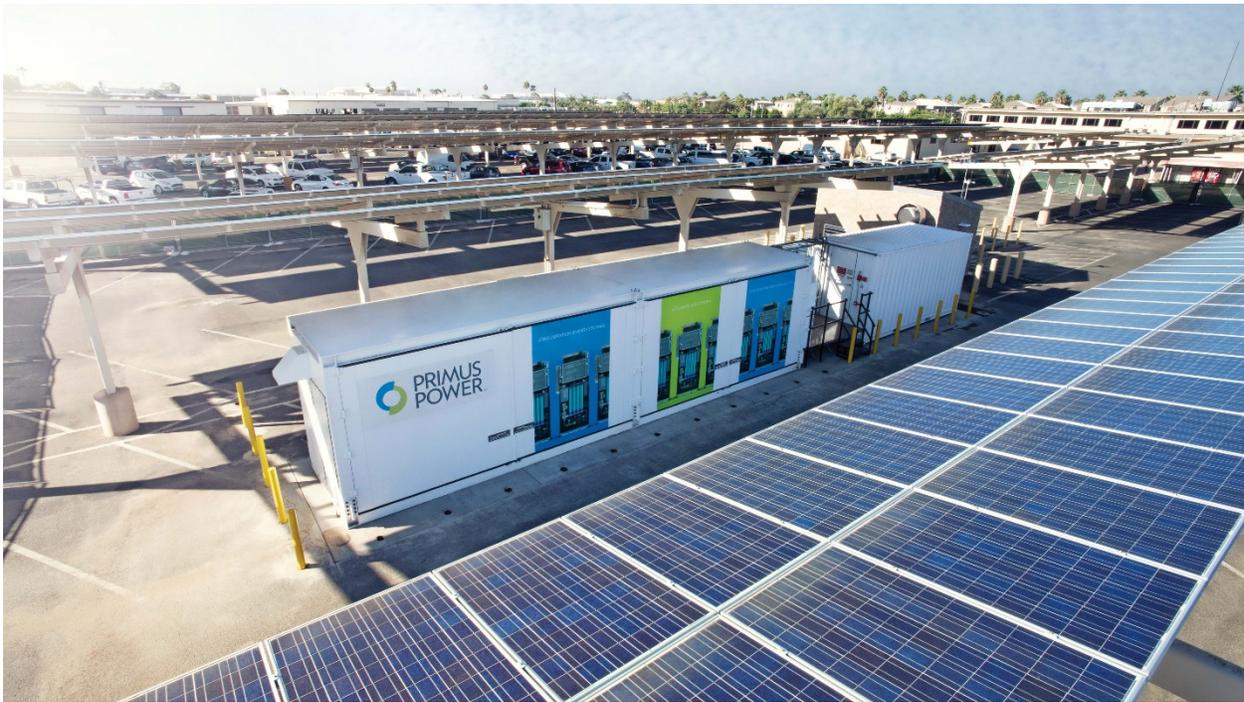
**Figure 2-6: Photo of installed system at MCAS Miramar.**

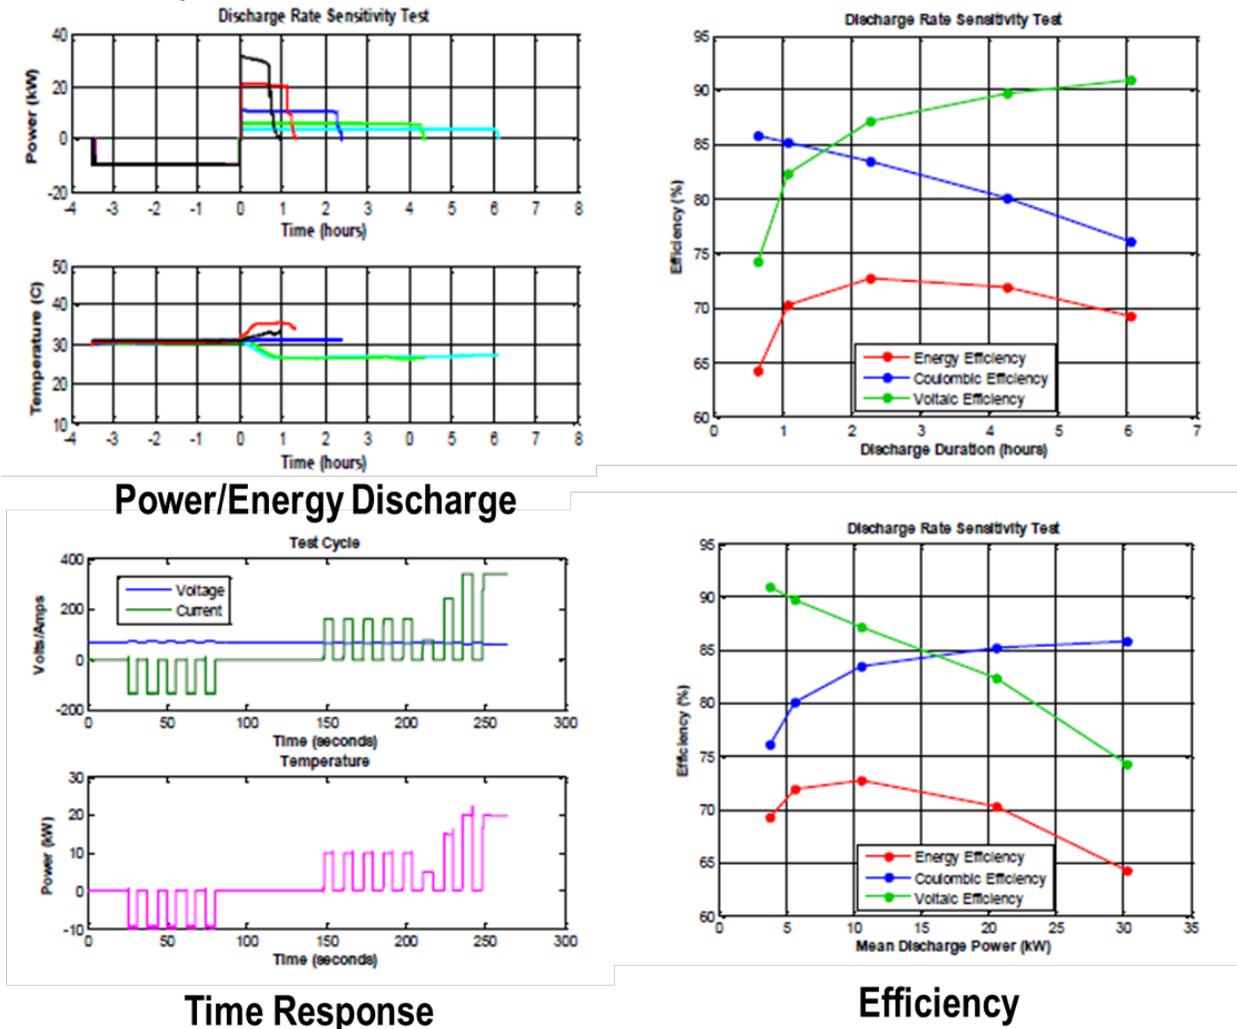
Figure 2-9: Summary of results of Sandia 3<sup>rd</sup> party testing.

The testing also showed additional work was required to meet demonstration islanding duration objectives with reasonable load shedding. At 20kW EnergyCell was discharged at 20kW and achieved an energy capacity of 25kWh at just over 1 hour of discharge time. At 3kW of discharge power the capacity test resulted in 2+hr (43kWh) performance. In order to meet our system level performance objective with the number of EnergyCells originally proposed each energy cell would need to have an EnergyCapacity of 80kWh at 20kW. After the testing Primus showed that in-house testing of smaller cells had exceeded 40kWh with altered additives and discharge controls. Primus planned to continue developing electrolyte chemistry and charging modifications to meet the 80kWh objective in their SOW.

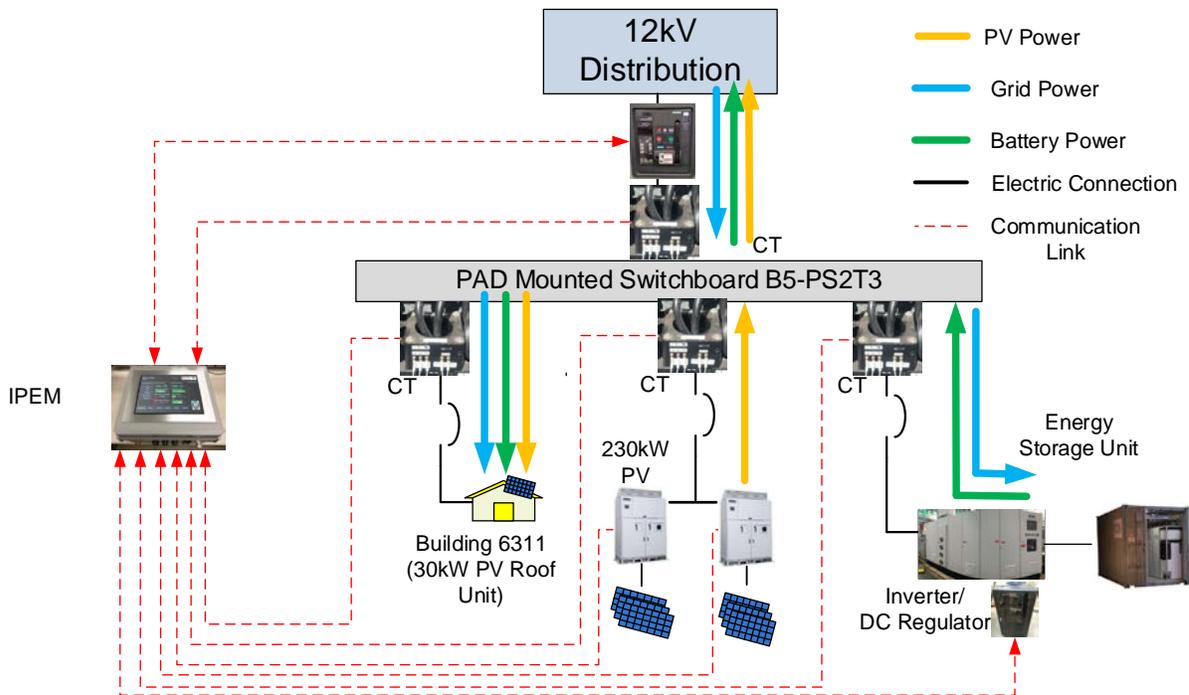
**Figure 2-10: One line diagram for the MCAS Miramar microgrid circuit for the ESTCP project.**

While Primus was working on scaling up and building their large scale system in 2014, Raytheon orchestrated hardware in the loop testing of the Miramar microgrid utilizing the National Renewable Energy Laboratory (NRELs) Energy System Integration Facility (ESIF) funded by Raytheon outside the funding of this ESTCP program but provided was directly beneficial to this project. The intention of the testing was to provide high-fidelity evaluation of the MCAS Miramar microgrid in a simulated operational environment with real hardware in the loop testing with full-scale/full power simulated sources and loads. The system testing reduced a lot of risk on integrating the IPEM controller to manage the existing Advanced Energy PV inverters at MCAS Miramar, the Primus ESS, and the various metering and control logic of the microgrid. The testing at NREL was designed to re-create the designed Miramar microgrid at as high a fidelity as possible. Figure 2-10 below shows a one line diagram for the Miramar microgrid circuit for the ESTCP project.

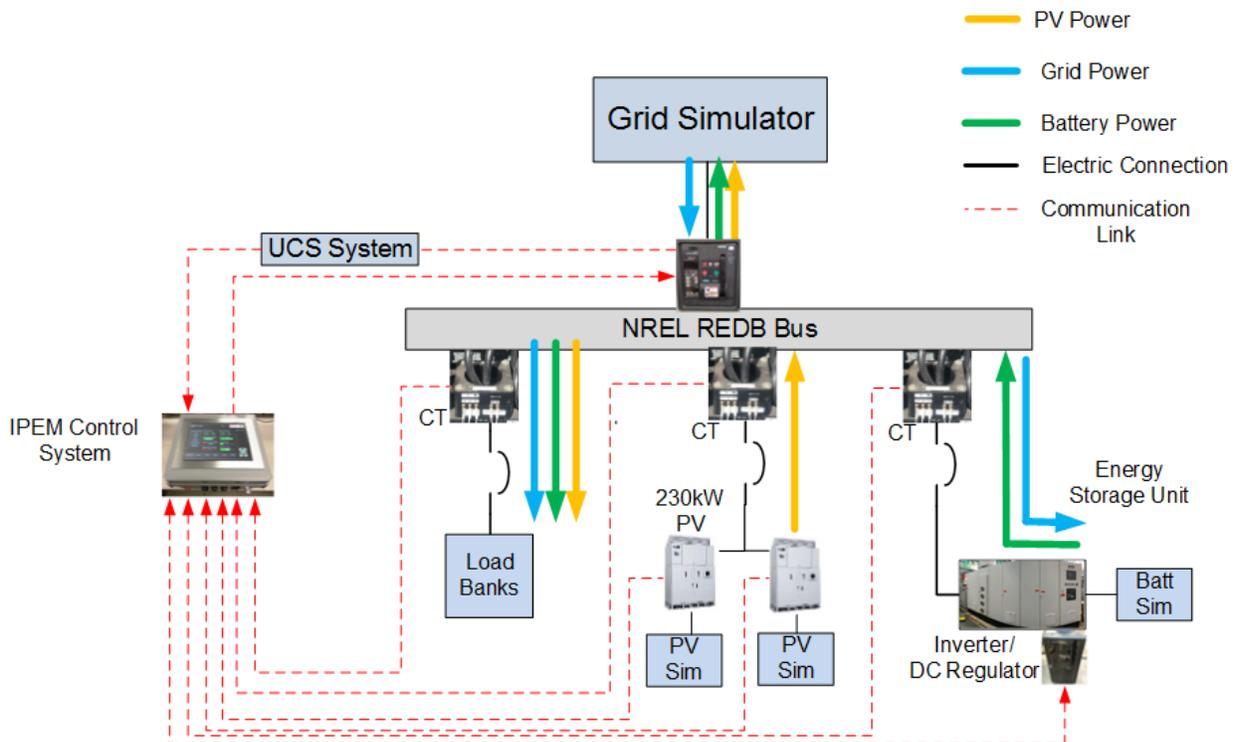
**Figure 2-11: One line diagram design for test setup at NRELs ESIF facility.**

Figure 2-11 shows the one line diagram for the circuit that was designed to be used at NRELs ESIF facility. The NREL system utilized the same PV inverters that exist at MCAS Miramar, a similar main breaker point of common coupling, and the same inverter & BMS utilized by Primus' ESS.

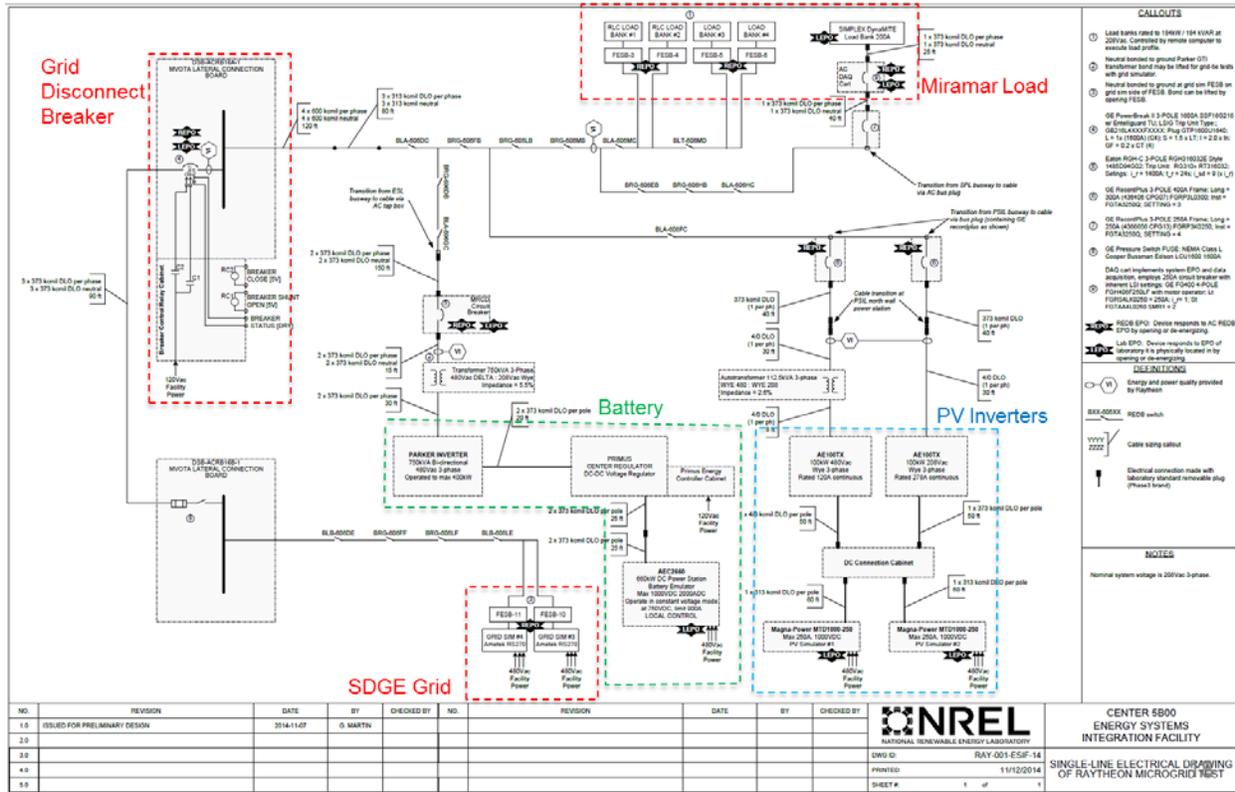
Figure 2-12: Detailed single line diagram implemented at NREL for ESIF testing.

The end result for the configuration used at NREL is shown in the detailed single line diagram shown Figure 2-12 below.

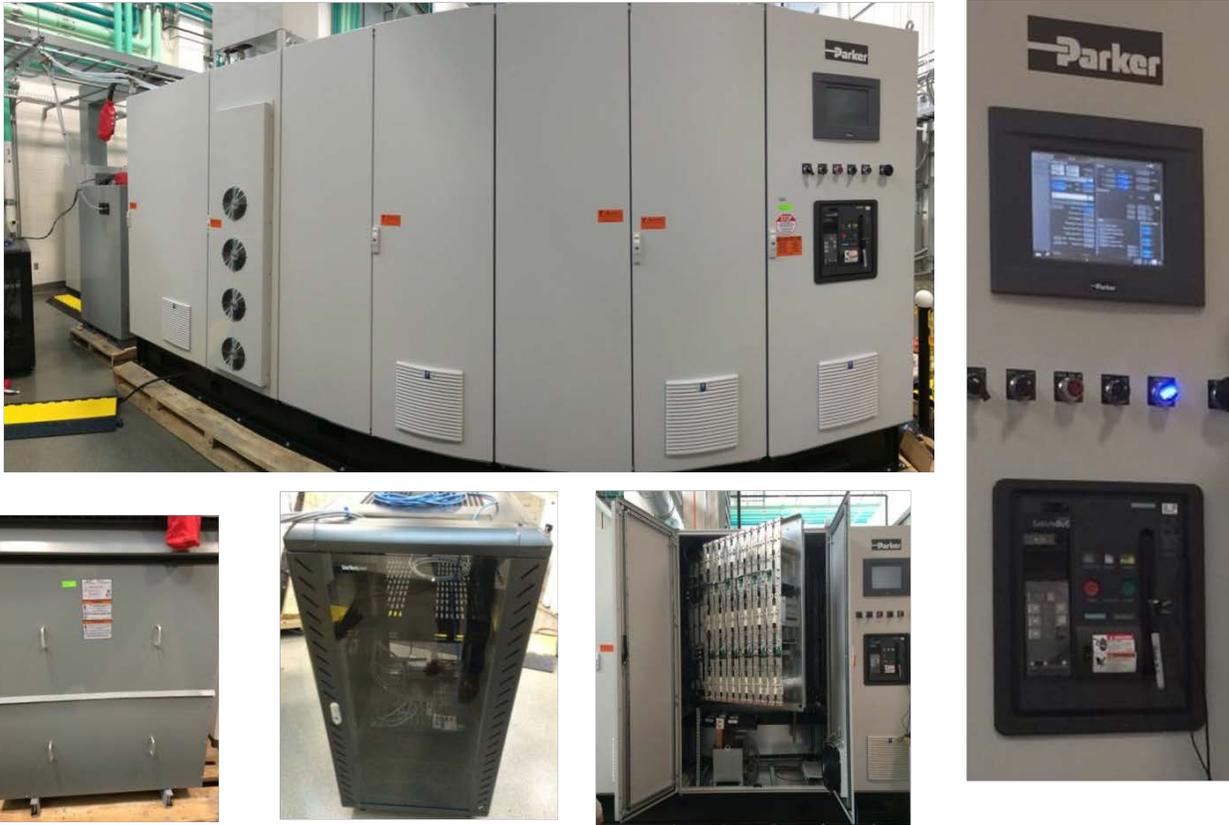
**Figure 2-14: Photos of the various equipment that is part of the NREL testing. The top left image is of Primus Powers 760kVA Parker grid tied inverter that is the main element in Primus' power electronics subsystem. The bottom left is of a 480 to 208 transformer, the bottom second from the left is Primus' EnergyBlock controller which manages Primus AC & DC busses. The bottom third from the left shows the capacitor bank within the Parker inverter. The right most image shows the AC breaker for the Parker inverter and the local HMI display.**

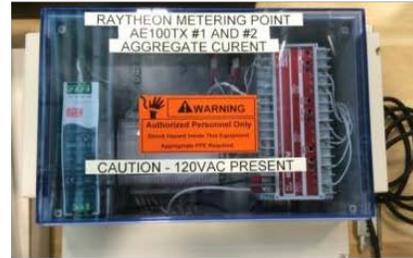
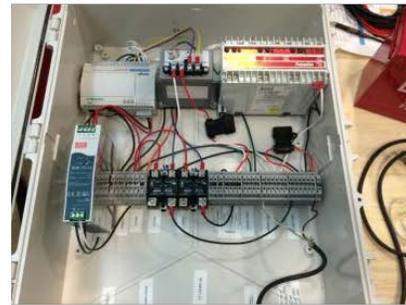
**Figure 2-15: Photos of the IPEM controller and ancillary equipment used during the NREL testing.**

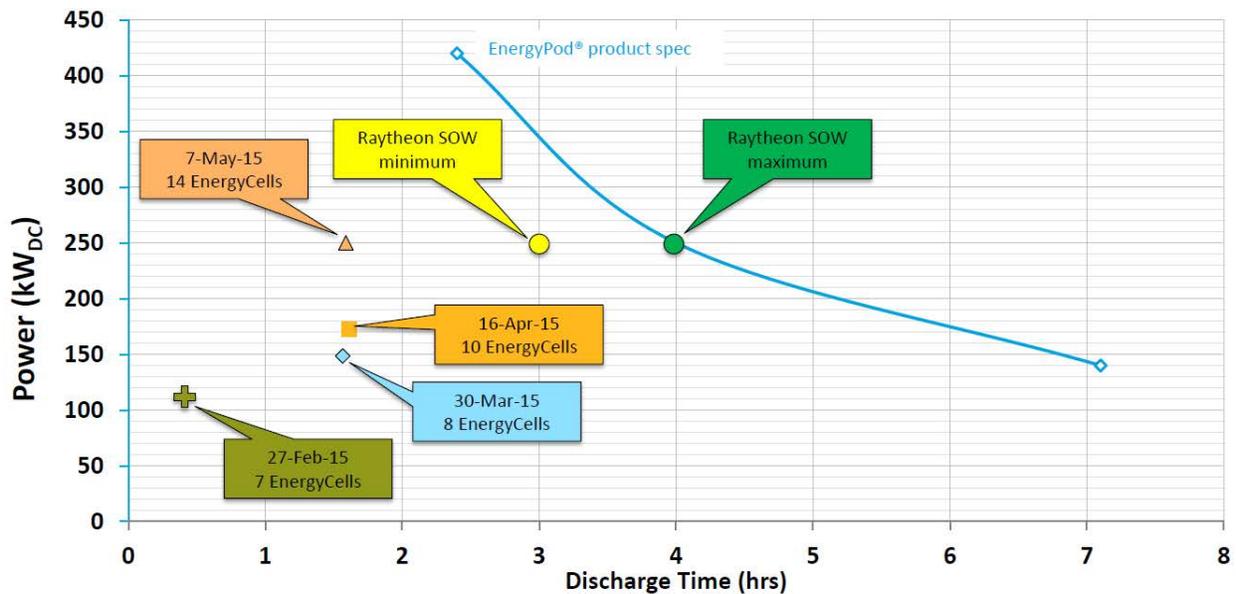
Figure 2-16: Energy capacity timeline and scale up from Primus Power since the November 2013 briefing.

During the course of the build of the ESS Primus Power was continuously trying to improve its energy capacity capabilities of their EnergyCells based on the original assessment by the Sandia testing. At the time of the FAT Primus presented their current state of the energy capacity available with the configuration of EnergyCells that were to be delivered to MCAS Miramar. Figure 2-16 below shows the progression of meeting the targeted energy capacity as Primus was able to manufacture more of its EnergyCells to populate the system.

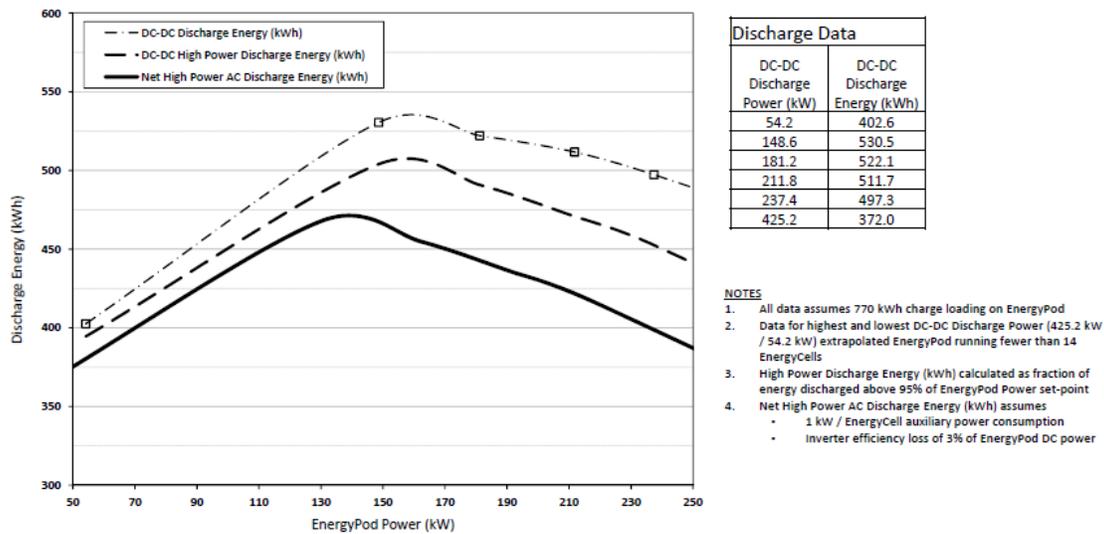
**Figure 2-19: Energy Capacity as a function of Discharge Rate shown on the DC output of the ESS.**

During the course of investigating the energy capacity limitation of the EnergyCells it was determined that the configuration of the flow channel frames within each of the EnergyCells was causing non-uniform zinc plating across the plating area of the electrodes. The non-uniform plating was leading to Zn inlet edge ridges that cause early shortening as the zinc reaches the top of the opposing electrode earlier than the other areas of the electrode. Primus presented solutions that provided better electrolyte flow across the electrode reducing the non-uniformity allow more zinc to be plated across the electrode surfaces improving the energy capacity. The new design of the cell frames were still in their test phase and would require retrofits of all 14 EnergyCells that were ready to be deployed further delaying the program.

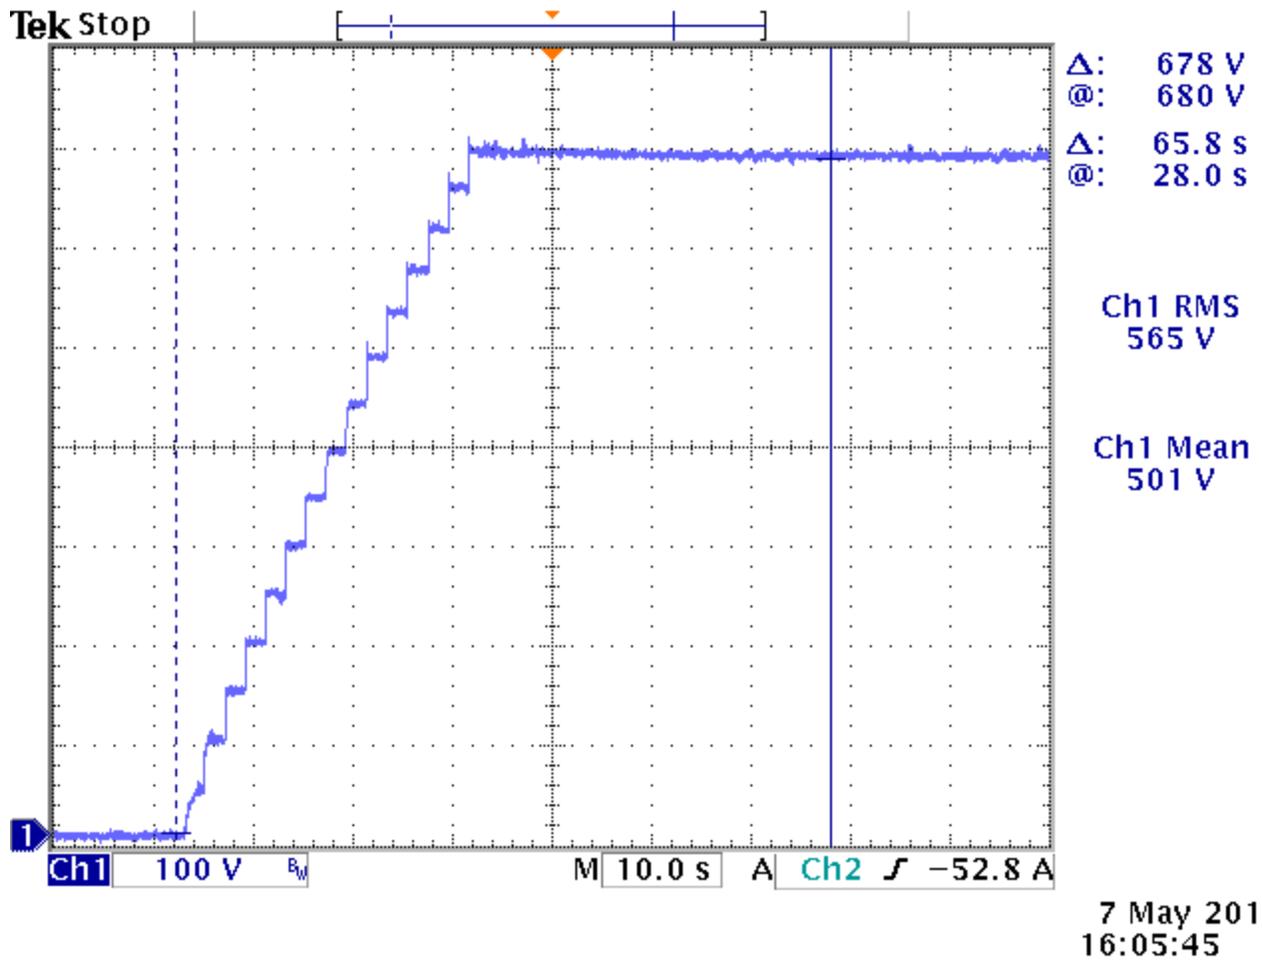
**Figure 2-20: Oscilloscope screenshot showing the connected logics of the EnergyPod and PowerBox. The inverter was started in islanding mode. The image shows the bus voltage being regulated continuously.**

Summary of test results are shown in Figure 2-20 below.

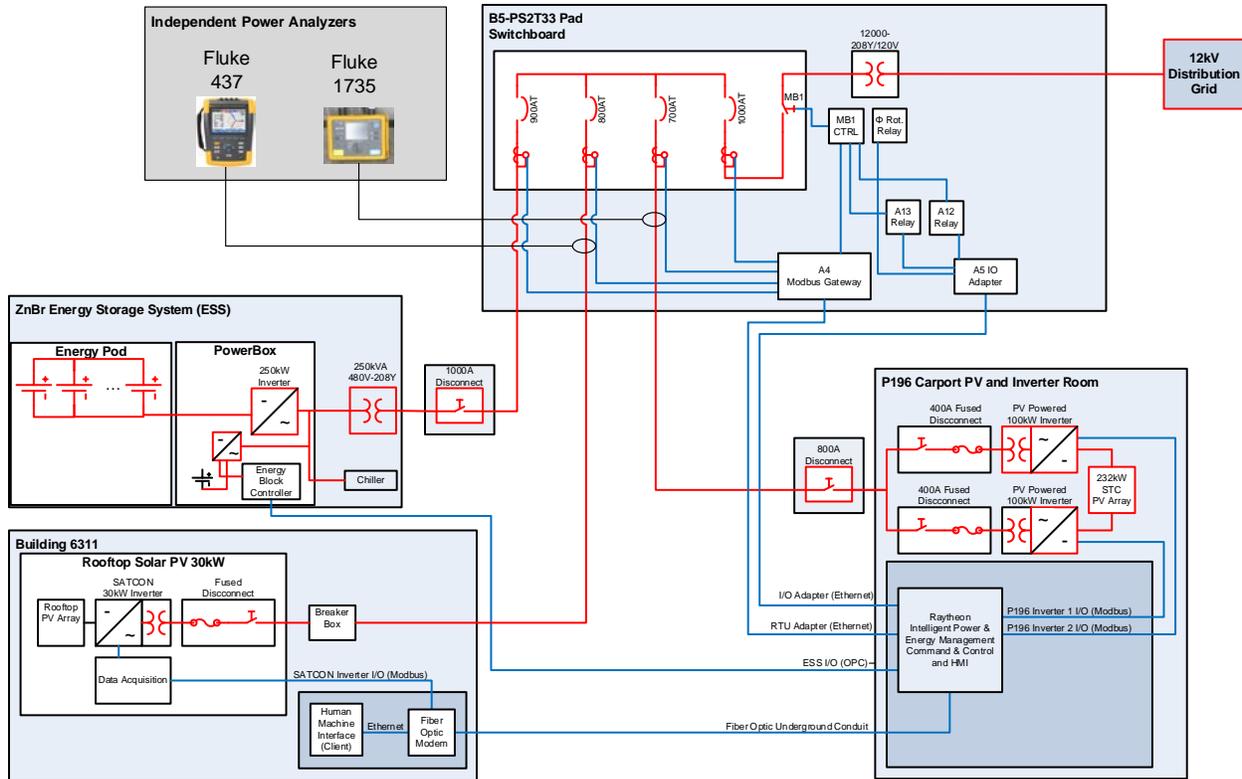
**Figure 3-1: Detailed interconnect diagram for the Islanding test setup**

Metering points for the islanding tests are shown in Figure 2-10 and in more detail in Figure 3-1 below. In addition to the metering data that is collected by the IPPEM system, two independent power analyzers were connected to the Building 6311 feeder breaker and the P196 Carport PV system to collect detailed data for analysis to IEEE 1547.4 requirements.

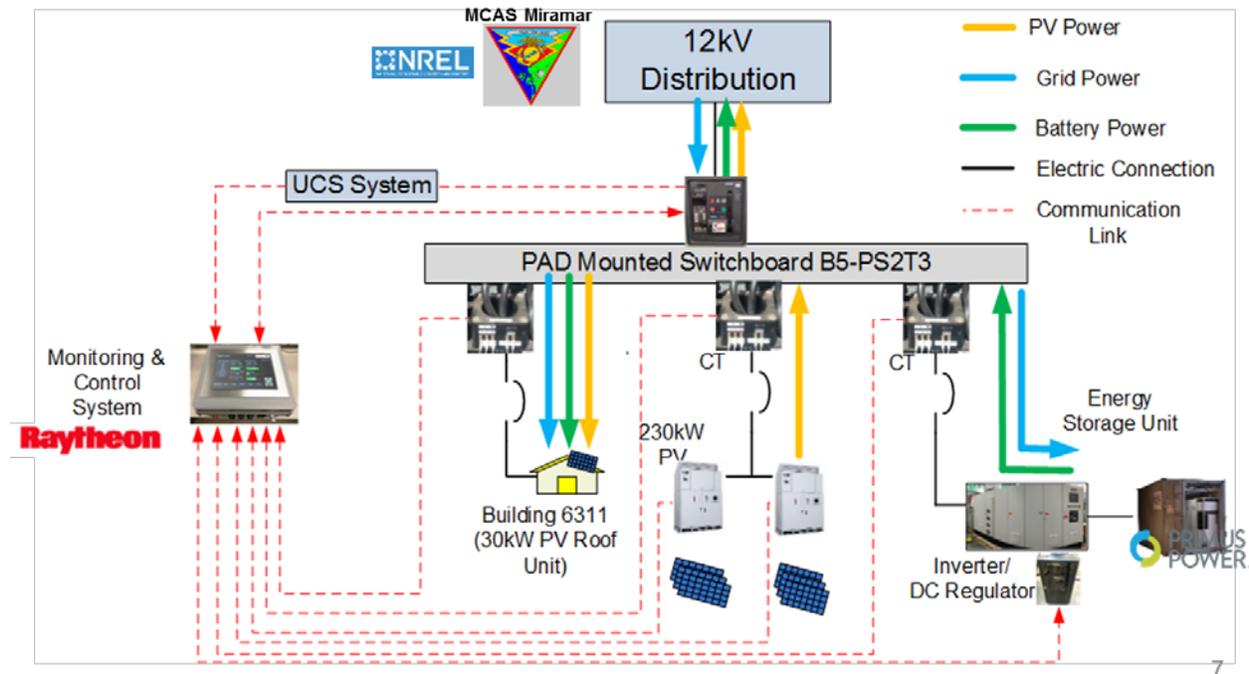
Figure 5-1: Interconnect diagram of Zn/Br installation at MCAS Miramar.

The ZnBr Installation is comprised of a ZnBr ESS integrated into the MCAS Miramar utility infrastructure which includes a 230kW carport PV subsystem and a 30kW rooftop PV subsystem. The ESS and the PV subsystems are controlled by the IPEM microgrid controller which also controls and monitors the load demand and power quality required by the MCAS infrastructure, the status and power generation of the PV system, and the State of Health (SoH) of the ESS (See Figure 5-1).

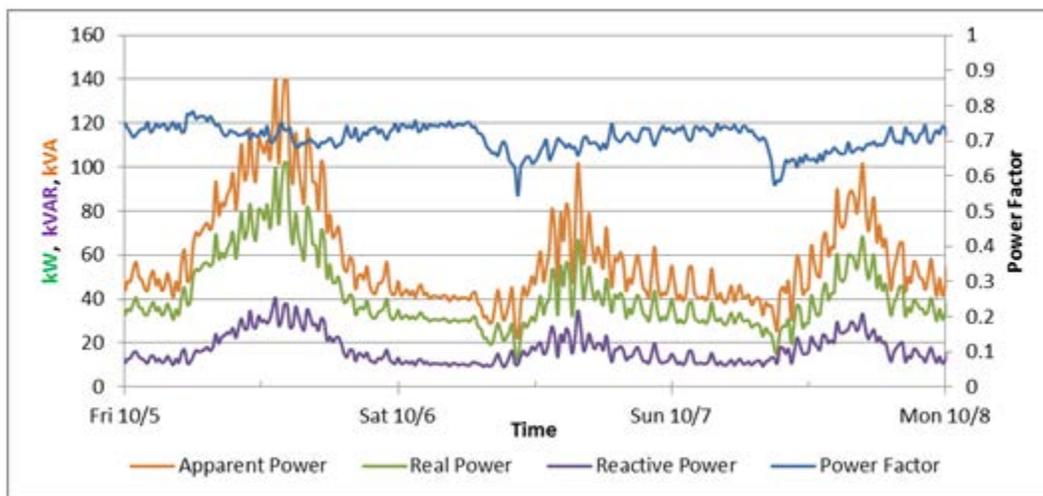
**Figure 5-5: Load profile for building 6311 including real, reactive and apparent power as a function of time. The data was sampled at 15 minute intervals. The power factor is plotted on the secondary axis.**

The load profile for building 6311 at Miramar consists of both real and reactive power components. The reactive component of the Miramar load is mainly due to motor loads from its environmental controls (heating and air conditioning). A plot of building 6311's load profile including the real and reactive power components is shown in Figure 5-5.

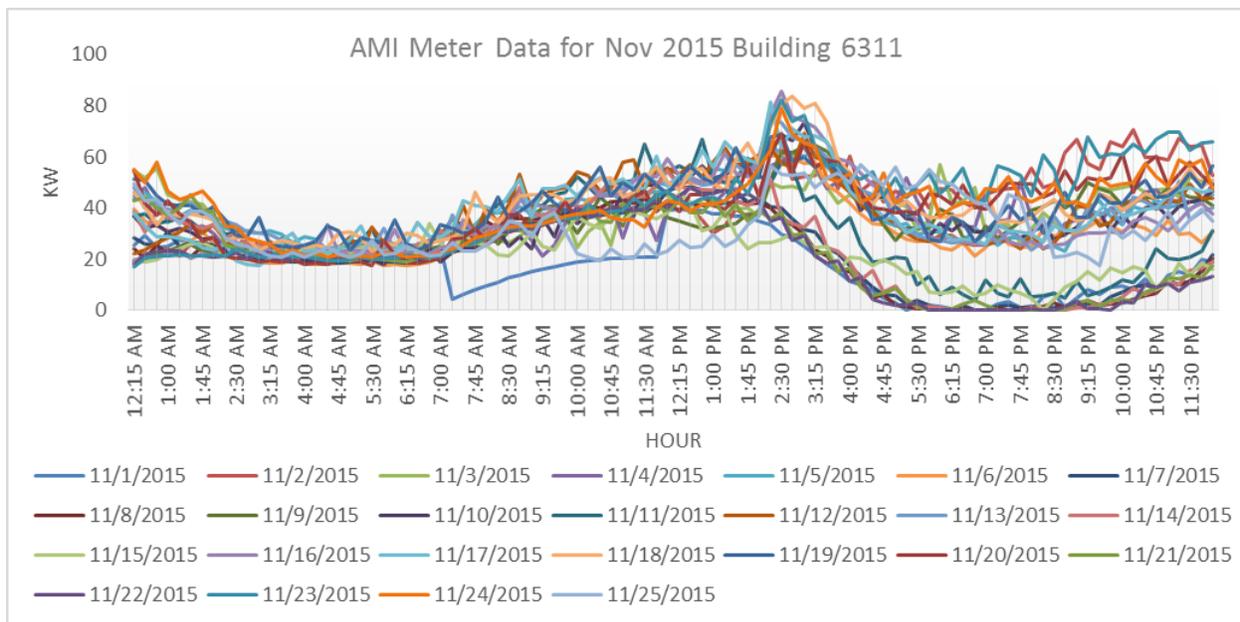
Figure 5-7: Daily load profiles for building 6311 during November 2015.

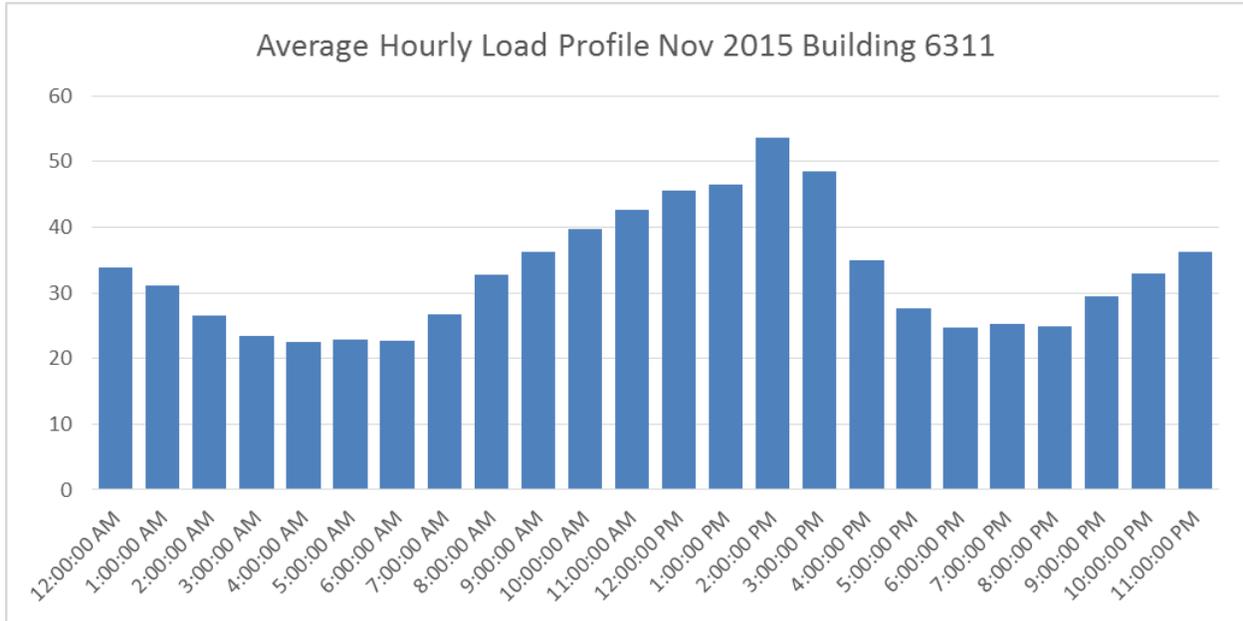
Figure 5-8: Average hourly load profile for building 6311 during November 2015.

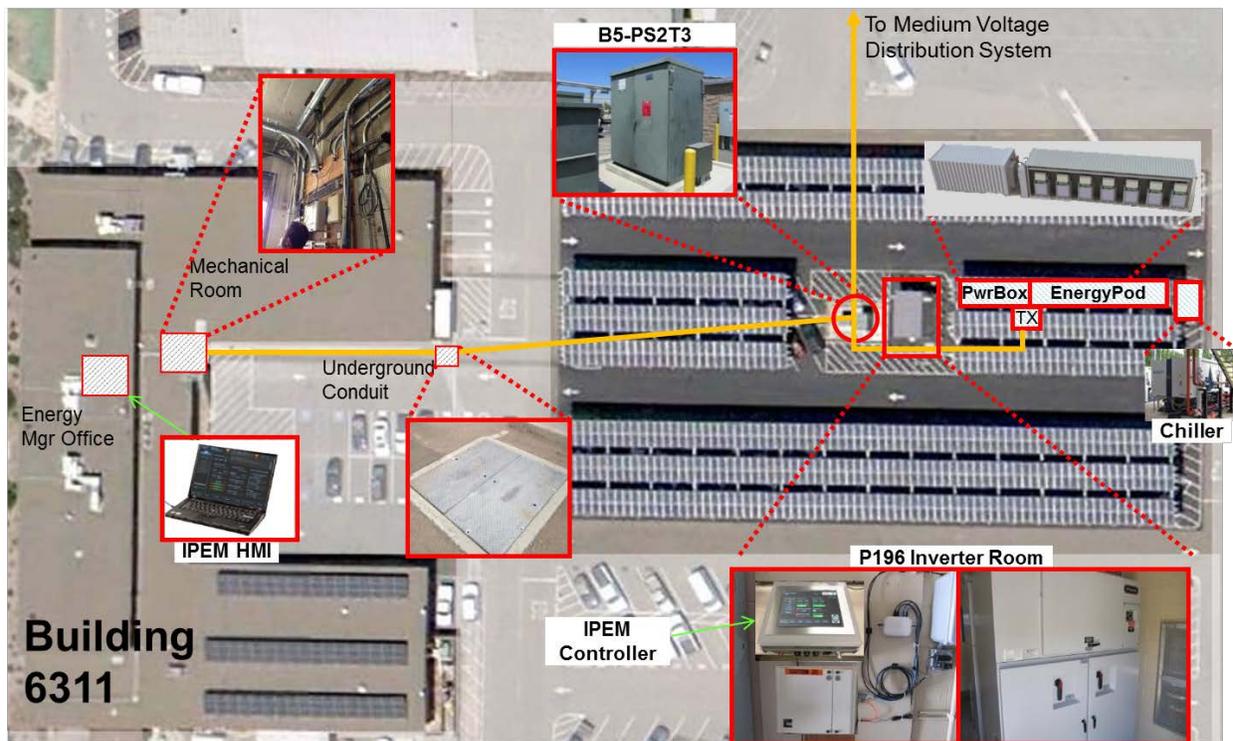
Figure 5-9: Birds eye view of MCAS Miramar site and layout of system components.

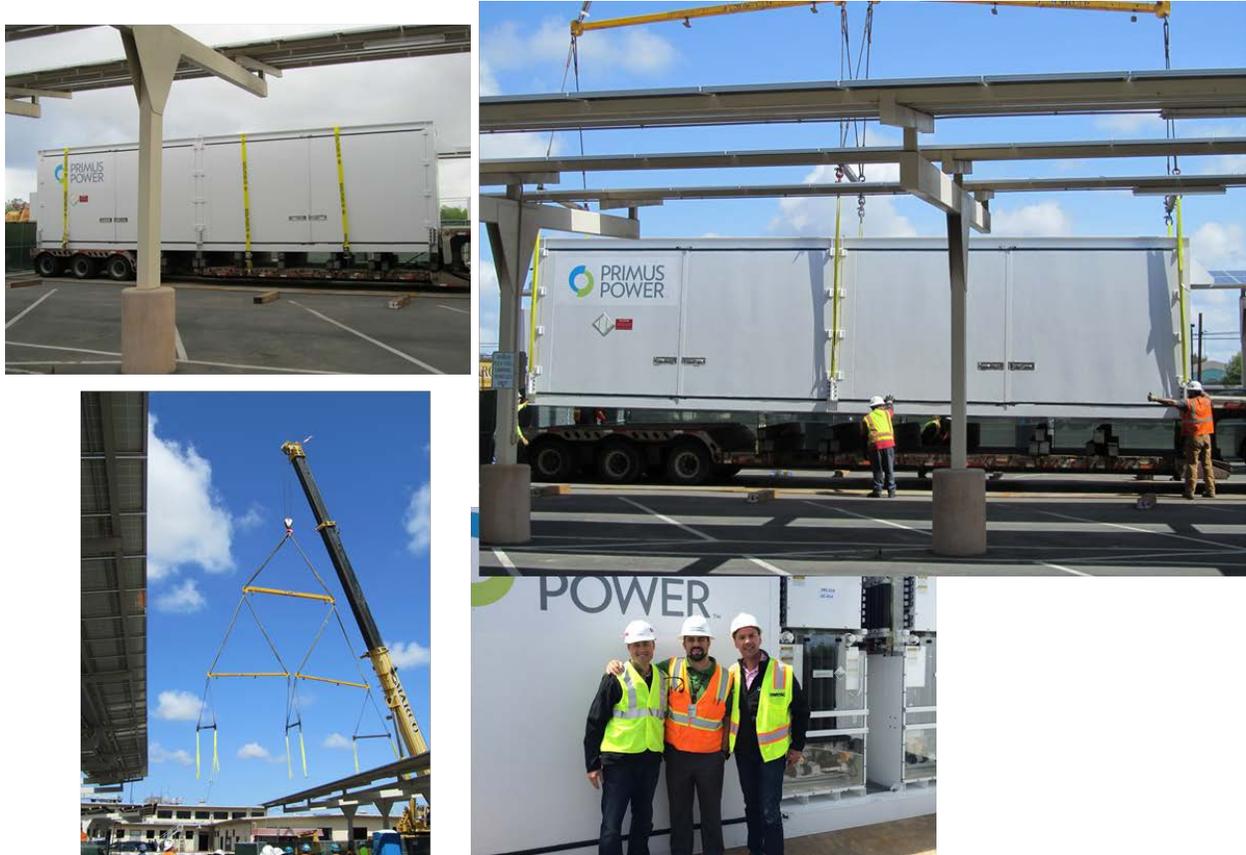
**Figure 5-10: Photos of the Primus ESS being delivered to MCAS Miramar. The EnergyPod need to have a large crane in order to lift it off of the delivery truck.**

Primus' ZnBr battery was delivered and installed on May 2015. Pictures of the battery being delivered are shown in Figure 5-10 below.

The ESS location is positioned in the parking lot of building 6311 next to the P196 inverter room and under one of the carport solar panel locations.

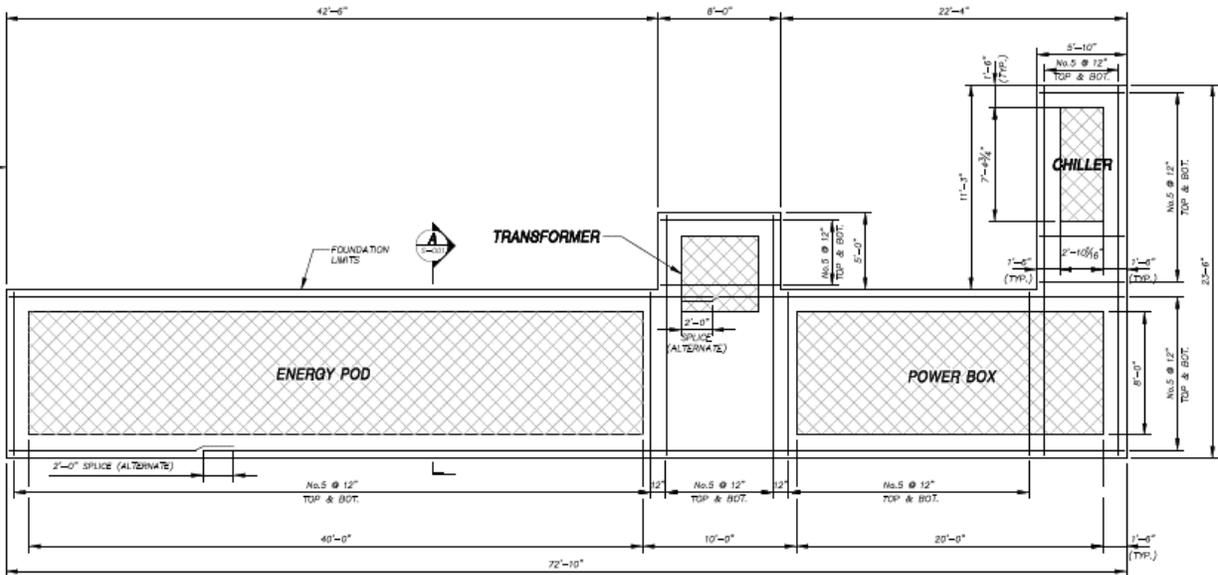
Figure 5-11: Construction drawing schematic of ESS location.

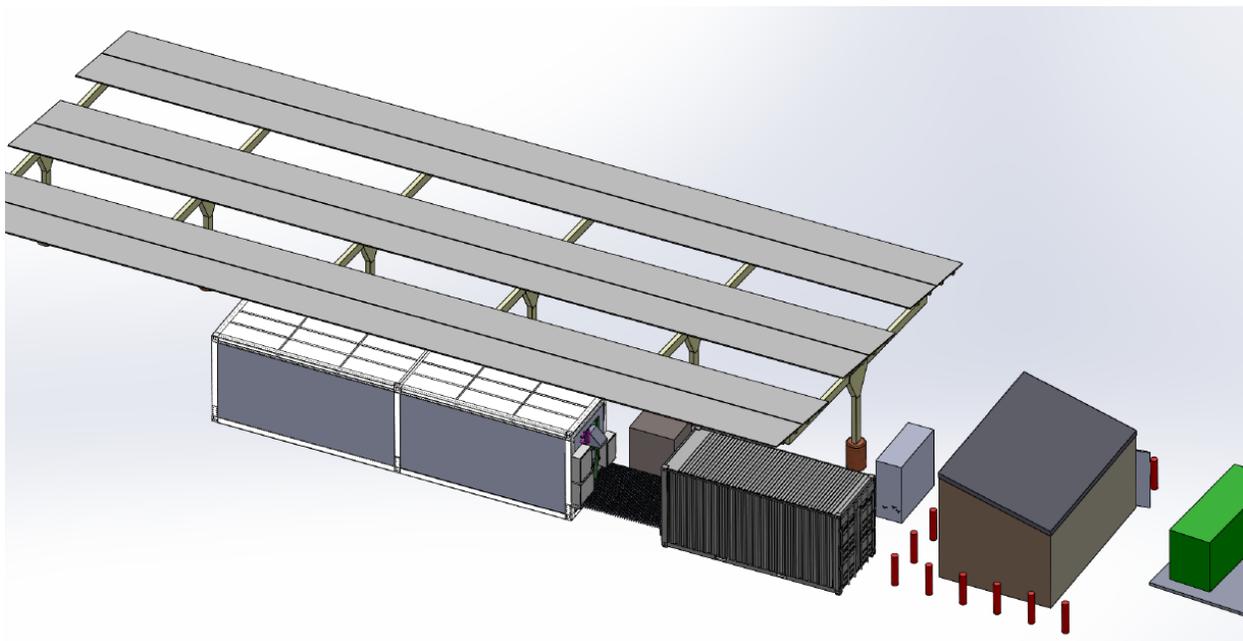
Figure 5-12: 3D CAD image of the ESS location.

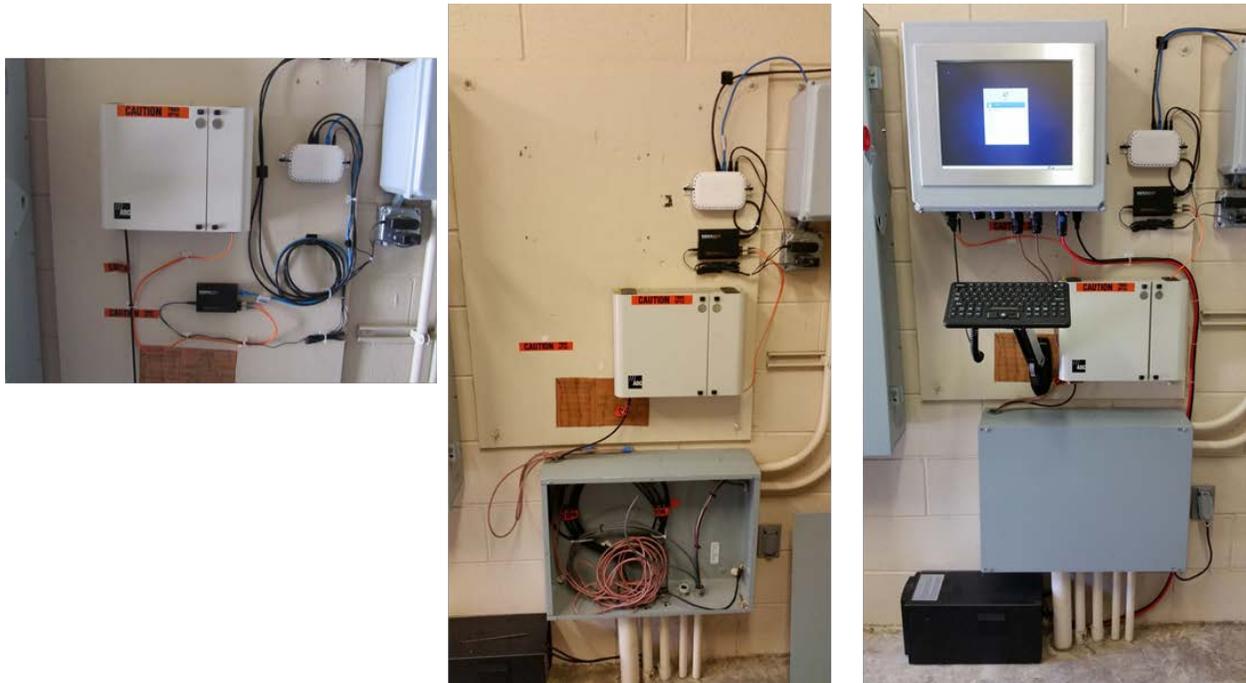
**Figure 5-14: Photos of inside the P196 inverter room where the IPEM controller was installed. The image on the left shows the location pre IPEM. The middle image shows some of the existing fiber termination block and equipment moved to accommodate the IPEM controller. The right image shows the IPEM controller and ancillary equipment installed.**
