# FINAL REPORT

Zinc Bromide Flow Battery Installation  
for Islanding and Backup Power

ESTCP Project EW-201242

SEPTEMBER 2016

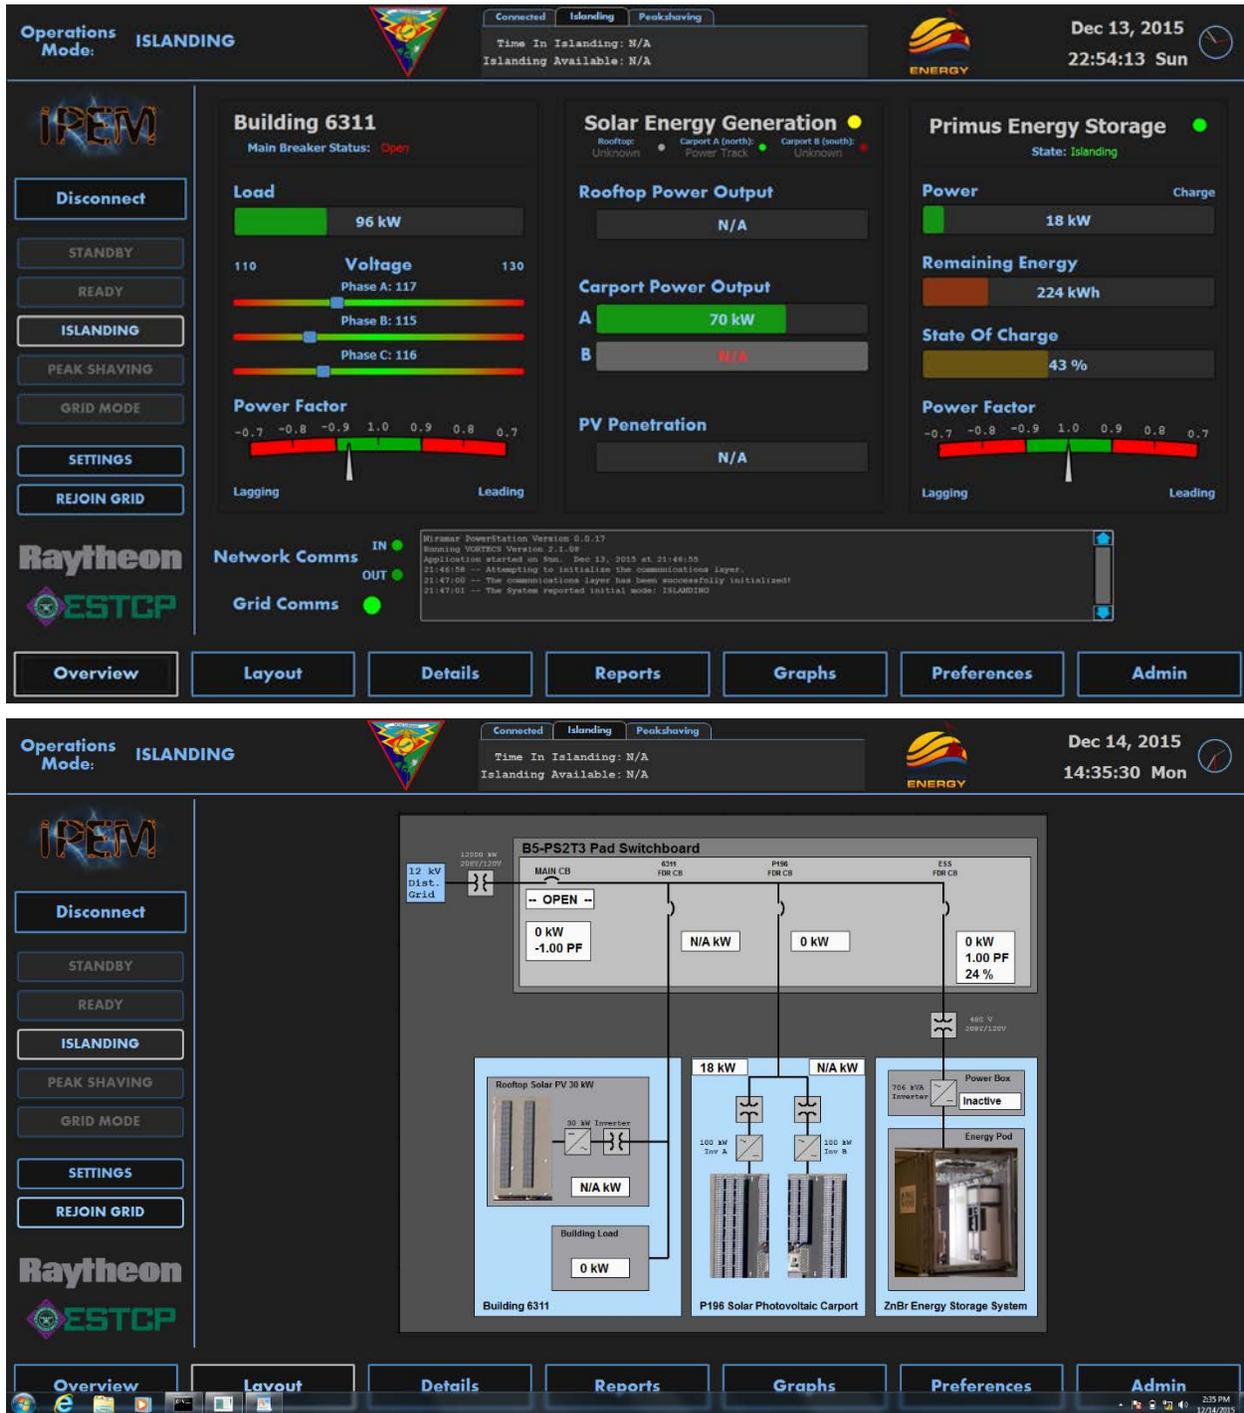
Figure 5-15: Screen shots of the IPEM HMI .

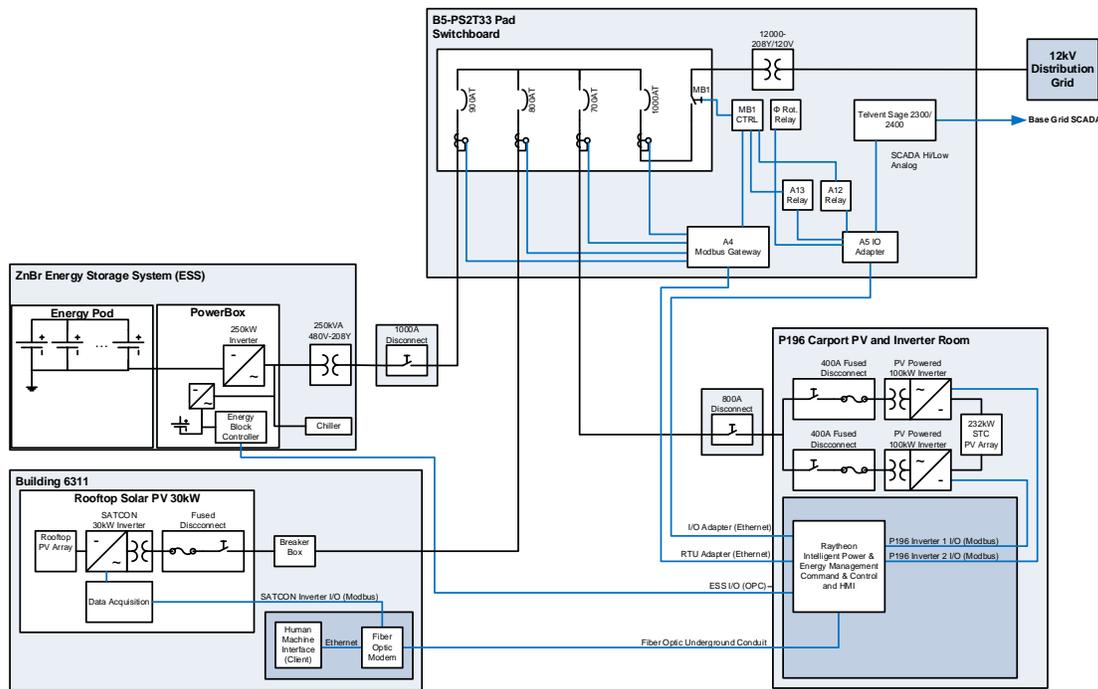
Figure 5-17: System configuration block diagram.

The test configuration is shown in Figure 5-17.

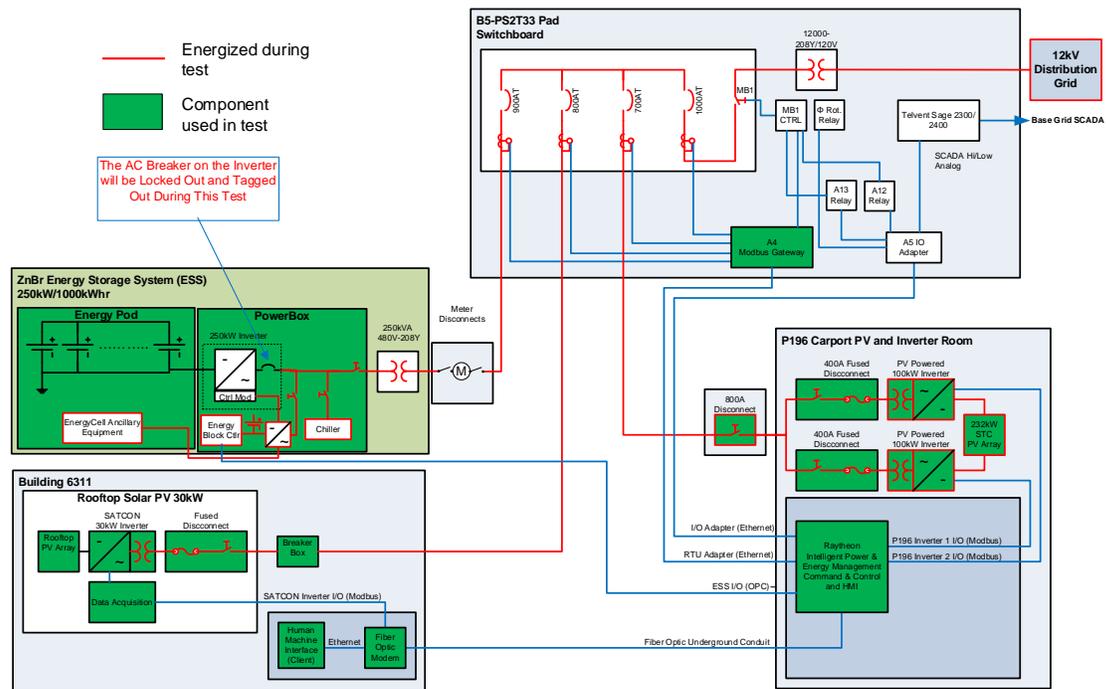
Figure 5-18: Test configuration for PV Comms and Curtailment Test

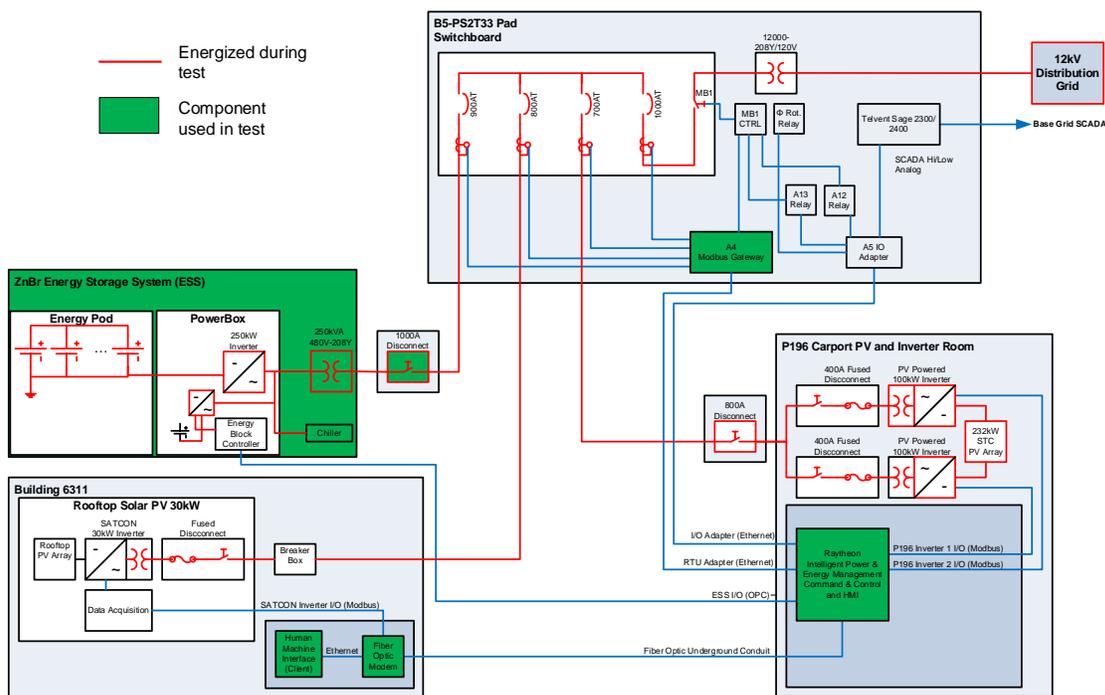
**Figure 5-19: Test configuration for Energy Storage Charge/Discharge Test .**

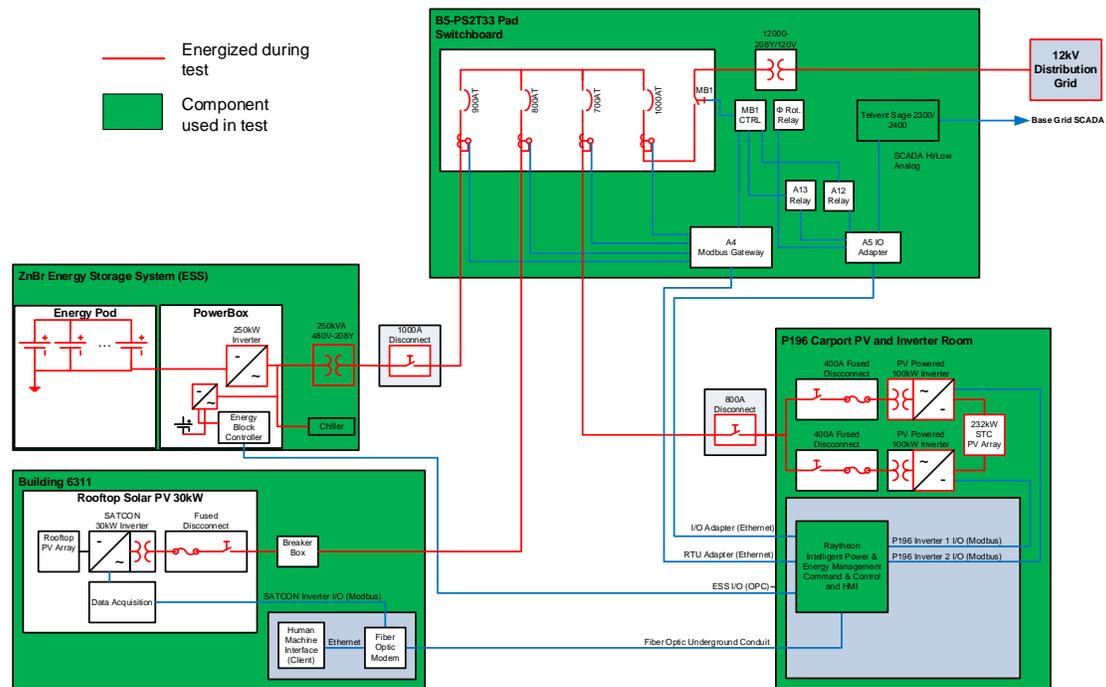
Figure 5-20: Test configuration for Islanded Mode Tests

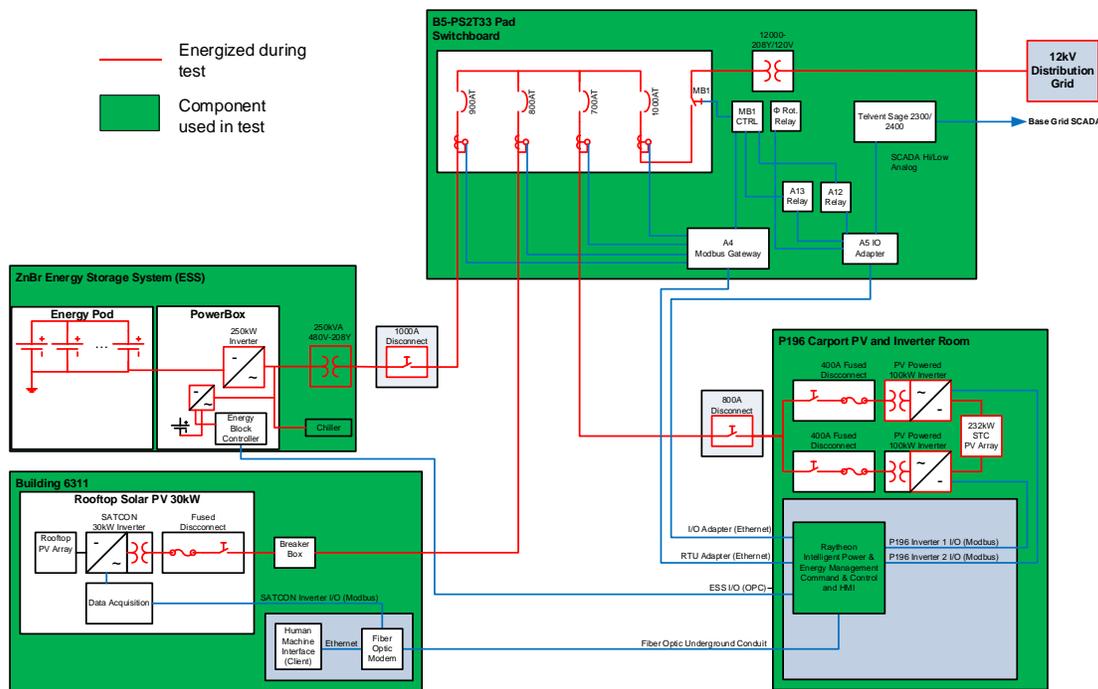
Figure 5-21: Test configuration for Islanded Mode Tests

The Islanded Mode Tests encompass a subset of tests that step through the various stages of islanded operations. The Islanded Mode Tests are divided into three subcategories: 1) Pre-Island Conditions 2) Grid Transition and 3) Full Islanding. For the Islanded Mode Tests all equipment in the test setup is used.

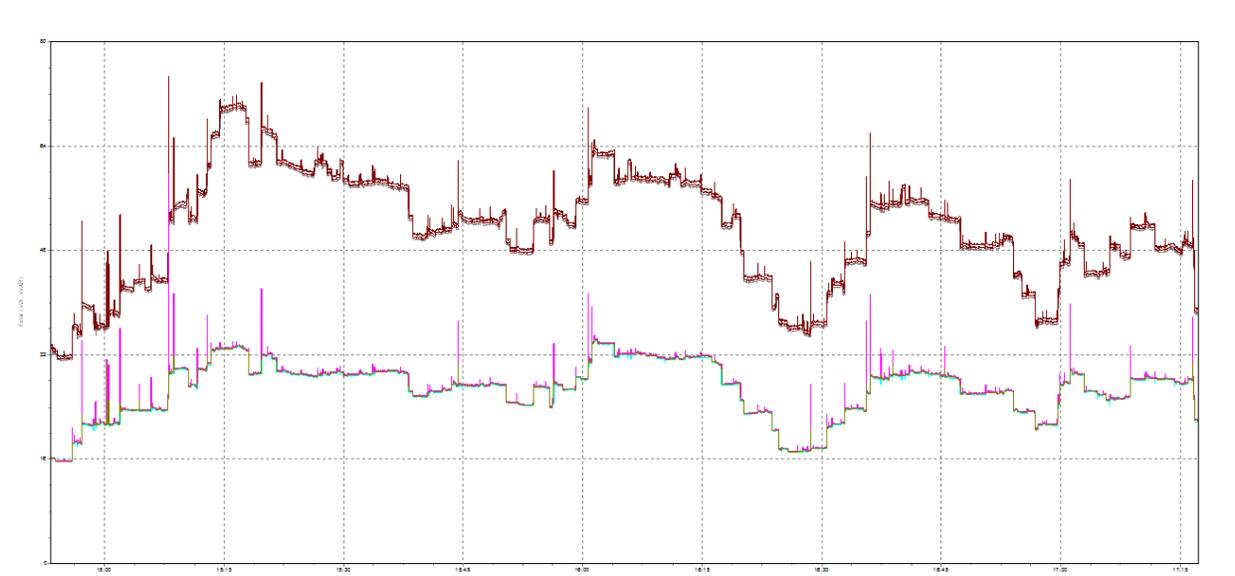
Figure 5-23: Plot of total real power (kW) and reactive power (kVAR) over time. Power factor ranged from about 0.86 to 0.89. Peak 6311 load on Sunday was about 70 kW at 1515.

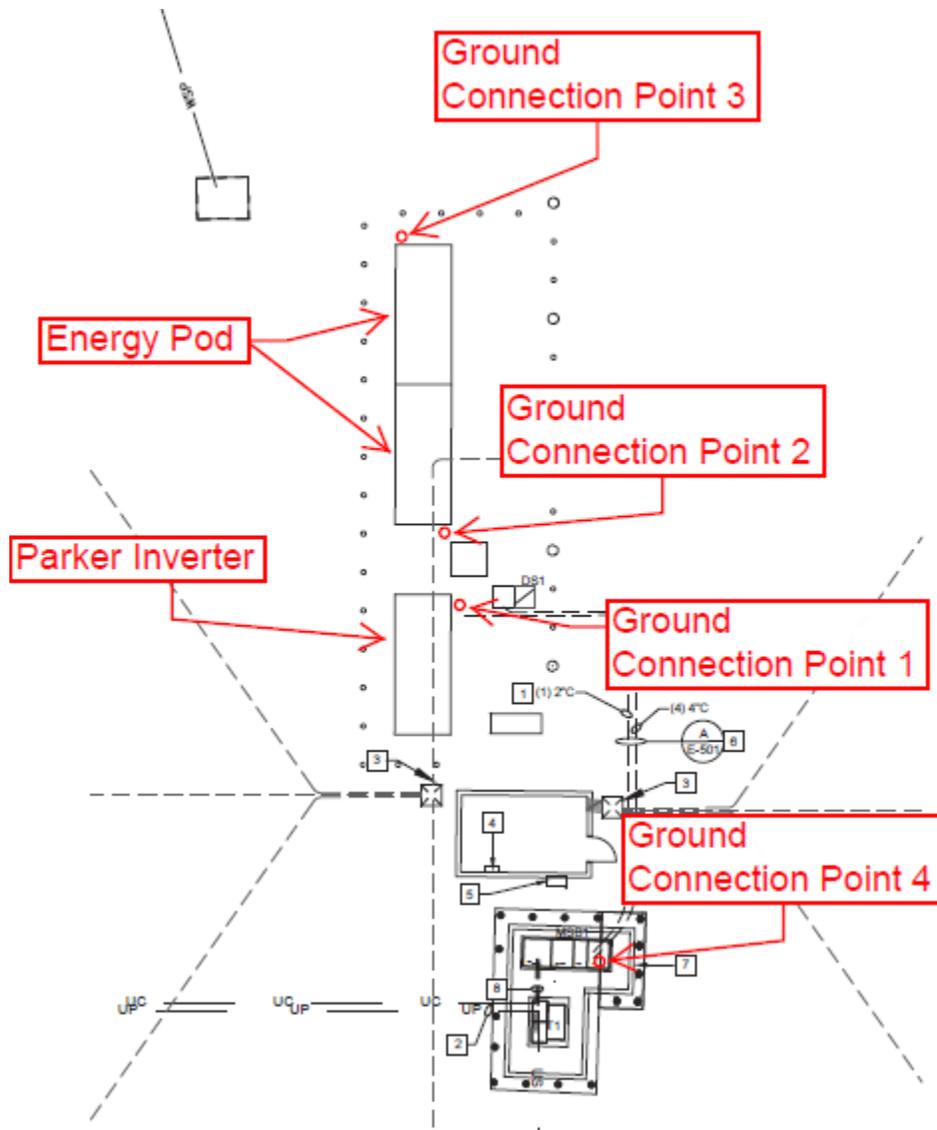
Figure 5-24: Ground current measurement schematic.

During this and other tests, ground currents were observed at various grounding electrode connection points, as shown in Figure 5-24. The results of these measurements are shown in Table 5-5

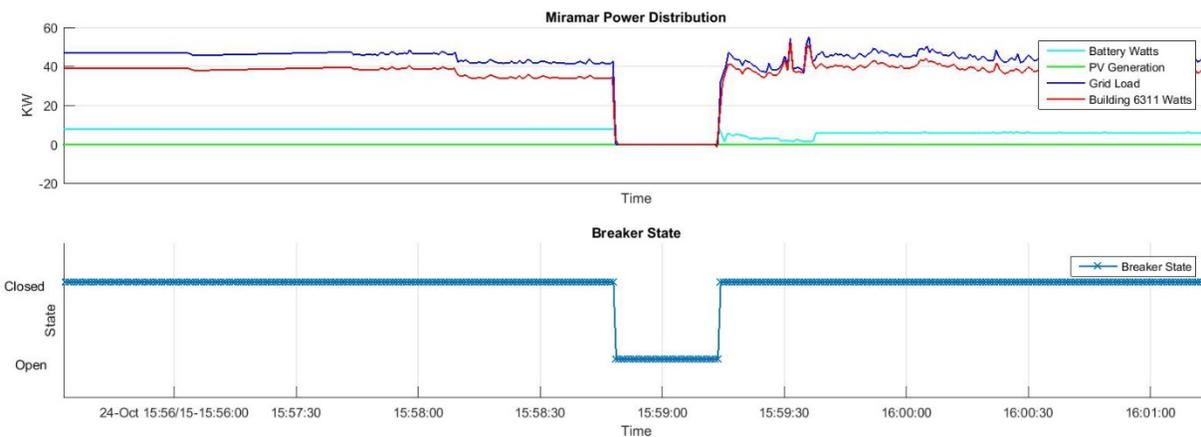
**Figure 5-25: Timeline for Islanded Operation with Battery Only test on 10/25/15.**

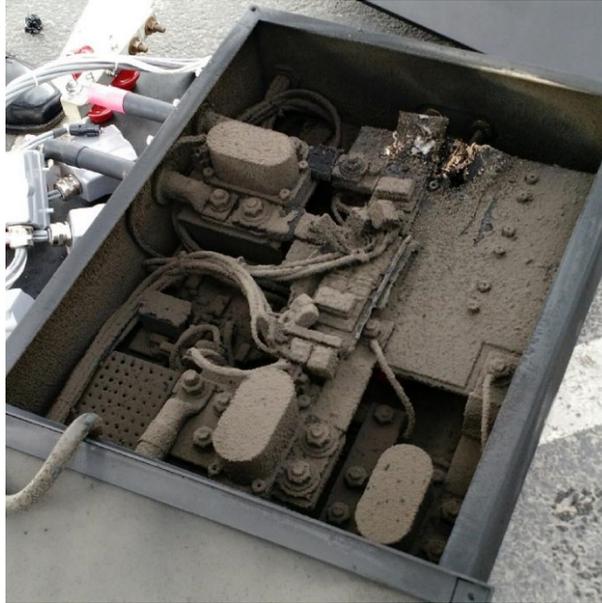
**Figure 5-26: Photo of damaged H-bridge system.**

This test was repeated on the morning of 12/12/15 after Primus Power was able to validate the proper sequencing for the shutdown of EnergyCells when exiting Islanding Mode. Once validated another islanding demonstration test was scheduled for 12/11/15 to 12/13/15. On 12/10/15 a component failure occurred in one of the H-Bridges of one of the EnergyCells activated a smoke detector within the EnergyPod. The audible alarms were triggered and MCAS personnel heard

the alarm and notified the Miramar Fire Department. The event did not result in a fire however the event signifies the importance of having proper safety monitoring and fire protection mechanisms in place. Due to the damaged H-Bridge the EnergyCell with that component as well as an adjacent EnergyCell would not be available during the 12/11-12/13 islanding tests. Therefore the system would only have 12 of the 14 EnergyCells available for testing.

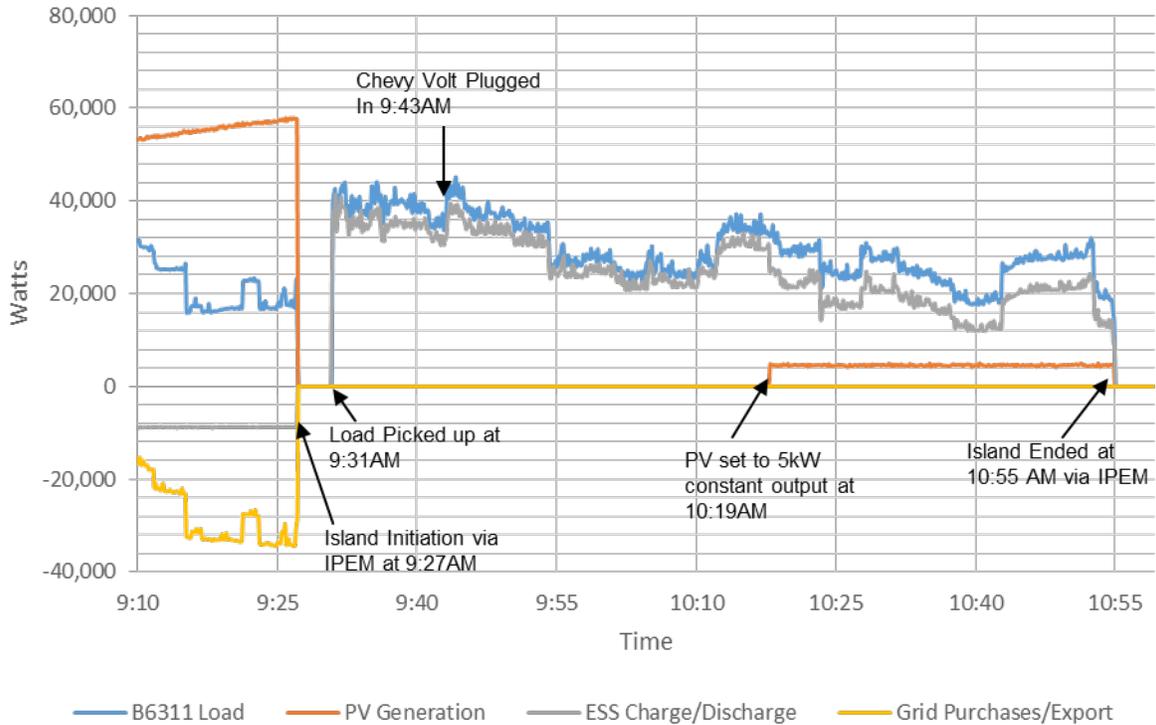
**Figure 5-27: Summary of islanding data on the morning of 12/12/2015.**

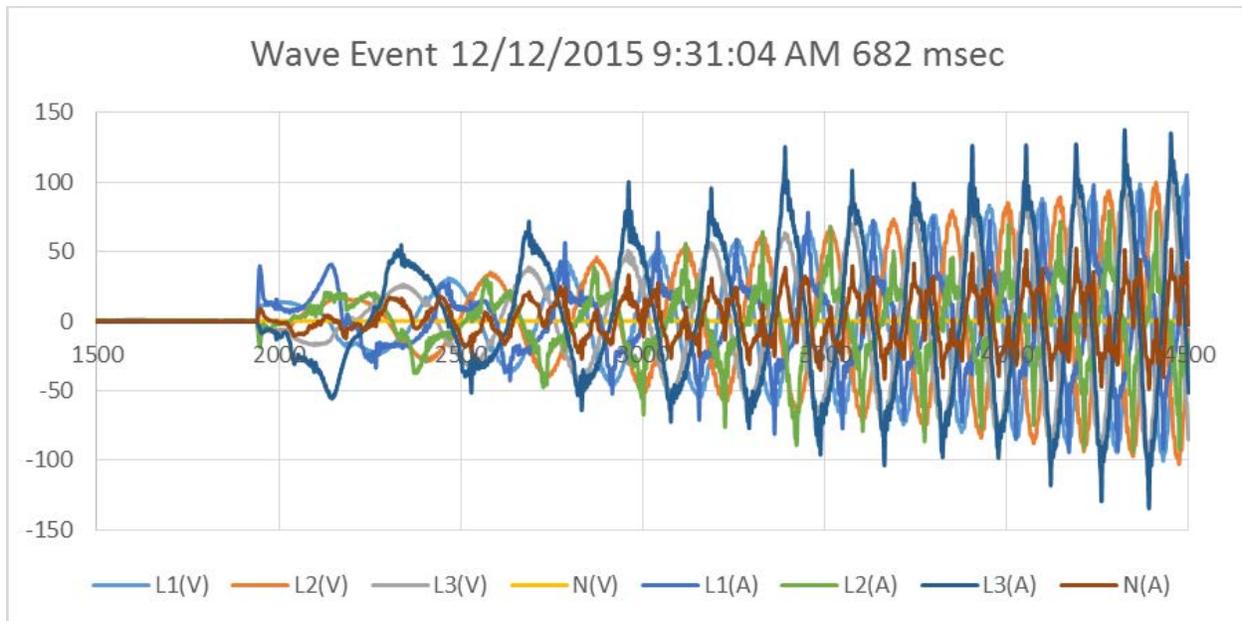
**Figure 5-28: Voltage and current waveform of building 6311’s load provided by the ESS.**

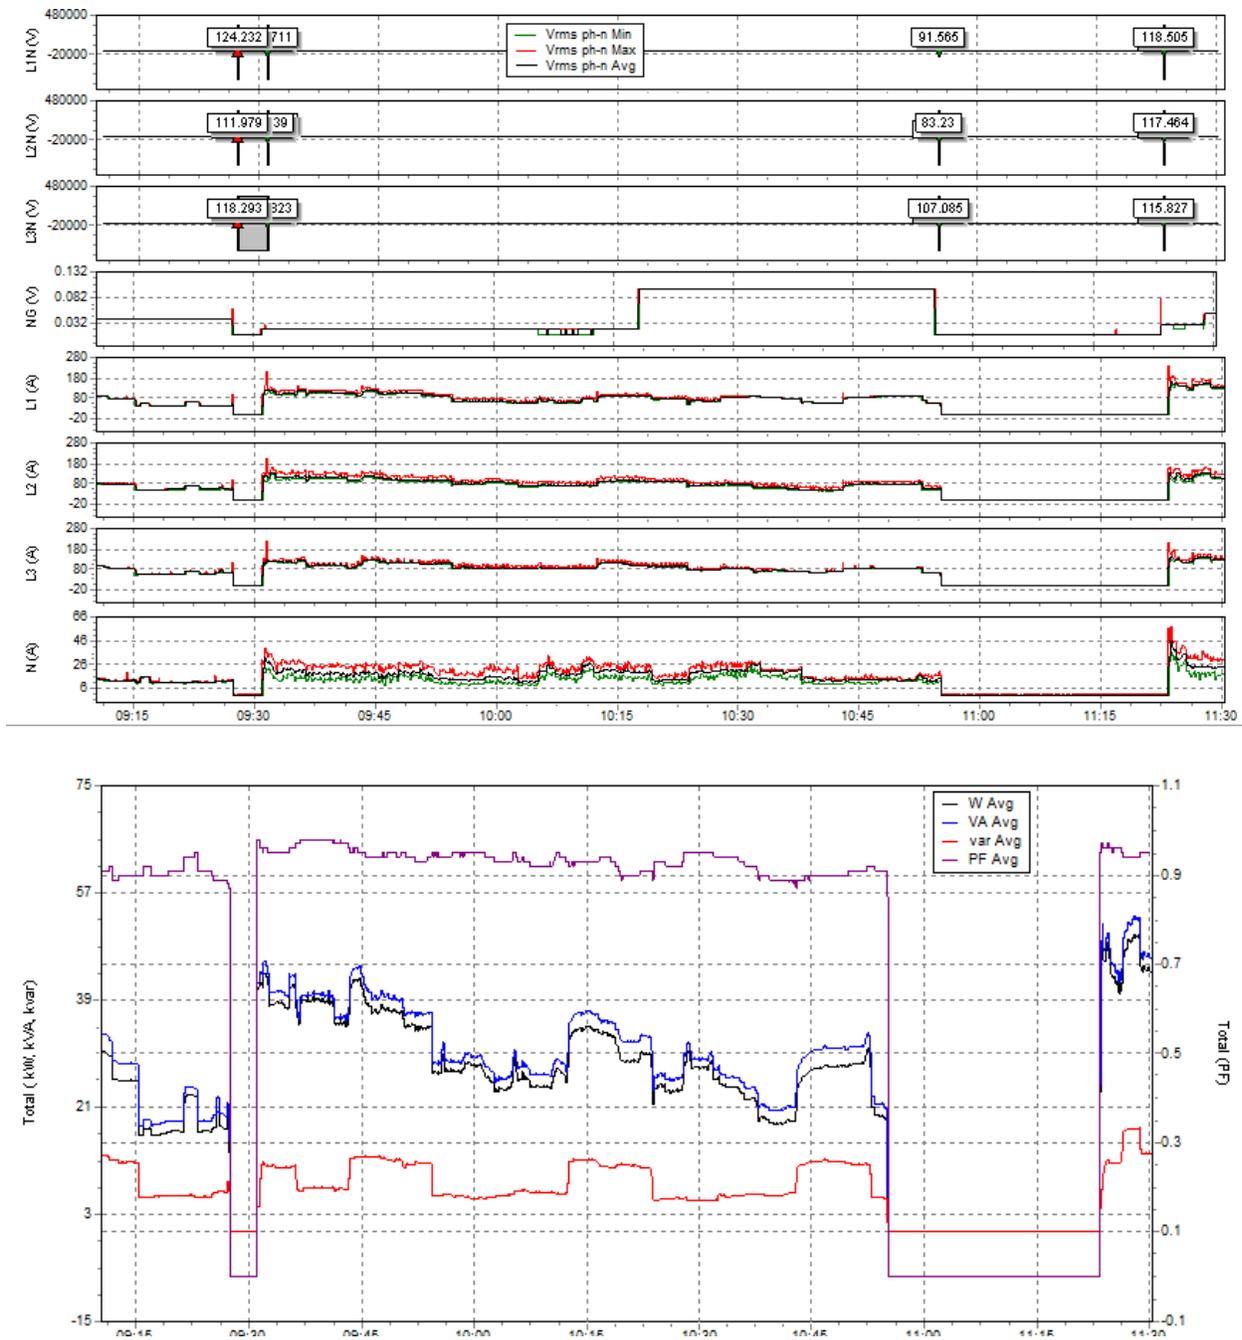
Figure 5-29: Detailed load data taken from Fluke 437II that was attached to Building 6311 circuit during 12/12/15 morning islanding test.

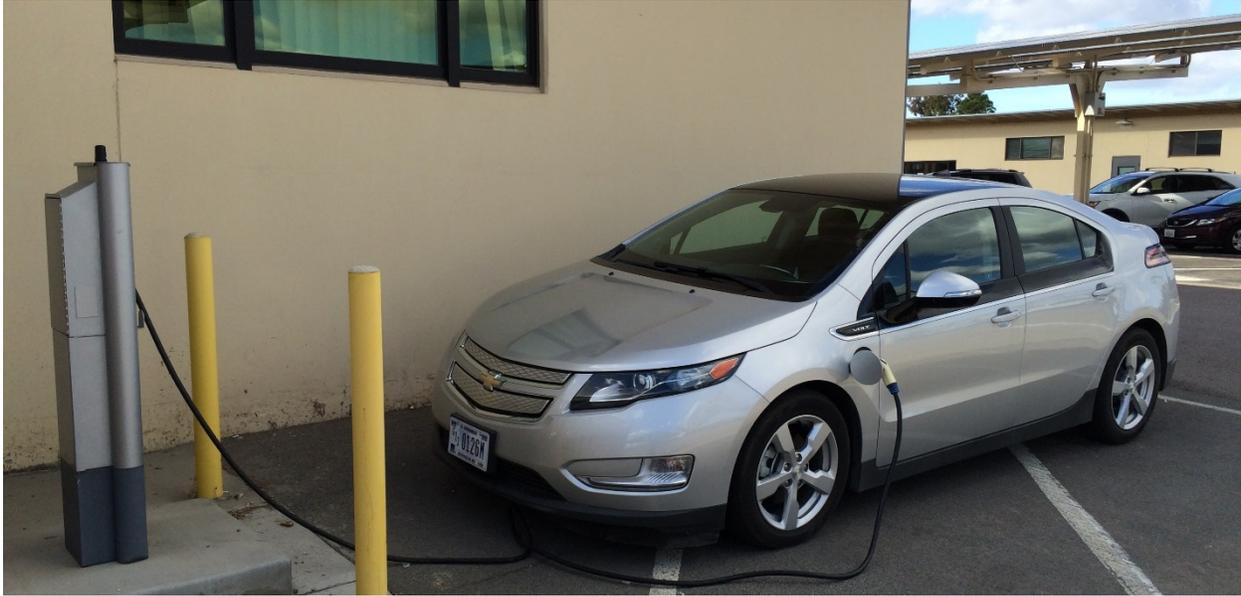
**Figure 5-30: Photo of Chevy Volt used in islanding demonstration outside of building 6311.**

Once everything was determined to be stable, at 9:43 AM a Chevy Volt was plugged into the circuit to add a large battery load to the building to see if the ESS could handle the type of load.

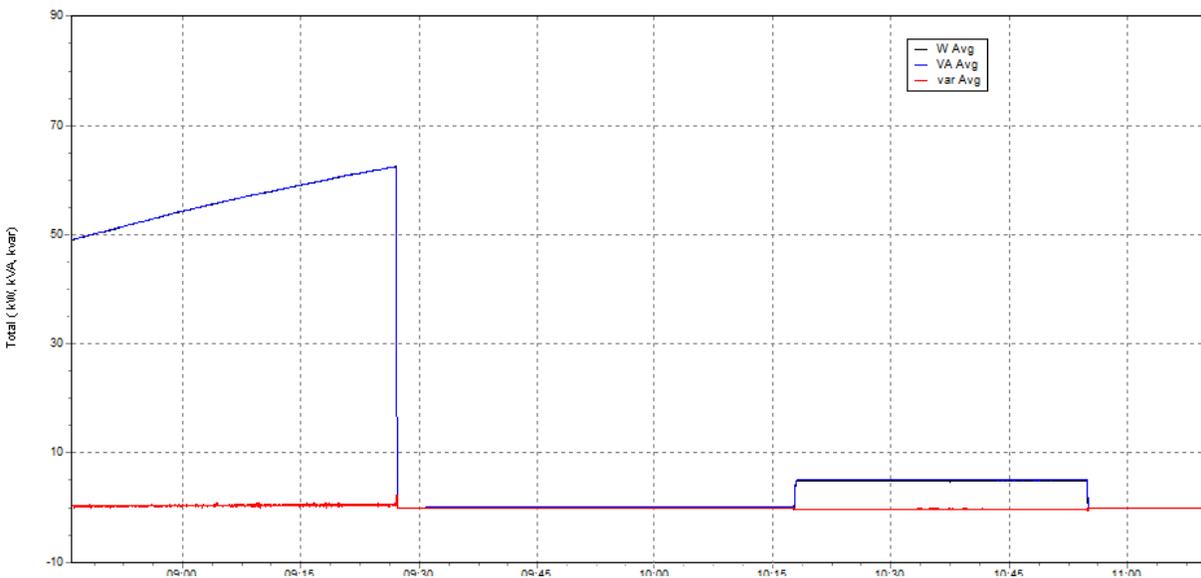
**Figure 5-31: Data from Fluke 1735 meter that was attached to the P196 PV circuit.**

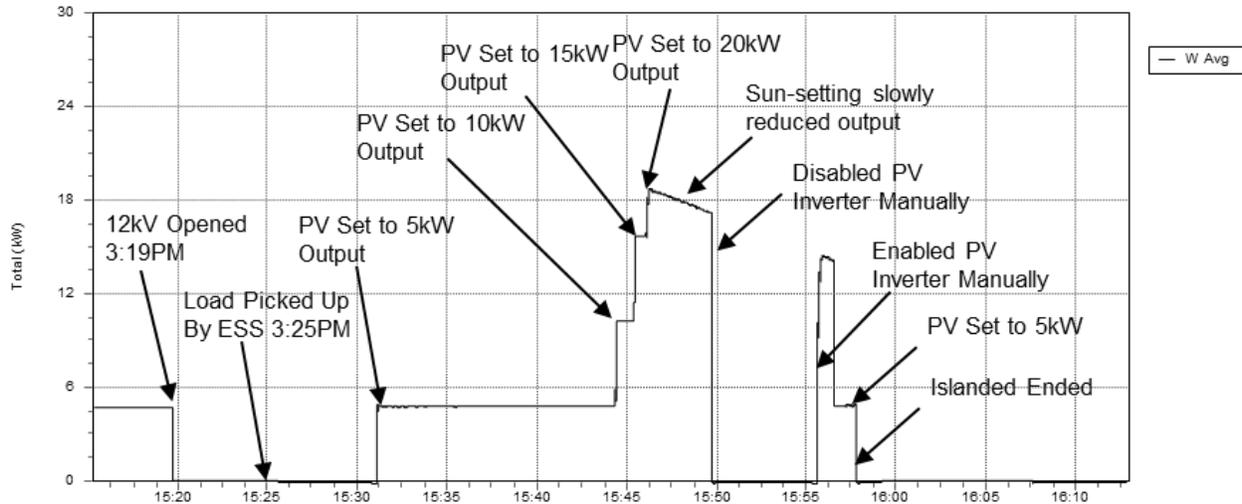
**Figure 5-33: Power data from the Fluke 1735 meter that was attached to the P196 PV circuit during 12/12/15 afternoon islanding.**

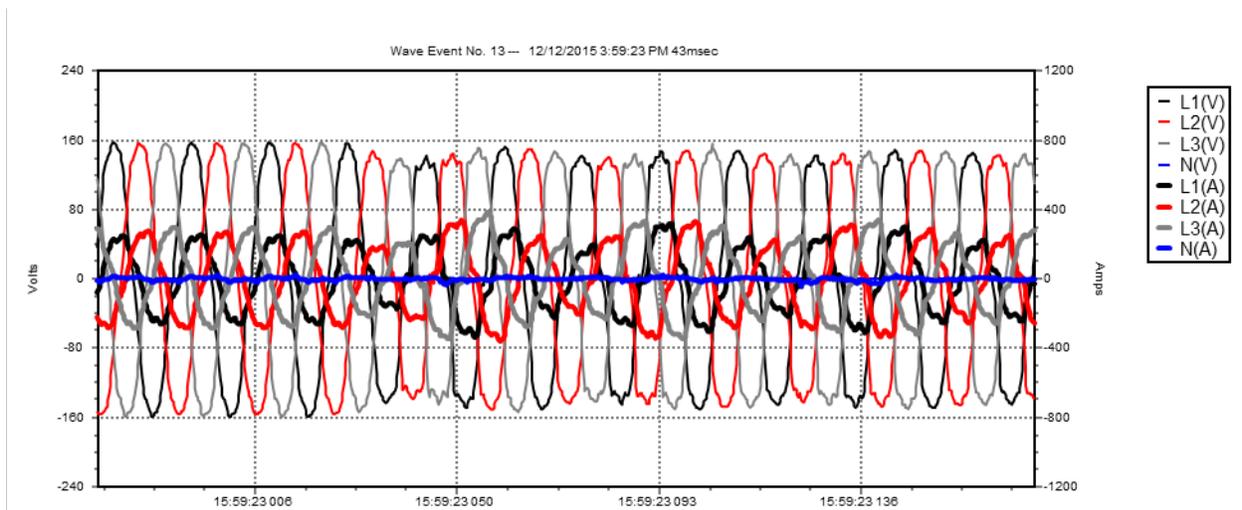
**Figure 5-34: The AC waveform collected from the Fluke 437 during the final seconds of islanding the system.**

As the AE inverter energized one of the EnergyCells was starting to lose voltage and took itself out of current source. This in addition to interaction with the AE inverter started causing oscillations in the voltage control of the microgrid. Small flickers were observed in the lights within the building. The AC waveform during this time was recorded on the Fluke 437 and is shown in Figure 5-34.

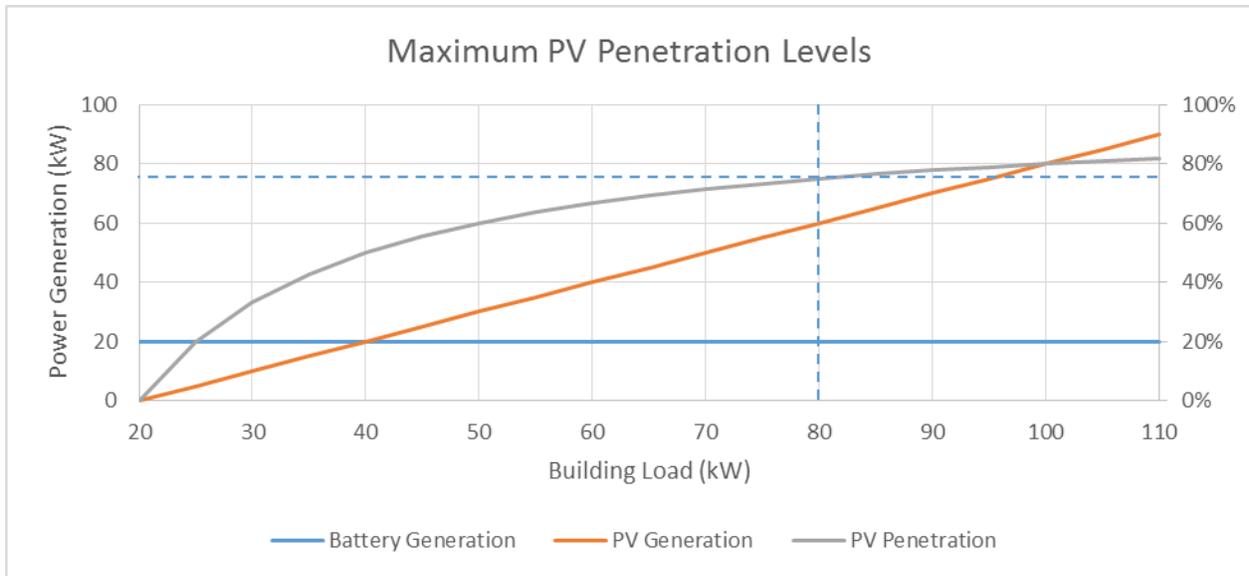
**Figure 5-37: Graph showing the theoretical relationship of building load, PV generation, and minimum battery generation output and how it relates to PV penetration levels.**

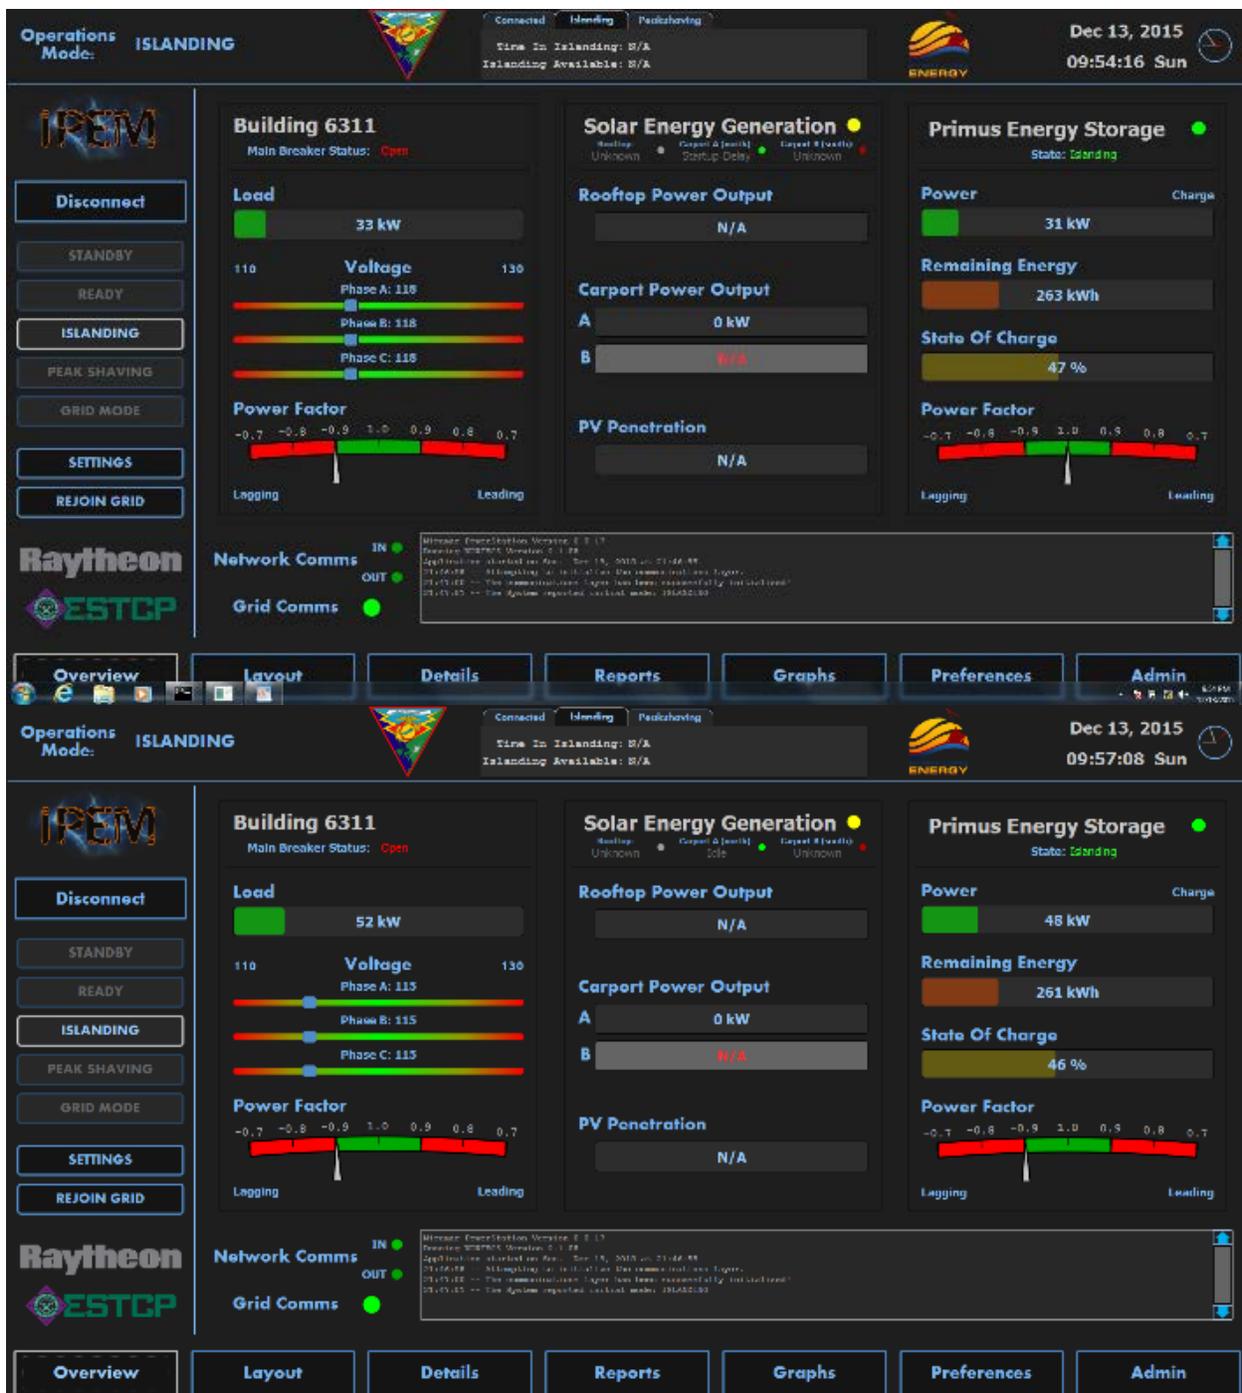
Figure 5-38: Screenshots of the IPEM HMI during the 12/13/15 islanding event. Screenshot shows the initial loads of building 6311, ESS status and PV generation status. There is currently no PV output but the status on Carport A inverter (shown in red square) indicates the inverter is online and in its Startup/Bootup delay per UL1741 in the left image and in its Idle mode ready to output power in the right image.

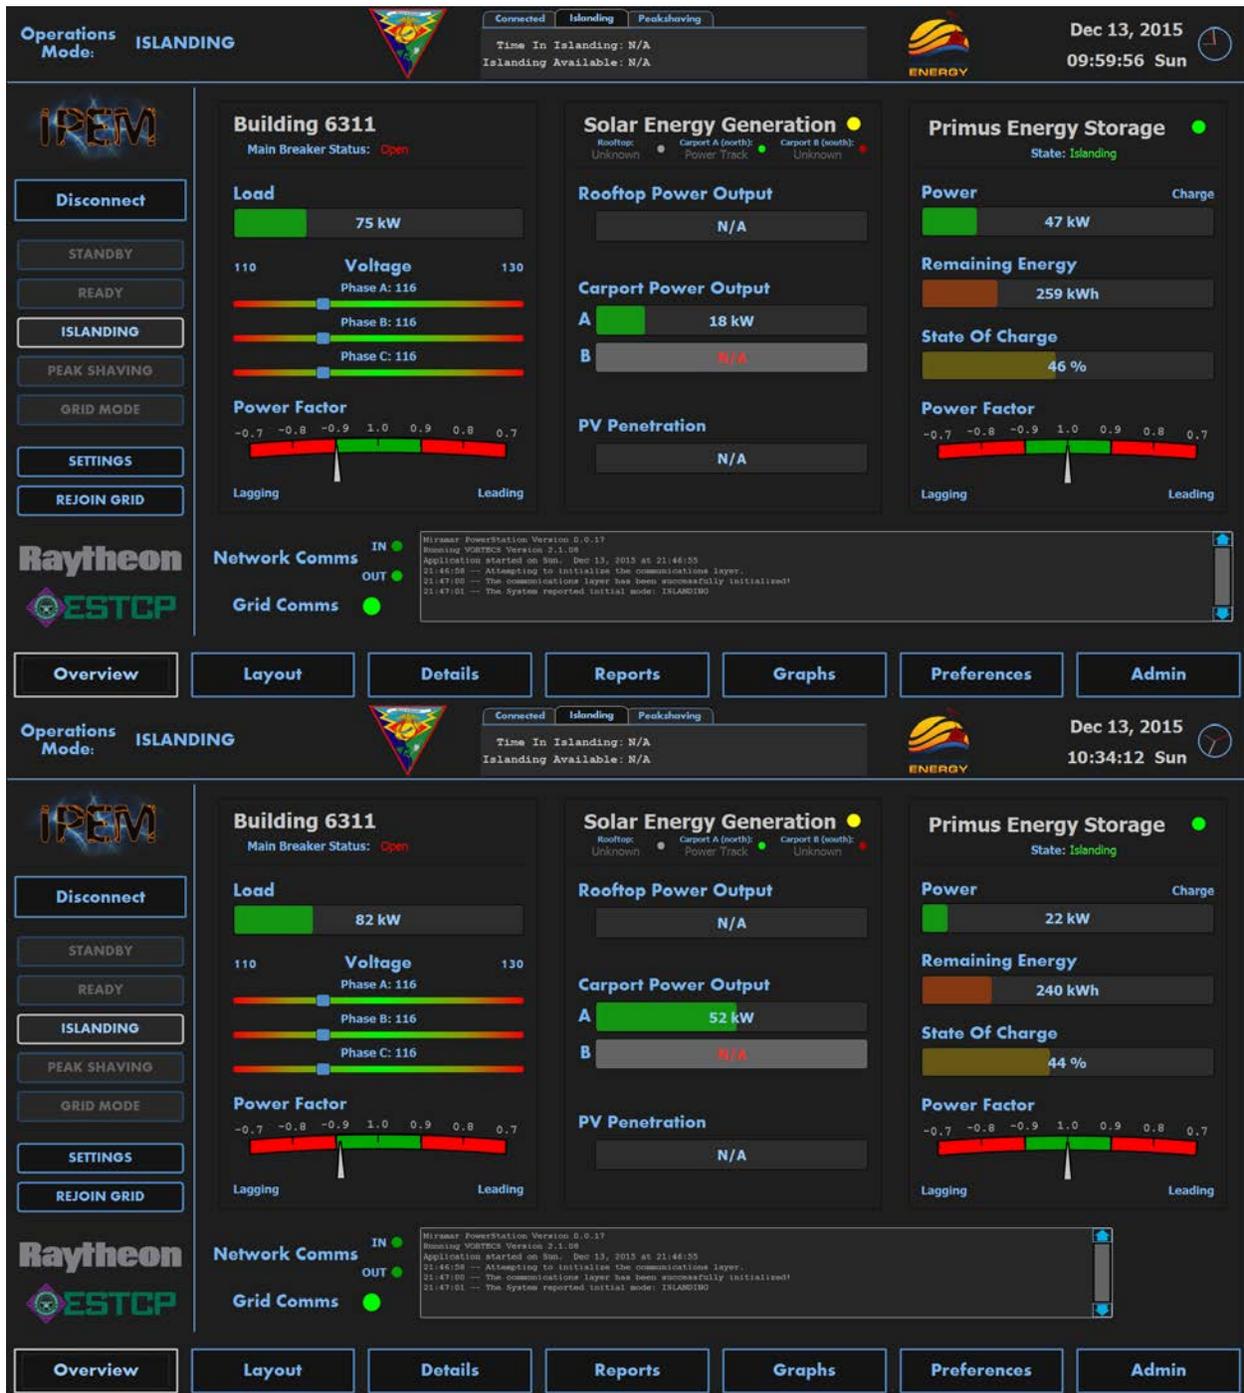
Figure 5-39: Screenshots of the IPEM HMI during the 12/13/15 islanding event. These screenshots show the initial output power of the PV system and its relationship with the load and the ESS output power. The image on the top is at 9:59AM when the PV penetration level was initial set at 30%. The image on the right is at 10:34AM when the PV penetration level was set at 65%.

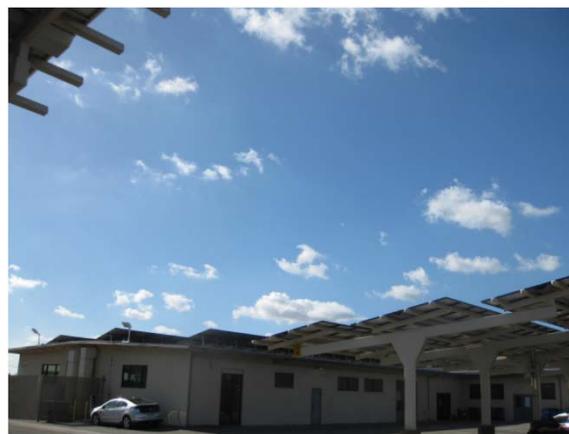
**Figure 5-41: Clouds forming in the southwestern sky.**

Just before noon clouds started appearing on the horizon heading towards Miramar (Figure 5-41). At ~12:00PM larger clouds started passing over the carport PV system causing the PV generation to drop very quickly.

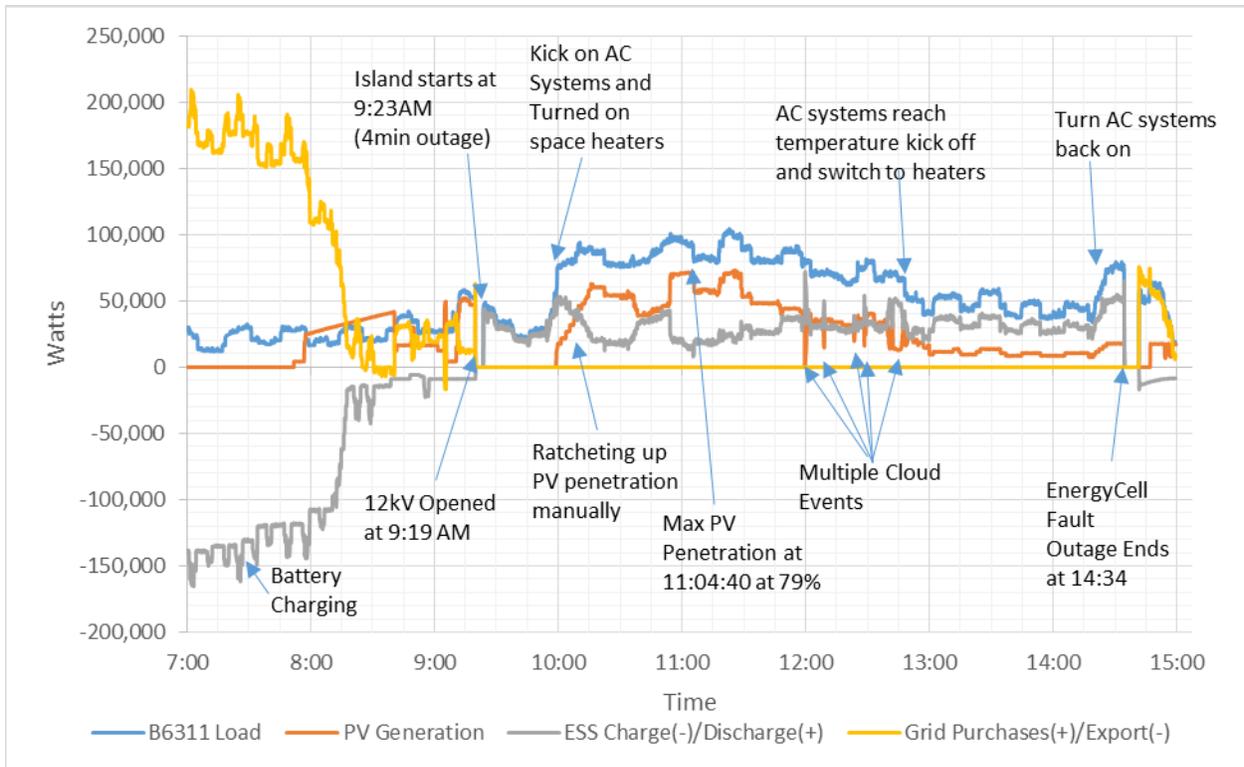
**Figure 5-42: Summary load and generation profile during 12/13/15 islanding demonstration test.**

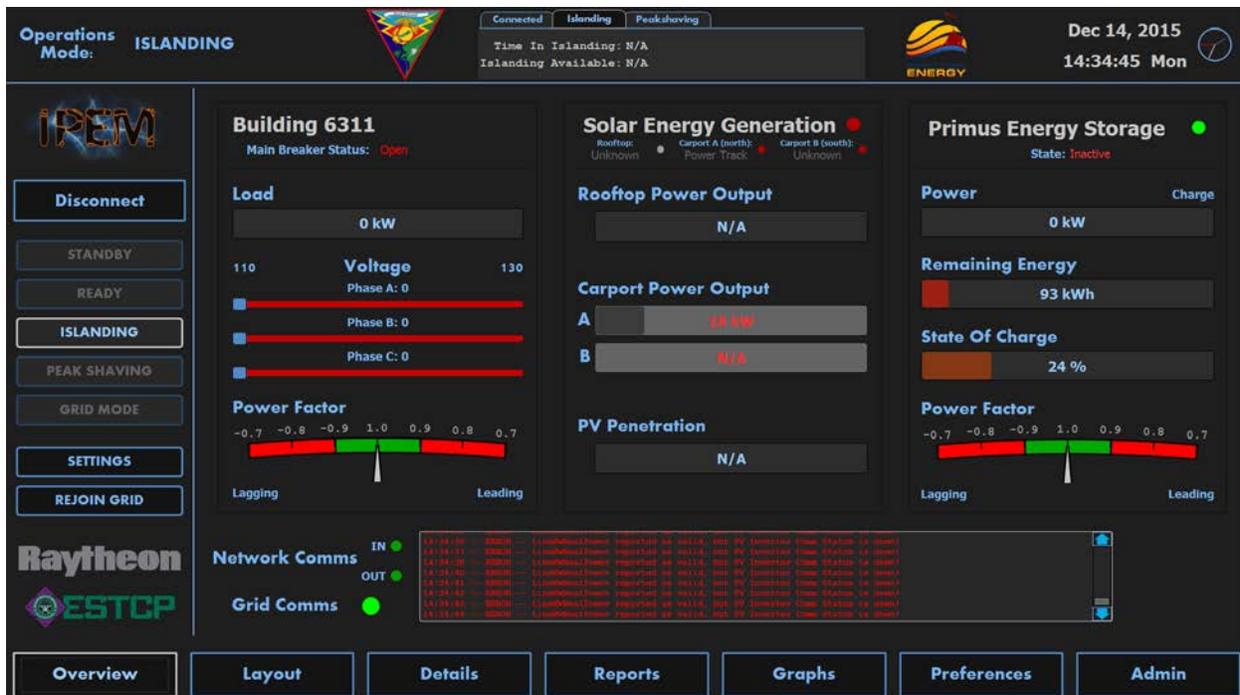
Figure 5-43: Screenshot of IPEM HMI at taken 2:34 when the ESS exhibited a fault and went into its inactive mode.

At 2:34PM the ESS reported a fault which caused its central regulator to ramp itself down and go into its inactive mode. The building lost power and the IPEM controller reported the ESS in its Inactive state (Figure 5-43).

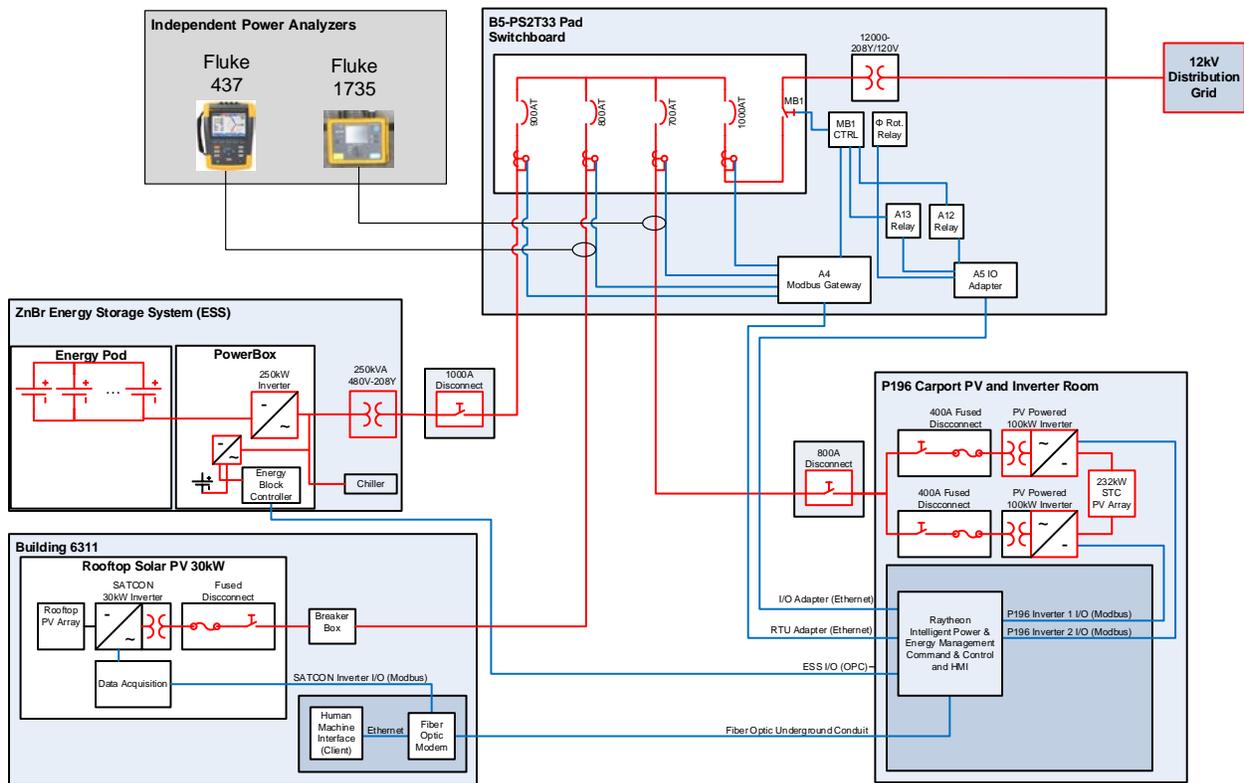
**Figure 5-44: Detailed schematic of the interconnection of the various subsystem components of the installation.**
