# FINAL REPORT

Zinc Bromide Flow Battery Installation  
for Islanding and Backup Power

ESTCP Project EW-201242

SEPTEMBER 2016

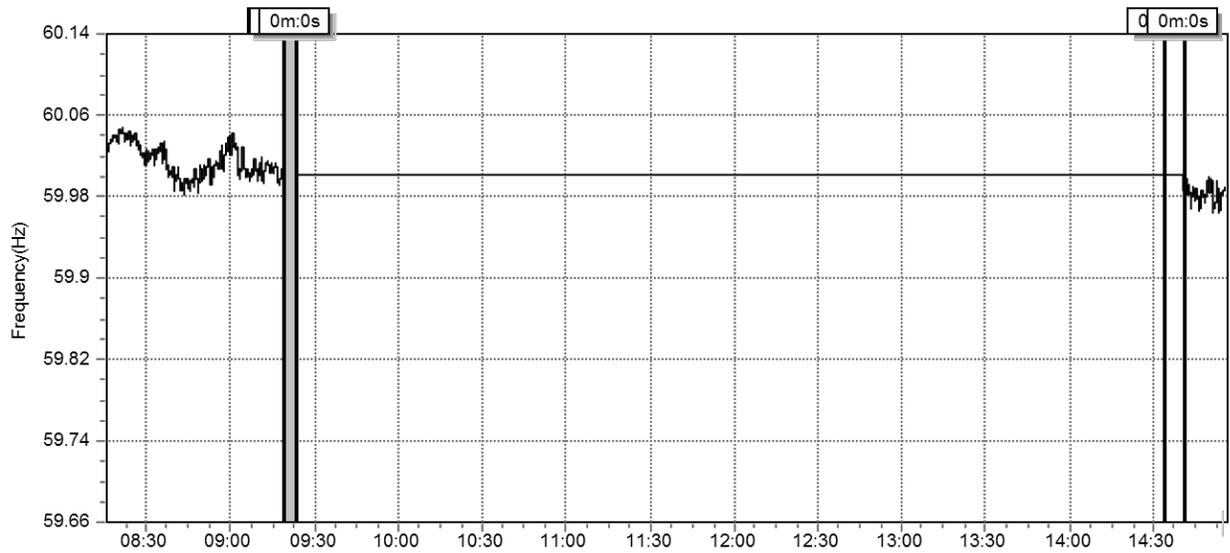
**Figure 6-1: Frequency measurements during 12/13/15 islanding demonstration test. Data was taken from Fluke 437 power analyzer. Frequency was maintained at a very stable 60hz.**

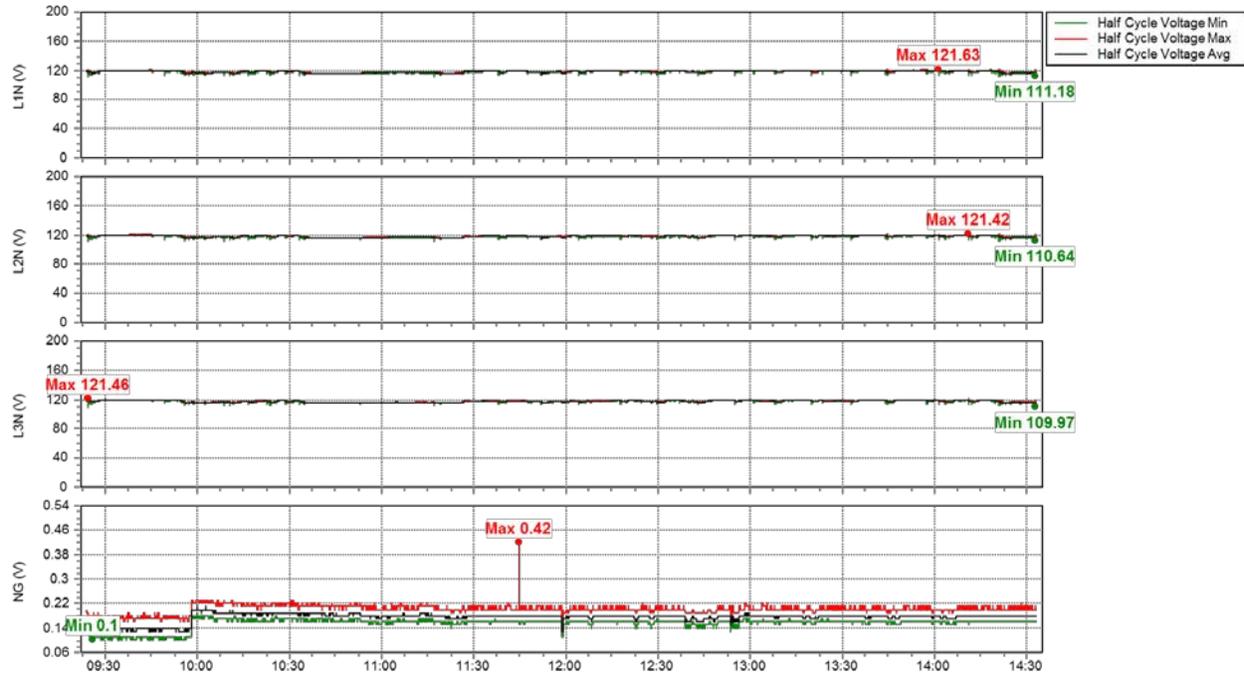
**Figure 6-2: Phase to phase voltage data during 12/13/15 islanding demonstration test.**

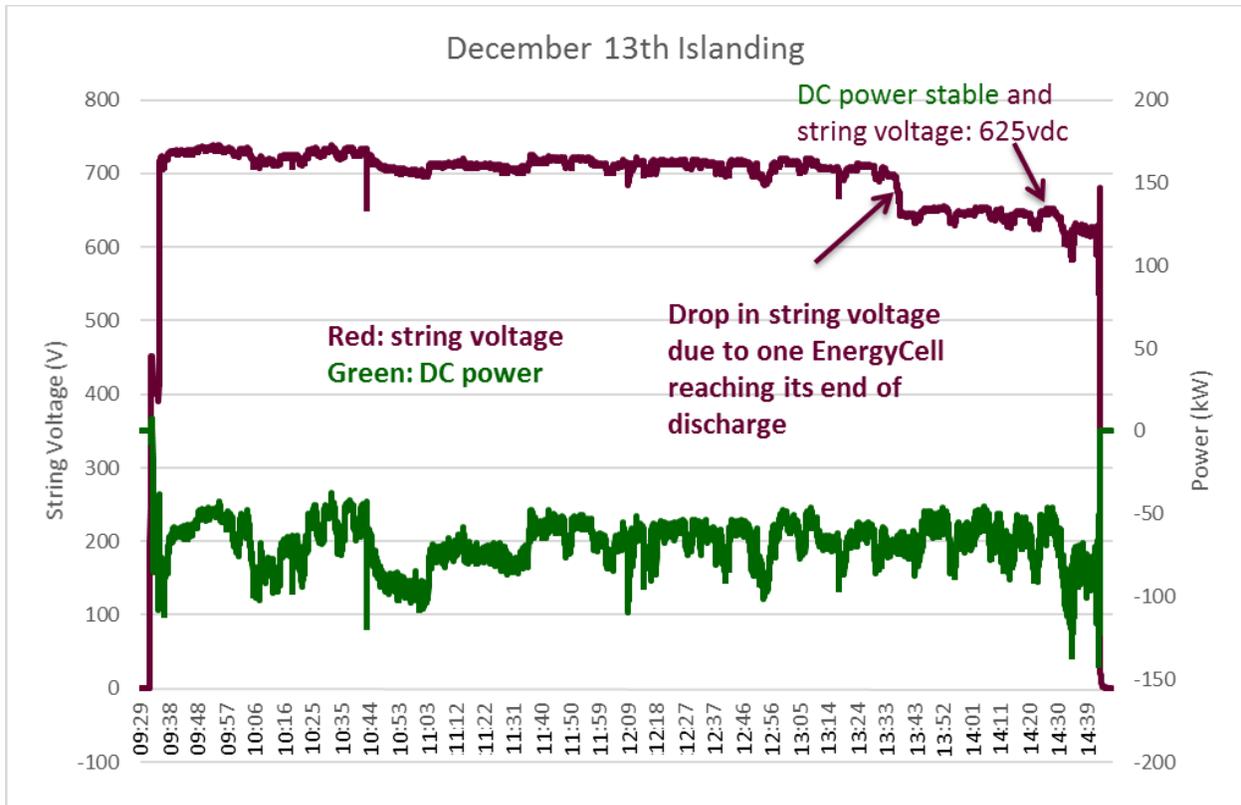
Figure 6-3: Voltage measurements on the EnergyCell string and DC output power from the Primus central regulator going into the Parker inverter. At ~1:40PM one of the twelve EnergyCells active during the test reached its end of discharge and took itself out of the string, dropping the string voltage. The string voltage appears stable all the way to point the fault occurred.

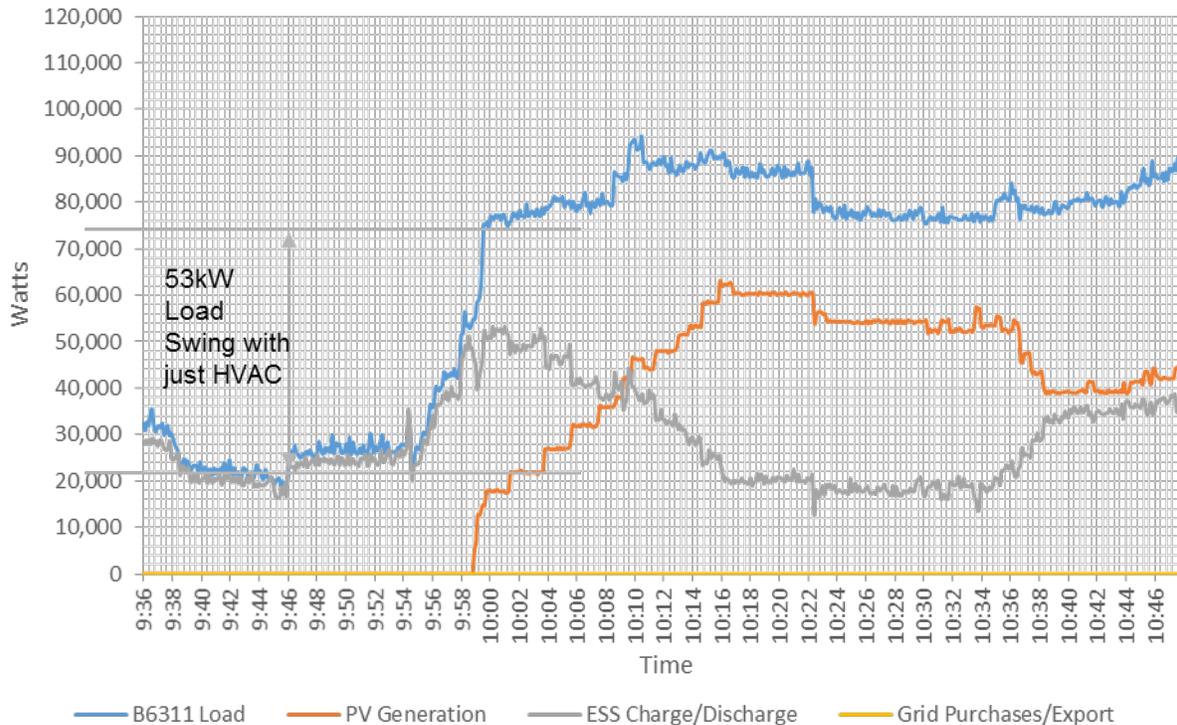
**Figure 6-4: Load profile from 12/13/15 islanding demonstration test highlighting load steps from manually increasing HVAC and building loads.**

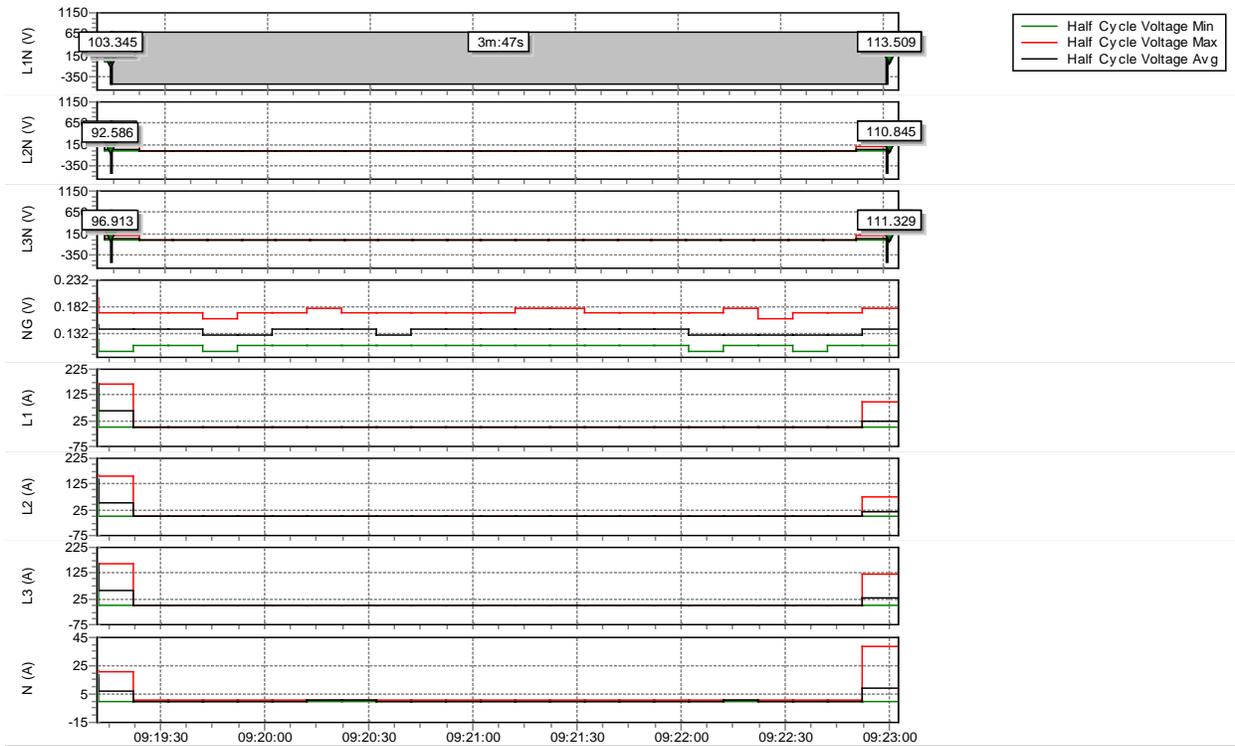
**Figure 6-5: Outage time from 12/13/15 islanding demonstration test to enter islanding mode. Grey box in L1N shows time recorded by Fluke 437 showing when the voltage was dropped and then restored.**

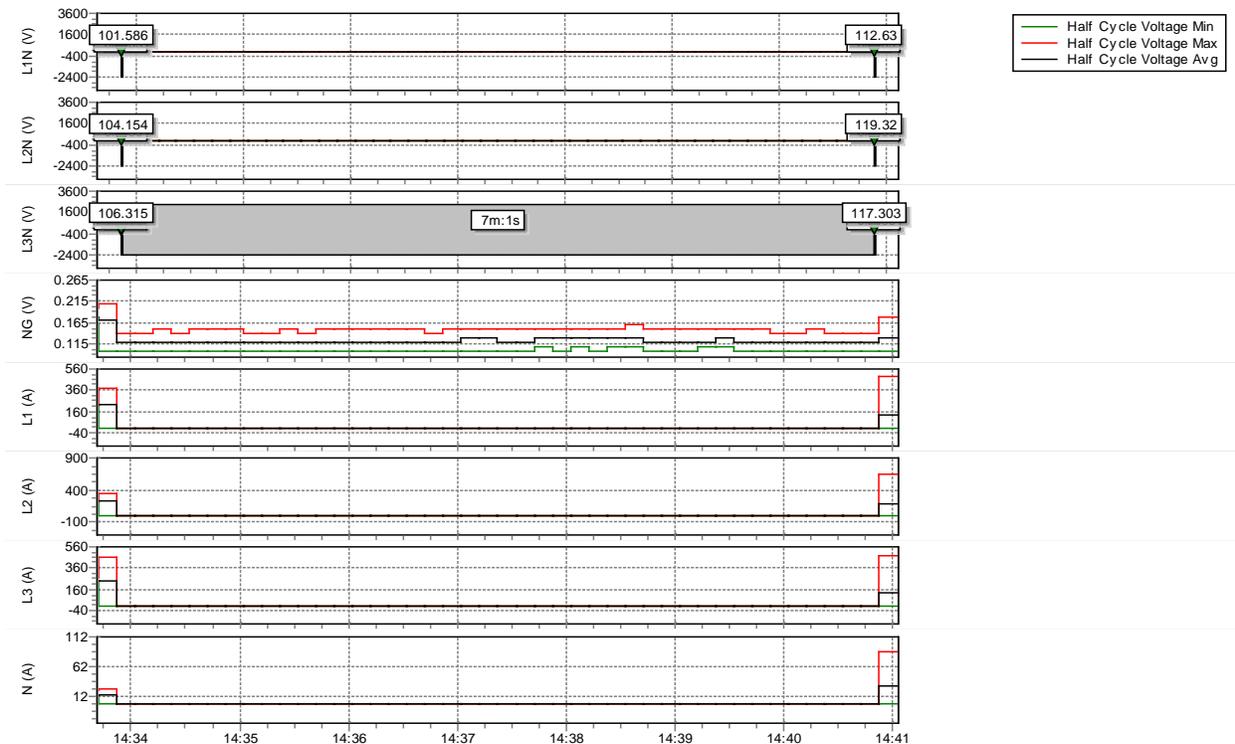
**Figure 6-6: Outage time from 12/13/15 islanding demonstration test to exit islanding mode. Grey box in L3N shows time recorded by Fluke 437 showing when the voltage was dropped and then restored.**

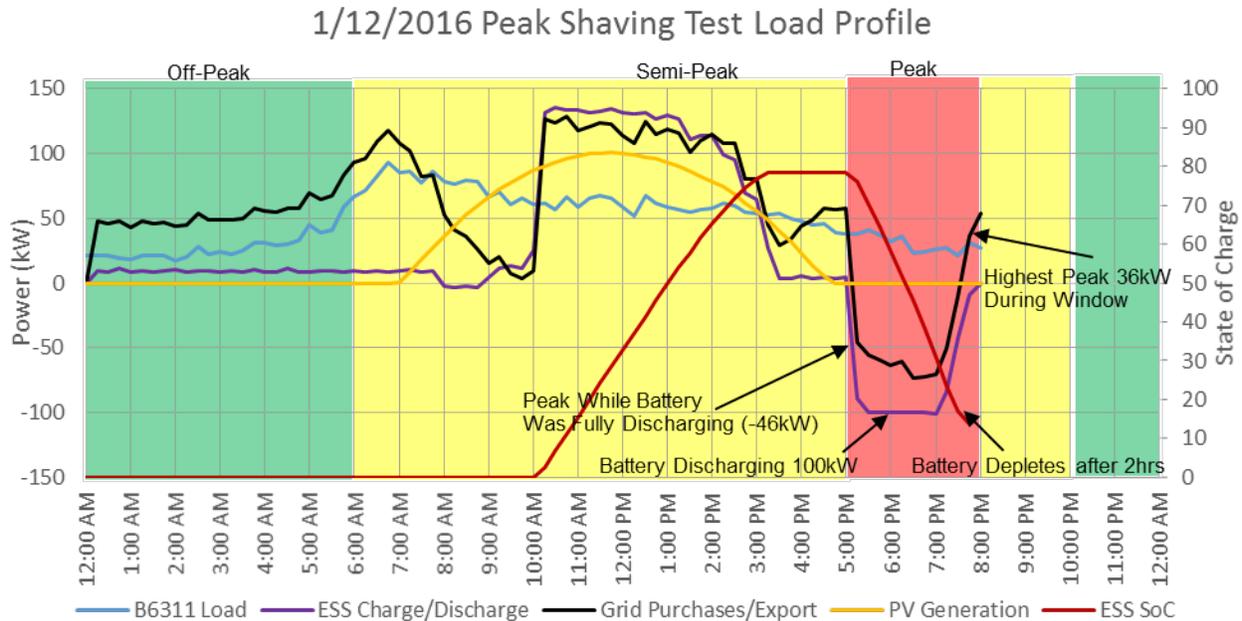
**Figure 6-8: Peak shaving test data.**

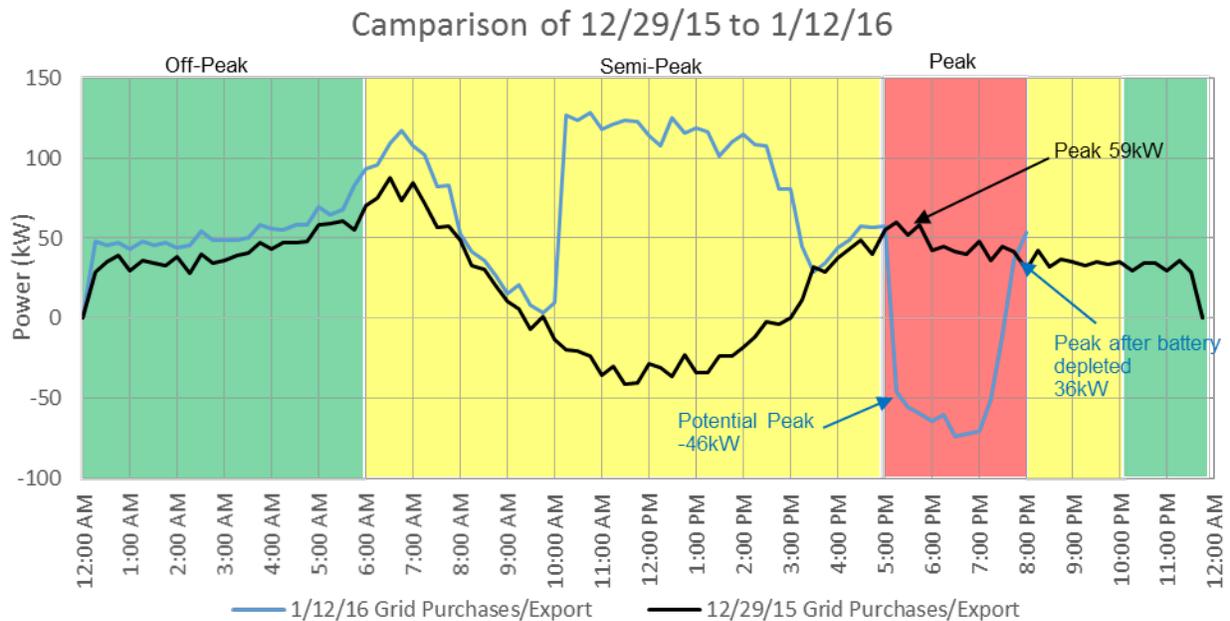
**Figure 6-9: Comparison of the load data collected on 12/12/15 to the data collected during the peak shaving test on 1/12/16.**

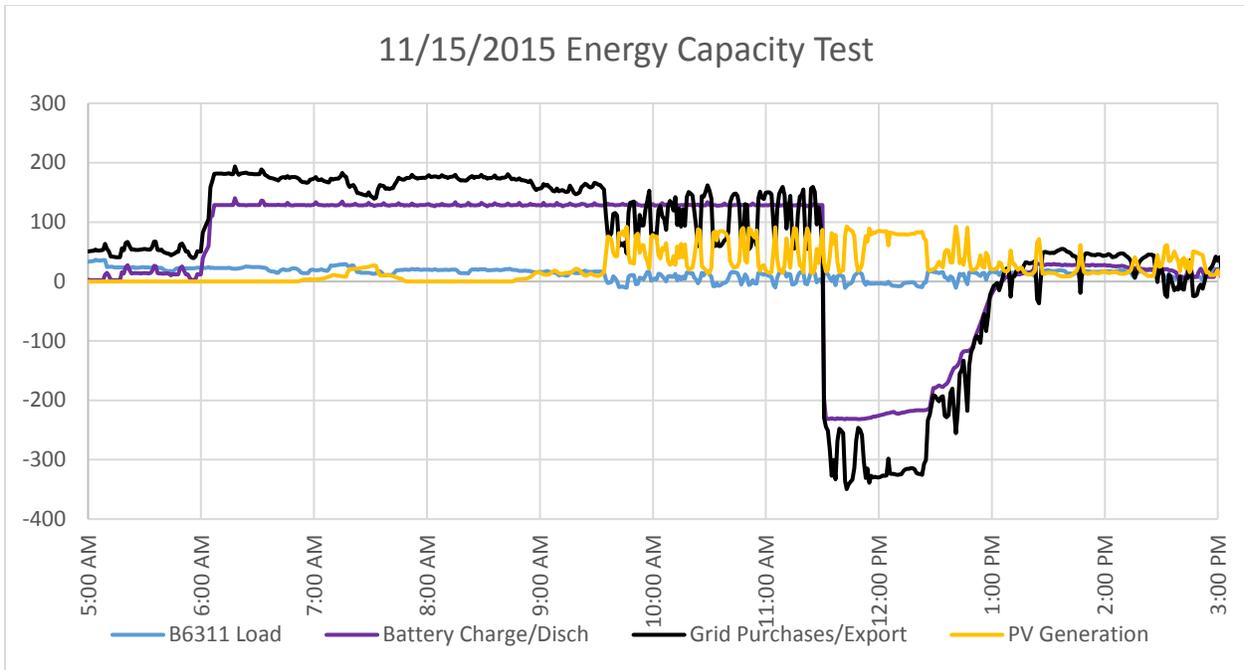
**Figure 6-10: Energy Capacity test conducted on 11/15/15. The discharge output of the battery was set to 230 kW output power.**

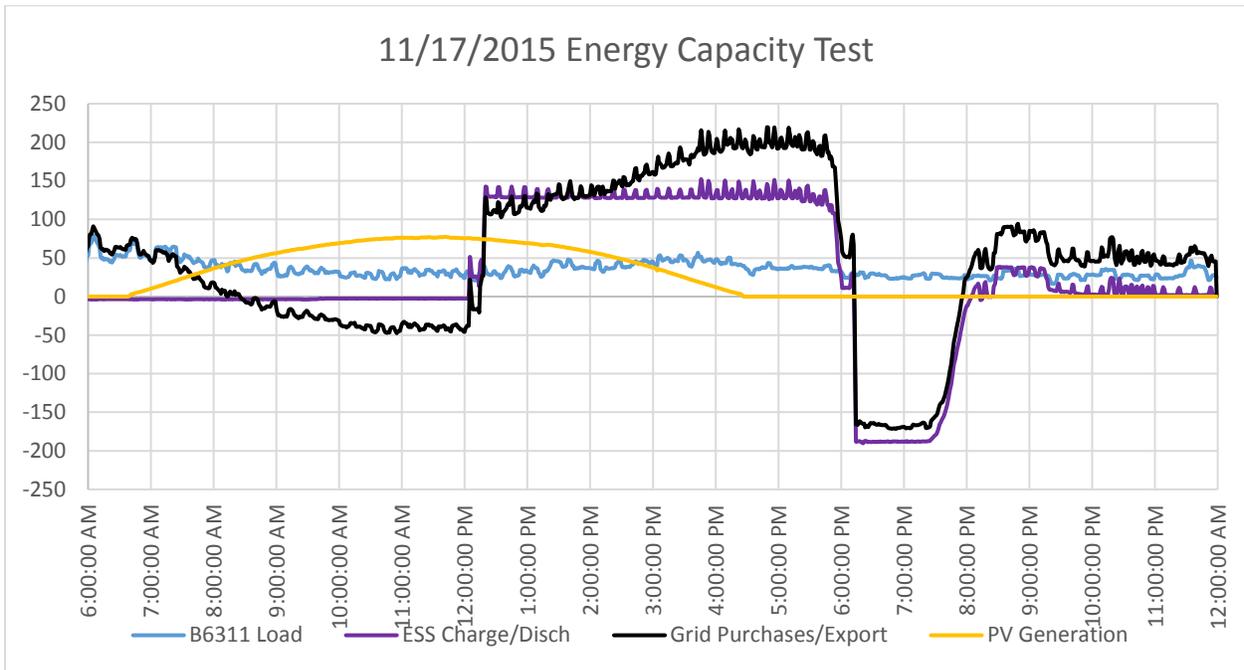
**Figure 6-11: Energy capacity test conducted on 11/17/2015. The discharge output of the battery was set to 190kW output power.**

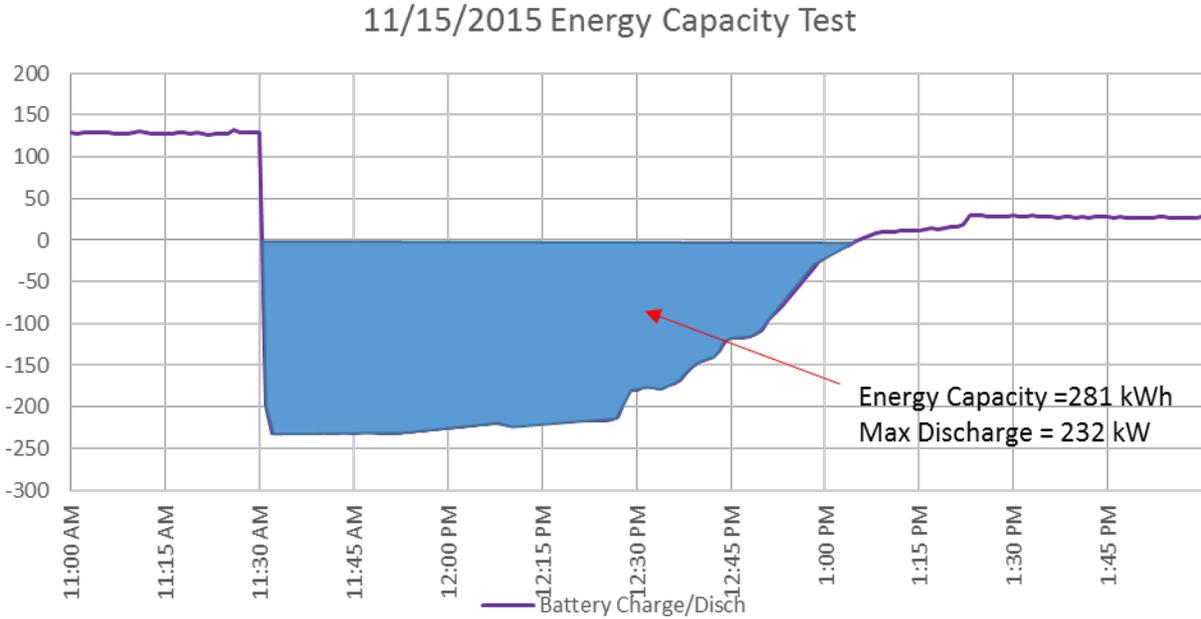
Figure 6-12: Energy capacity calculated for 11/15/15 test.

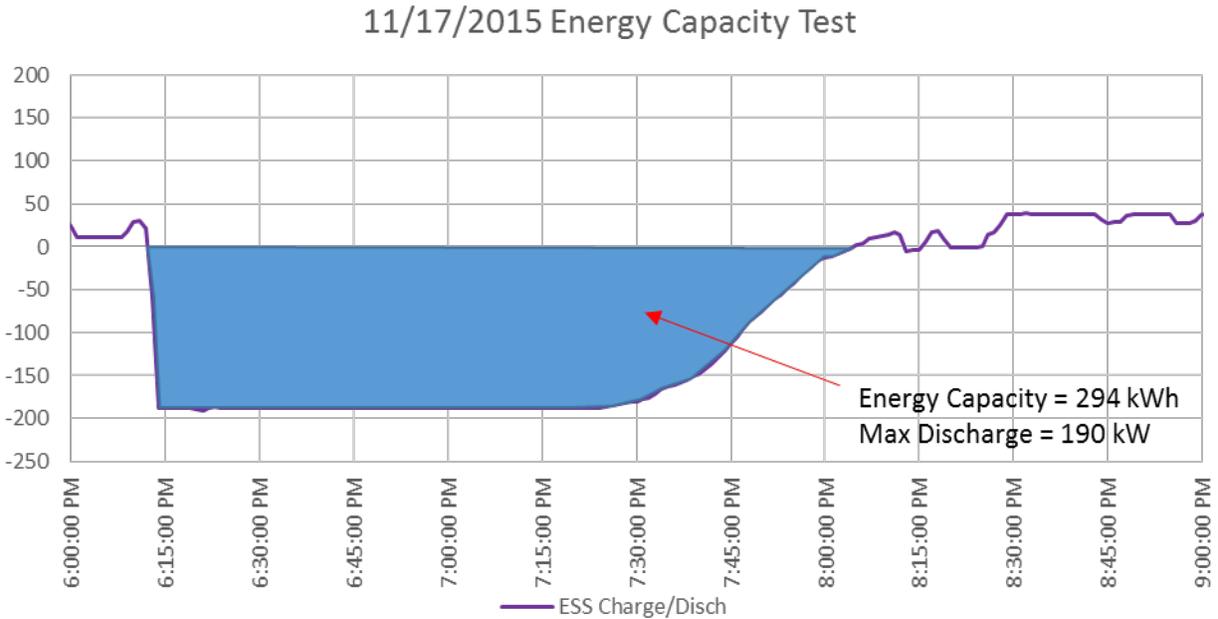
Figure 6-13: Energy capacity calculated for 11/17/15 test.
