Naval Research Laboratory
Washington, DC 20375

**Validation of HVOF WC/Co, WC/CoCr and Tribaloy
800 Thermal Spray Coatings as a Replacement for
Hard Chrome Plating on C-2/E-2/P-3 and C-130
Propeller Hub System Components**

May 2003

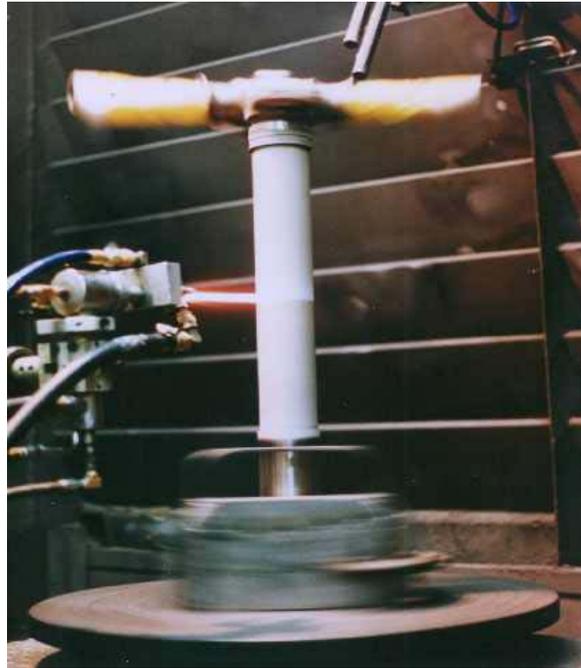
Figure 2-2. HVOF spray of landing gear inner cylinder.

Installation and operation: The HVOF gun can be hand-held and used in an open-fronted booth. However, the supersonic gas stream is extremely loud and requires that the operator use very good ear protection. For this reason the unit is usually installed on a six-axis robot arm in a sound-proof booth, programmed and operated remotely. Most depots already use this type of booth for their existing plasma spray operations. Since the method is frequently used for cylindrical items the most common arrangement is to rotate the component on a horizontal rotating table and move the gun up and down the axis.

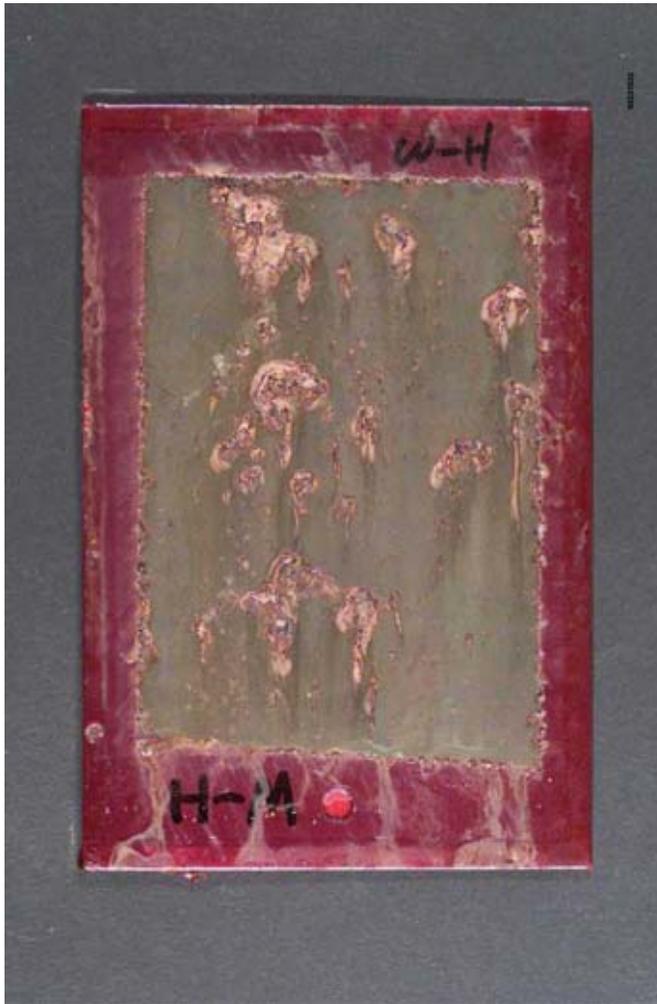
Figure 3-2 0.001 inch thick WC/Co HVOF

The WC/Co and WC/CoCr corroded in one or two specific locations rather than many locations. Due to the very dense nature of the coatings, the coating must fail from a few random flaws in the coating rather than evenly dispersed porosity. The source of these flaws was therefore important. If they were generated due to the warping of the panel, it is possible that better corrosion resistance could be expected on actual components that can resist warping.

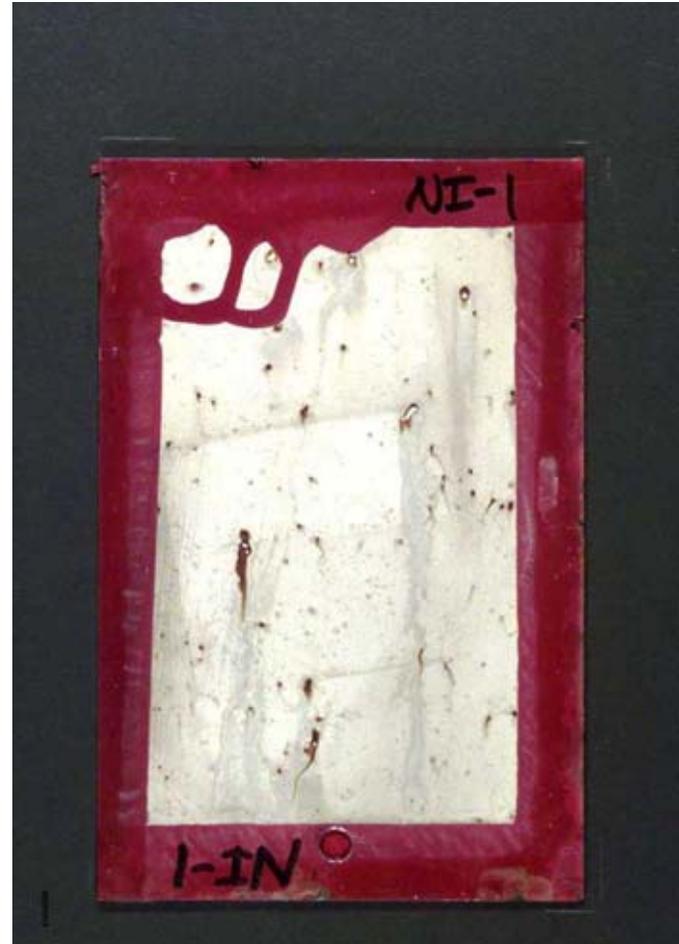
Figure 3-3 0.001 inch thick Nickel Plate

The nickel plate applied to the panel was soft nickel with a resulting tensile residual stress rather than a hard nickel with a compressive residual stress. This was due to miscommunications within the plating facility. While this condition would be less than optimum for wear testing, we believe it had a negligible impact on the outcome of the corrosion tests. In our opinion, the state of coating residual stress had little affect on the barrier protection provided by the nickel.

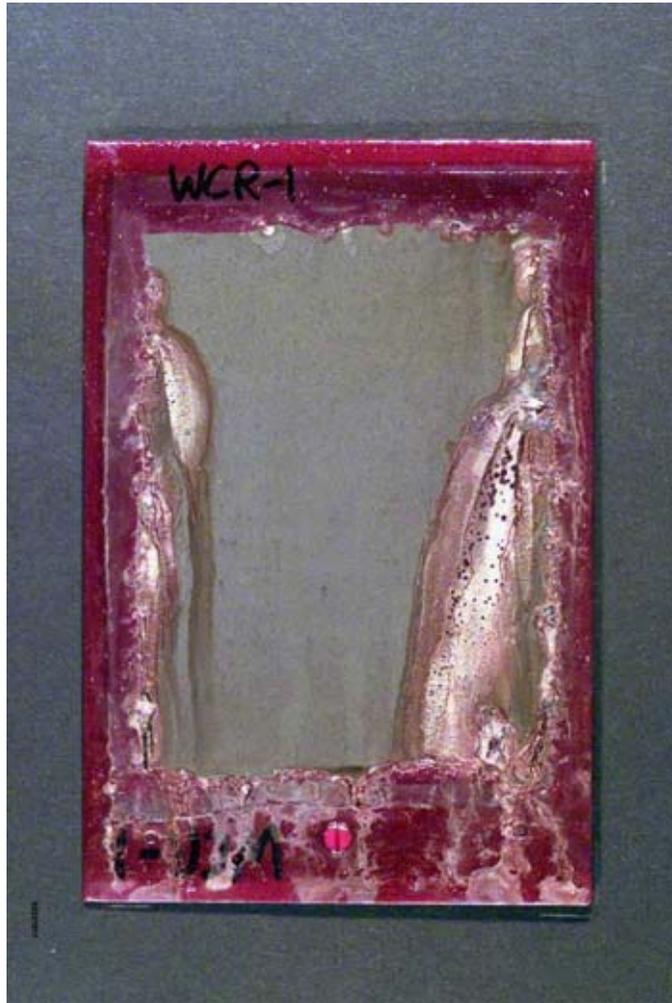
Figure 3-4 0.001 inch thick WC/CoCr HVOF

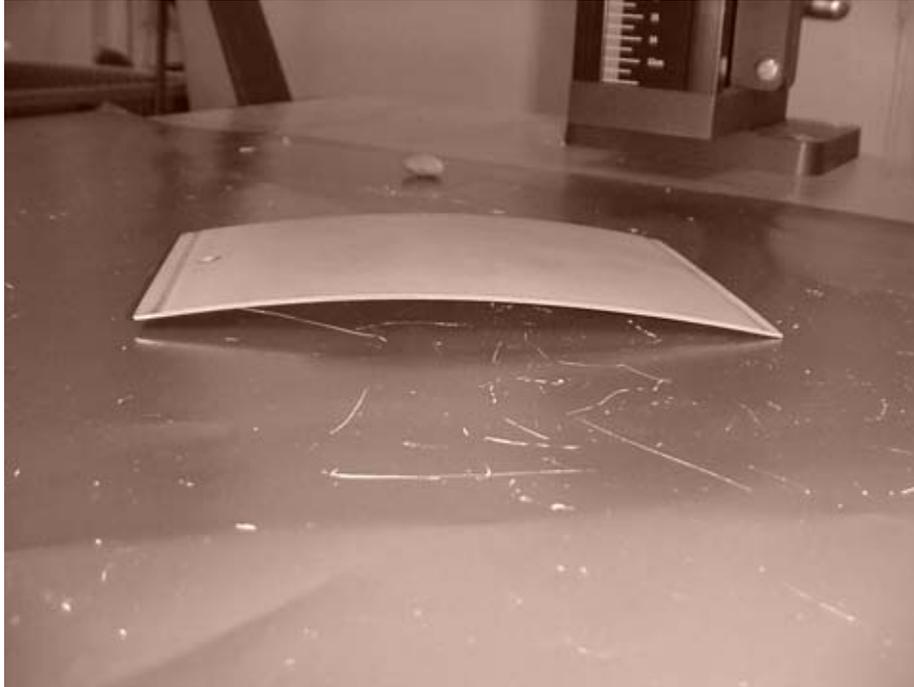
Figure 3-6 WC/Co Coated Panel, Top Surface Coated

The high compressive stresses in the HVOF coatings caused the panels to warp substantially, as shown in Figure 3-6. To overcome this effect and restore flatness for grinding, the reverse sides of the panels were glass bead peened. The as-coated (not machined) panels were not peened. Even after peening some panels still bowed slightly in the opposite direction, see Figure 3-7. To prevent uneven grinding which would result in a non-uniform coating thickness, the edges of the panels were clamped to the table of the surface grinder to allow the middle of the panel to be machined. This setup was also required for the nickel-plated panels, which had bowed in tension creating a slightly concave surface.

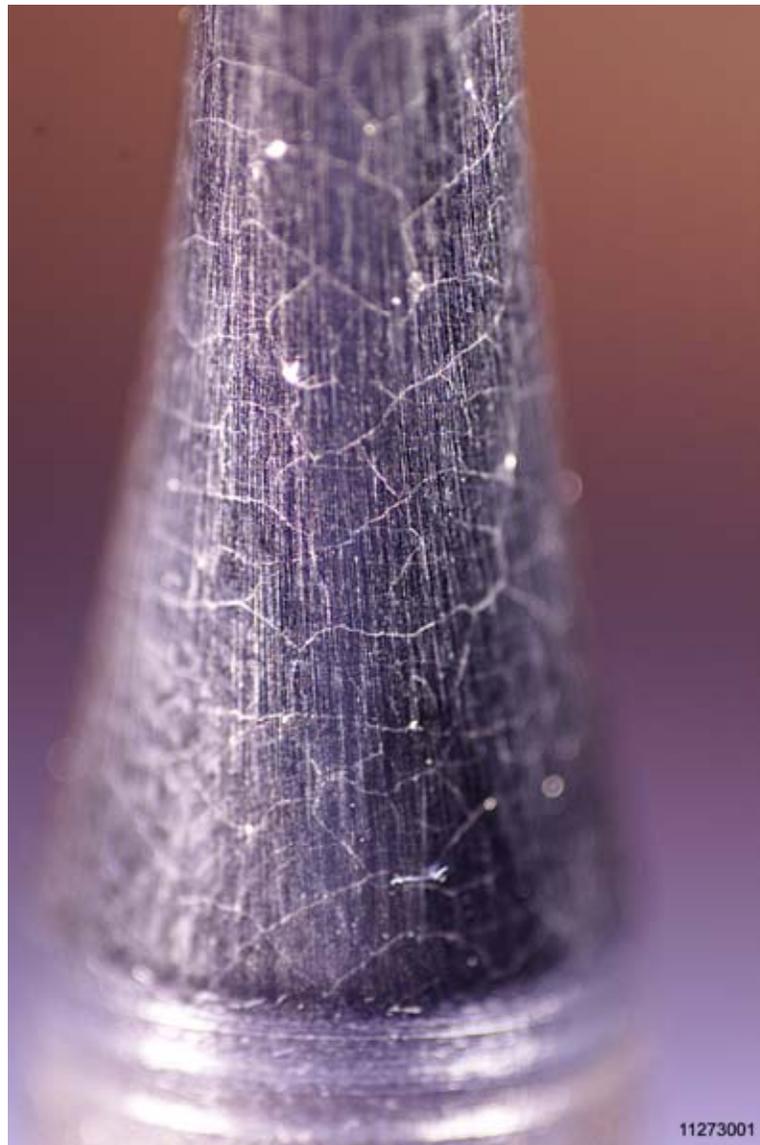
Figure 3-15 White light of EHC coated specimen showing cracks created by machining process.

The three thicknesses of chrome plate all showed fatigue strength decreases despite the fact that the steel substrate had been shot peened prior to plating. The EHC plated specimens exhibited 38 to 51 percent lower fatigue strengths. This effect is more in line with chrome plating over unpeened steel so selected specimens were returned to HS and were subjected to visual and fluorescent penetrant inspections. The report from the National Destructive Test lab reported grinding cracks were found away from the test sections of specimens representing all three plating thickness'. Figure 3-15 shows these cracks under normal lighting conditions.

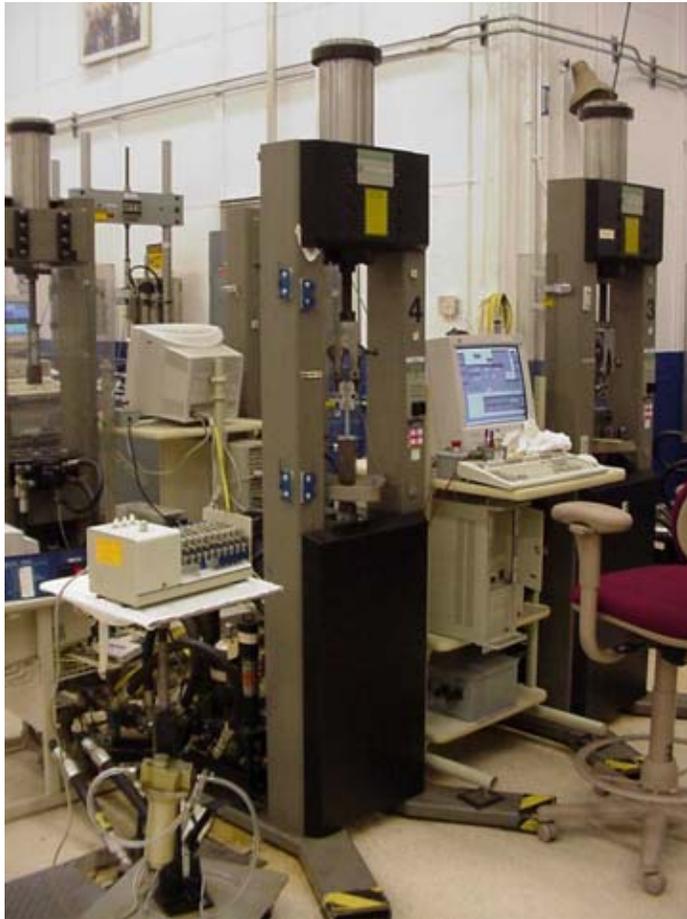
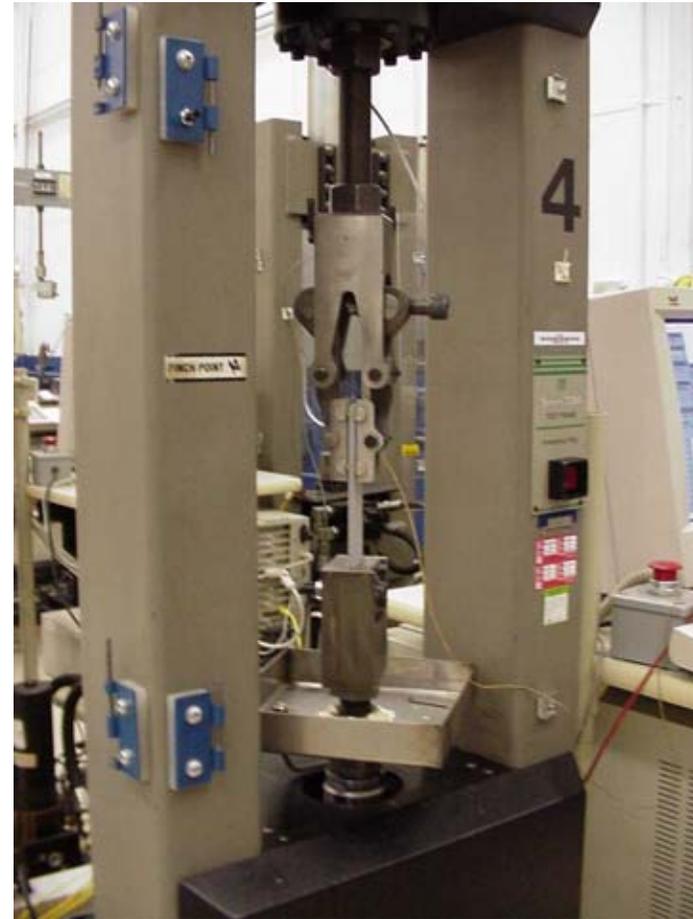
22,000 pound servo-hydraulic fatigue test frame

Test fixture including oil drip pan

Figure 3-19. Wear test fixture in test frame.

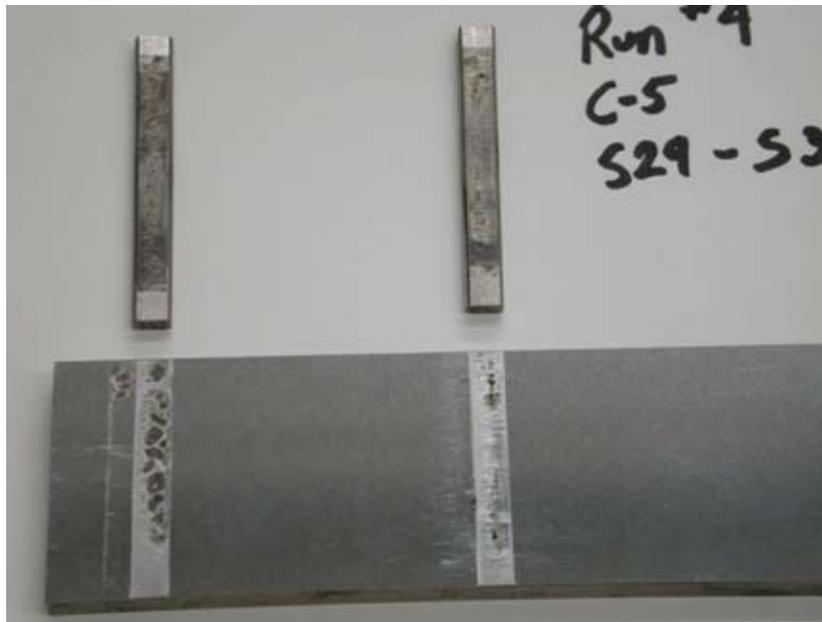
Figure 3-23 EHC Dithering in Contaminated Oil With Steel Counter-faces

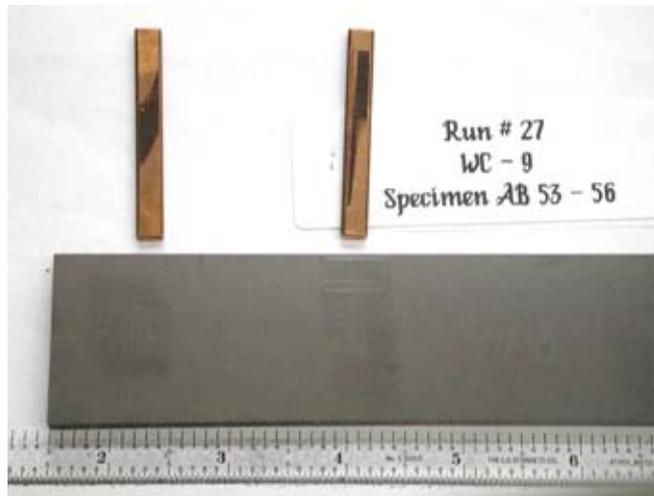
Figure 3-30 WC/Co Reciprocating Against Copper Counter-faces

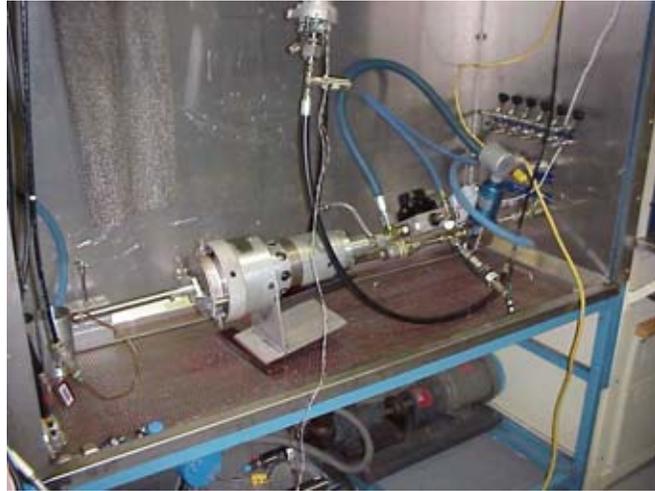
Figure 3-48 Low pitch stop sleeve testing fixture

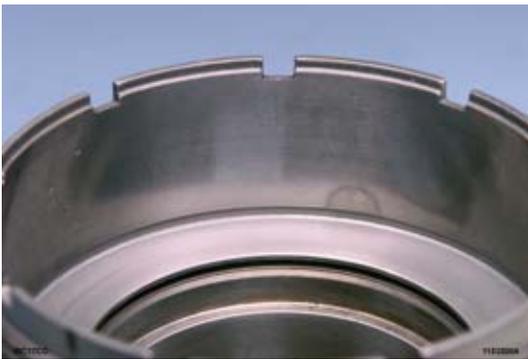
Chrome Sleeve

Piston Ring from Chrome Sleeve

WC-17Co Sleeve

Piston Ring from WC-17Co

Figure 3-50. Low pitch stop sleeves and piston rings after testing.

Based on the test results, Hamilton Sundstrand recommends WC/17Co as a replacement for chrome plate on the ID of the low pitch stop lever sleeve for the 54460 and 54H60 applications.. Wear of the HVOF coating in a simulated operating environment was less than the baseline chrome. The HVOF-coated bore produced less wear on the mating piston ring than did the chrome-plated bore.
