ESTCP
Cost and Performance Report

(WP-200301)

Low VOC Barrier Coating for Industrial Maintenance

September 2012

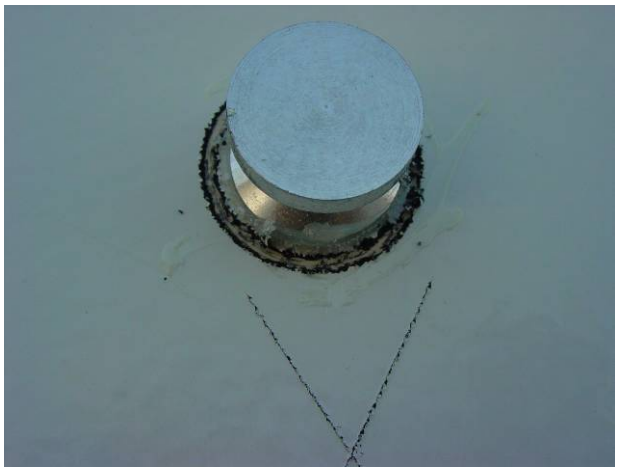
Pull and tape adhesion tests of the new coating, conducted several days after applications, indicated coating adhesion on tank 2001 roof of between 210 and 250 psi and 4A. Tests on tank 2003 roof and sides indicated adhesion between 190 to 230 psi and 5A. These results show good initial adhesion between the overcoat and the preexisting system – a condition vital to long-term performance. The 10 DFT samples collected from the Tank 2003 roof ranged from 9.5 to 20.7 mils while the 50 samples collected from the sides of the tank ranged from 11.0 to 25.6. The 10 roof samples collected from Tank 2001 ranged from 13.2 to 21.8 mils.

Figure 12. Adhesion testing of the coating after 1 year.
