FINAL REPORT

Ultraviolet (UV)-Curable Coatings for Aerospace Applications

ESTCP Project WP-0804

August 31, 2012

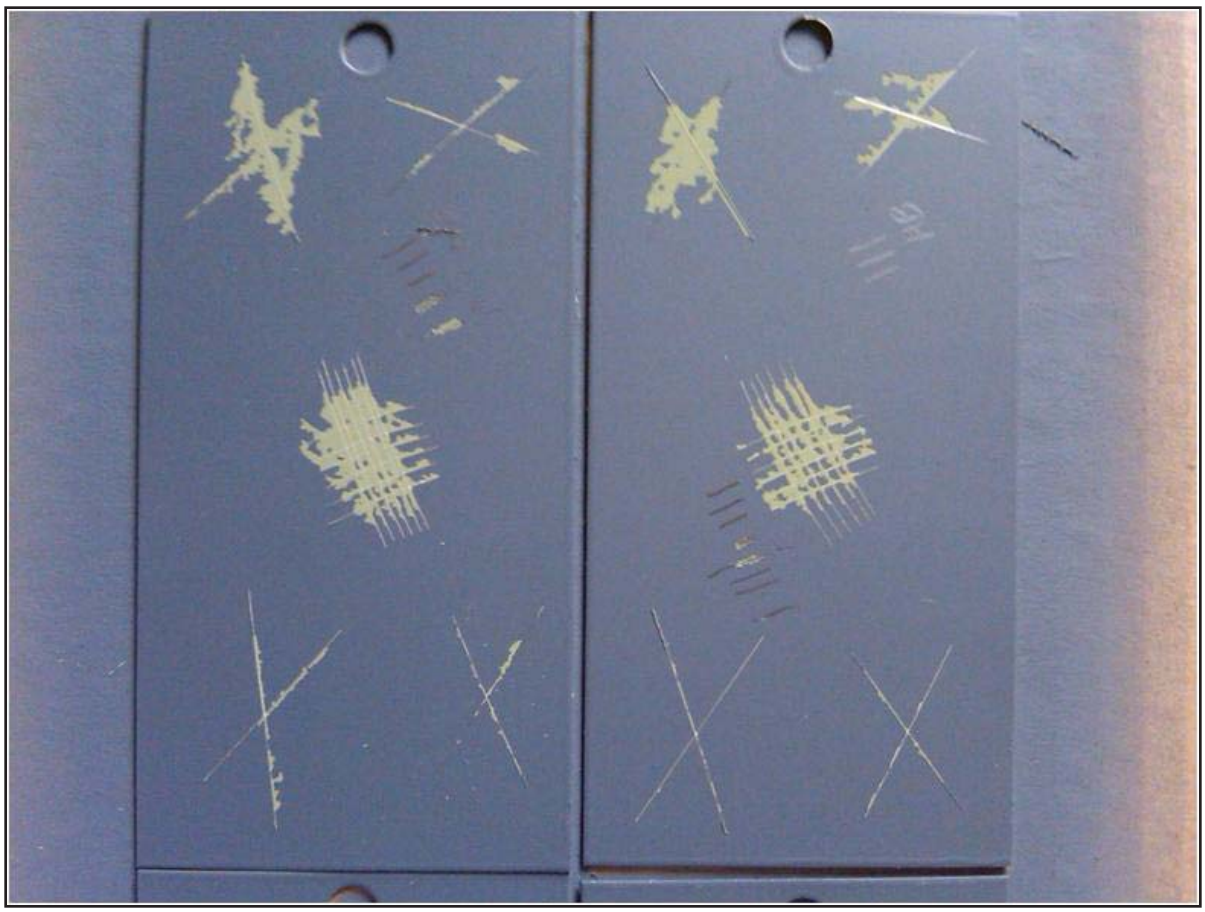
Figure 15. 21GY002 Adhesion Testing at 2 mil coating thickness

The 21GY002 was also applied and cured at a DFT thickness of approximately 3 mils. However, at this thickness the coating experienced a massive wrinkling effect during UV exposure that made it impossible to test, or even to measure an average DFT. Figure 16 shows the 21GY002 at approximately 3 mils of thickness.

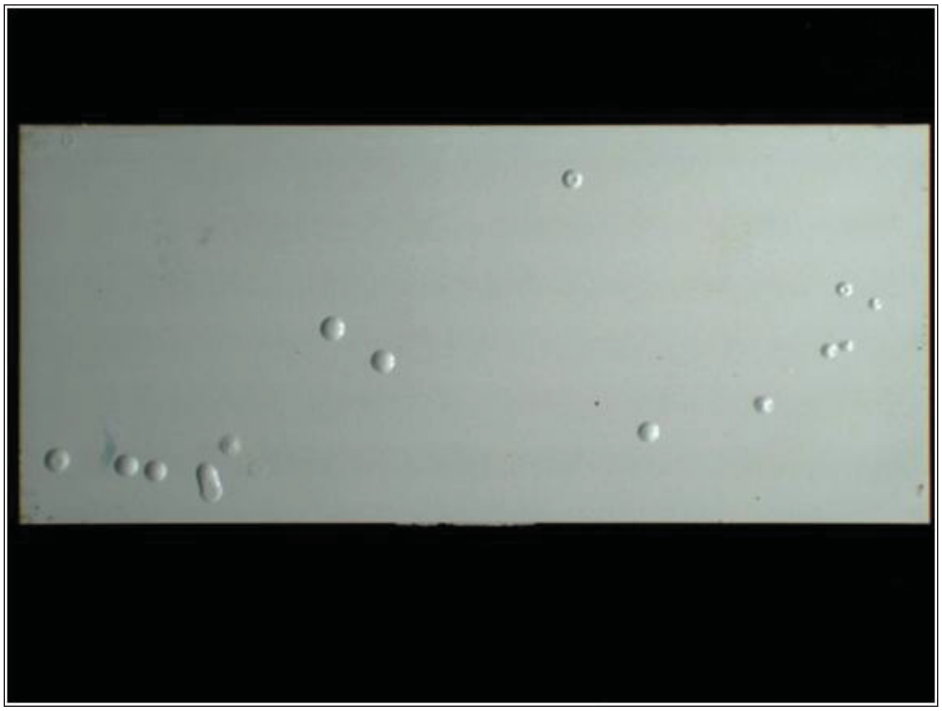
Figure 20. Humidity Resistance Sample 2987

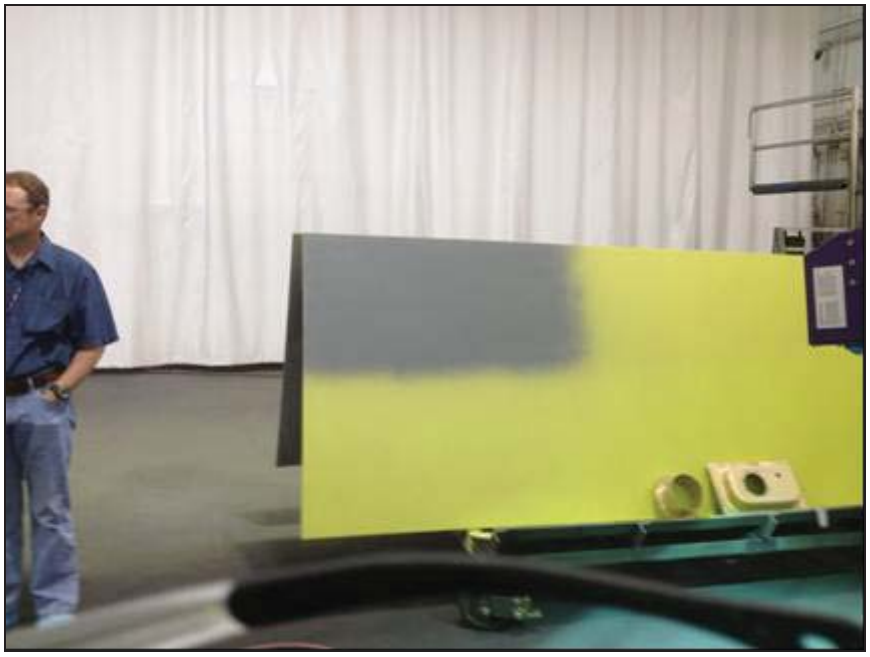
Figure 22. First Section Sprayed of CTC/BBM coating at OO-ALC

After the initial application, the wet-film thickness was measured using a standard wet-film coating thickness gauge. The initial readings showed the wet-film thickness to be 5 mils, which the applicator anticipated might produce a coating near the higher end of the intended DFT range. To ensure that coating thickness did not interfere with cure, a second section was sprayed and measured at 3.5 mil wet-film coating thickness. Both areas were allowed to flash off for 10 minutes to allow solvent to escape before the cure process began.

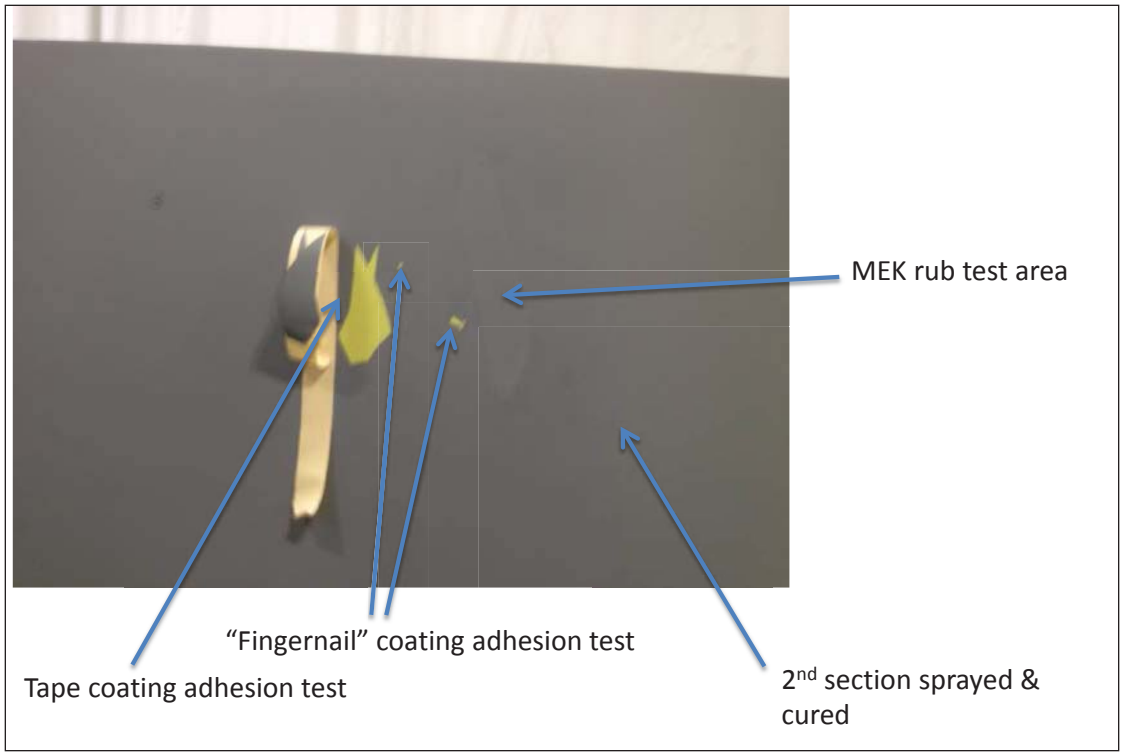
Figure 25. Cure Tests on Second Section

A pencil hardness test was attempted on the second area coated, but could not be conducted due to lack of adhesion between the primer and topcoat. Following the testing failures, the lamp intensity was measured again and was found to be at or above the recommended cure intensities. Based on the total adhesion failures of the coating, the demonstration was halted with the concurrence of the PI and no further spray/cure attempts were made with the remaining coating.

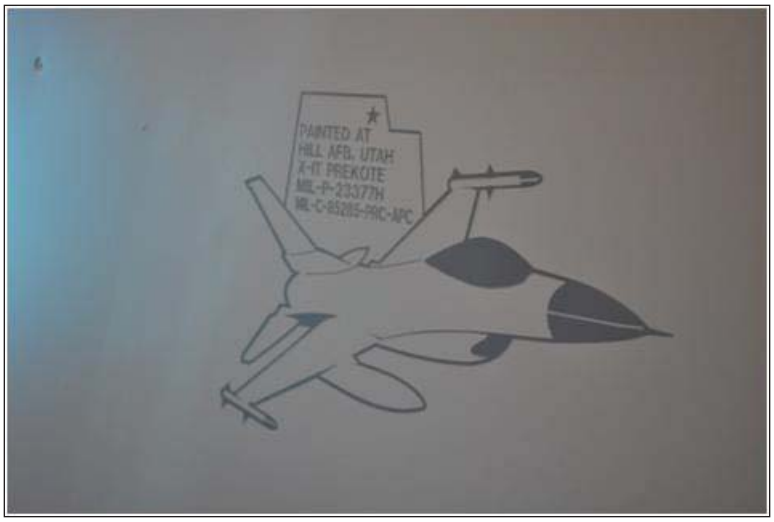
Figure 46. Completely Revealed Painted-At Tag Stencil

Maskant removal was completely successful, with no peel-away of the coating. However, a problem was detected at this point. The technician demonstrated smudges on his gloves, indicating that the coating was not completely cured despite exposure to UV light. After discussion, various personnel involved in the demonstration began pressing their fingers on the stencil to verify this. The coating was reported as feeling tacky and soft, definitely undercured. Pressure on the stencil surface left fingerprints.

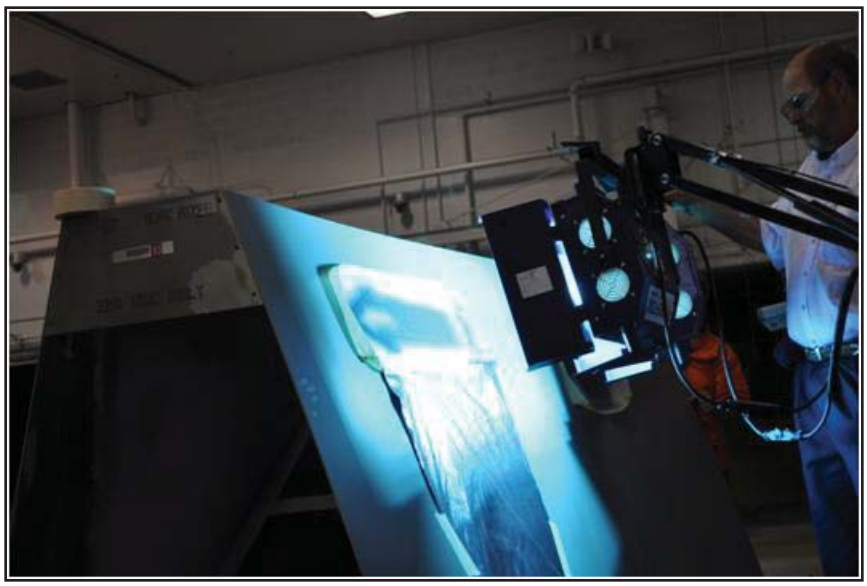
Figure 47. UV Cure of Rescue Arrow Stencil

H&S took UV measurements of the light reflected by the foil and reported extensive reflection of UV light, suggesting that use of reflective foil should be discouraged in UV-curable painting operations.

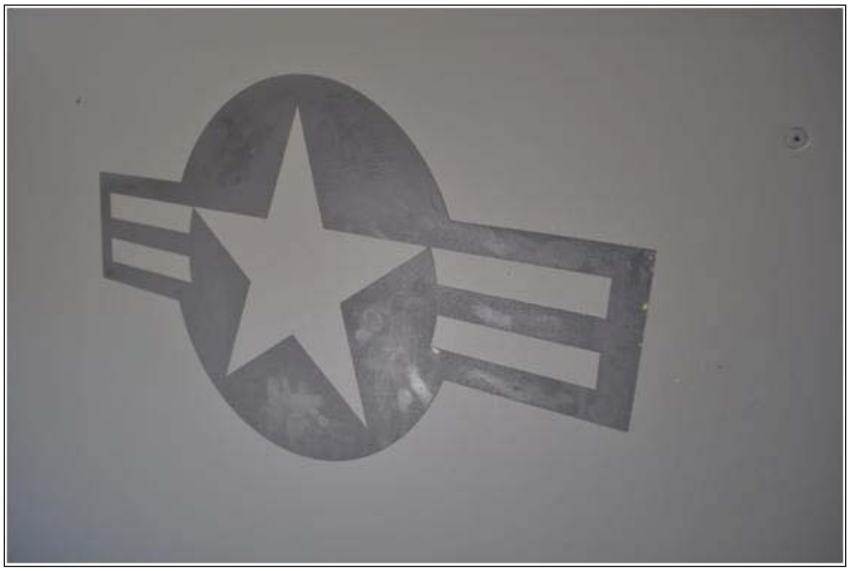
Figure 49. Prints Left in Stencil

At this point, the question was raised as to whether the coatings were somehow being underexposed to sufficient UV energy. In an attempt to achieve superior cure, the UV light was left over the Rescue Arrow for a full fifteen minutes of UV exposure. After removal of the light, the substrate temperature was recorded as being 132° F. As with the other stencils, the maskant material was successfully removed without any stencil peel-away.

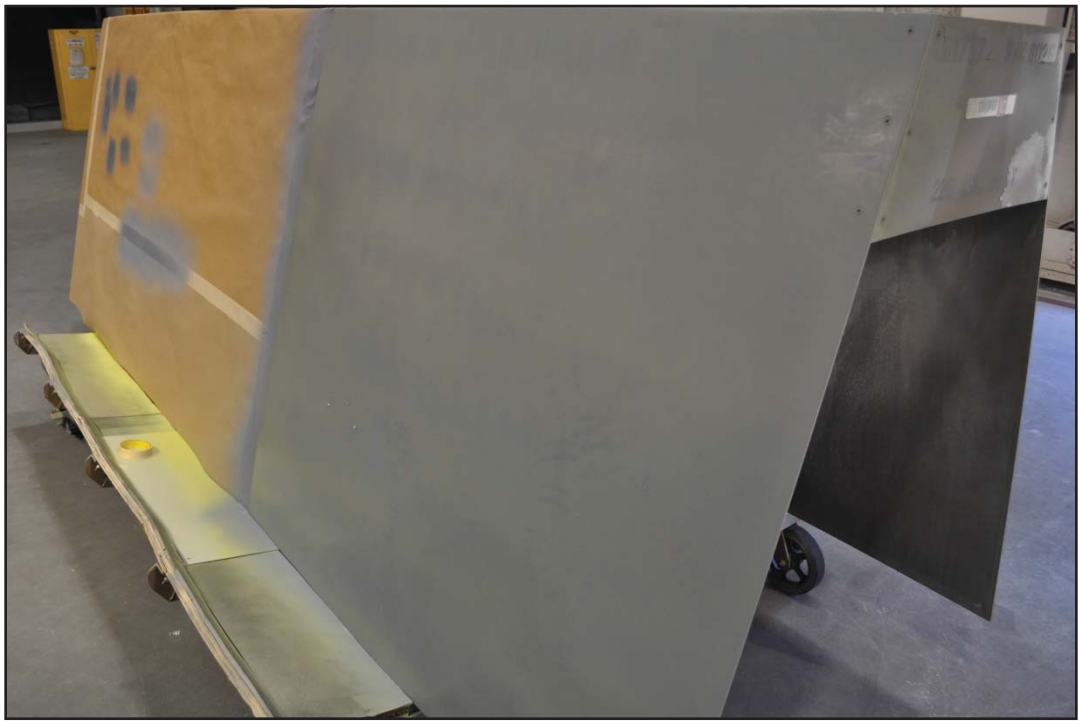
The coating post-cure was extremely thin, and patchy. DFT readings at various places on the sprayed surface were taken as: 2.1, 2.1, 1.8, 1.4, 1.9, and 1.8 mils, meaning that in many cases the UV 36173 was less than a mil dry once the approximate 1 mil thickness of the primer is subtracted from the stack-up total. Furthermore, the coating exhibited the same tacky, not-cured

feeling as the UV 36118 stencils. Pressing on the surface with fingers easily left marks. Figure 53 shows the cured UV 36173 surface.

Figure 53. Cured UV 36173 Surface
