ESTCP
Cost and Performance Report

(EW-201511)

Automated Aerosol-Sealing of Building Envelopes

January 2018

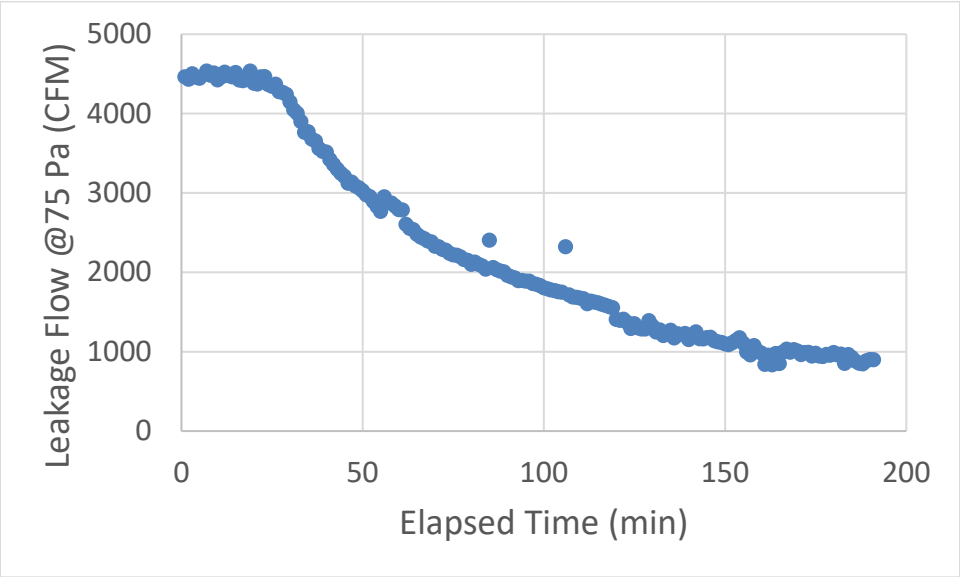
Figure 6. Sealing Profile for Building 2177 at Quantico Marine Corp Base (MCB)

The sealing results for building 2177 at Quantico were very impressive sealing 80% of the available leakage area in three hours of injection. Figure 6 shows the sealing profile for the demonstration. The pre and post air sealing results with the "as found" condition showed a total air leakage reduction of 68% going from 4,503 cfm at 75 Pa to 1,440 cfm at 75 Pa which brought this building to within the USACE specification for air leakage in new buildings. This demonstration highlights the overall capability of the aerosol sealing approach by showing a 1950s era building getting sealed to the standard outlined for all new military installations in only a couple days of work.

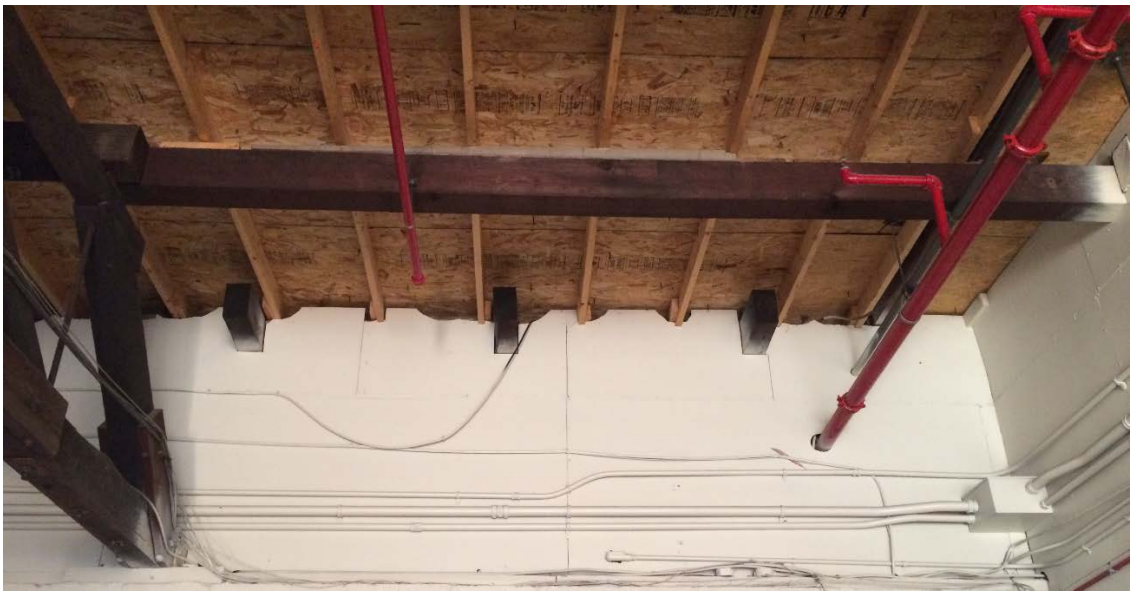
Figure 7. Photo Showing Large Holes in Wallboard at the Roof Rafters of Building M/608A at NSA Mechanicsburg

At first inspection it was assumed that some manual sealing would be required to deal with large holes in the wallboard (Figure 7), but after a closer look it appeared that the soffit construction behind the wallboard was built with suitable gaps for the aerosol sealing method to address. It was therefore decided to begin sealing without supplemental manual sealing. The building had several large roll-up doors that were temporarily sealed prior to the aerosol injection to prevent sealing those doors.

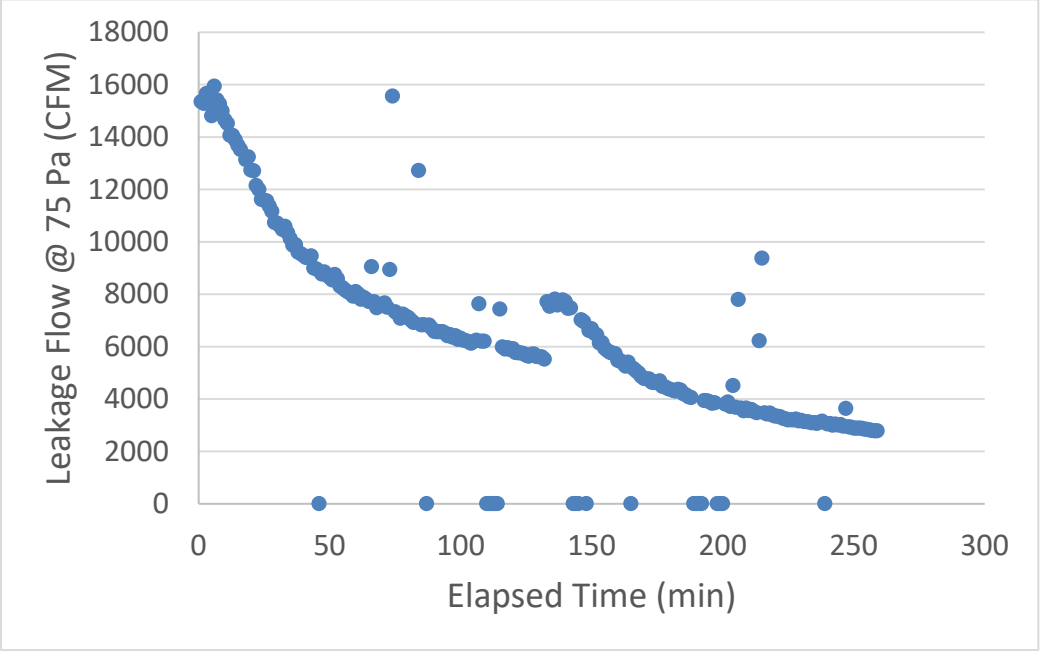
Figure 8. Sealing Profile Showing Both Sealing Events for Building M/608A at NSA Mechanicsburg

Two distinct sealing events occurred sealing 82% of the available leakage. Figure 8 shows the sealing profile for both sealing events. Each sealing effort sealed about 60% of the available leakage in two hours of injection. Ultimately, 64% of the building leakage was sealed over only four hours of total injection time. The building leakage started at 18,210 cfm at 75 Pa and was reduced to 6,515 cfm at 75 Pa.

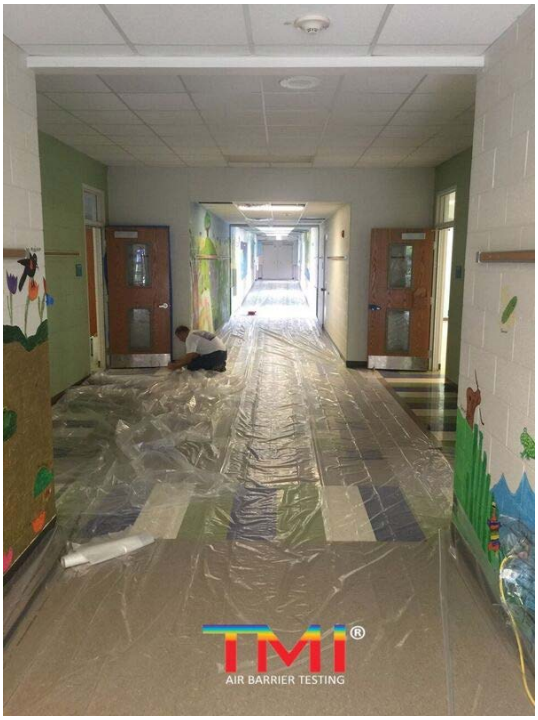
Figure 11. Photo Showing Floor Prepped at Ashurst Elementary at MCB Quantico (left), and Floor Not Prepped at Building 608A at NSA Mechanicsburg (right)

The aerosol sealing demonstrations in this project did encounter situations where the floors needed to be protected from aerosol deposition. In these cases, plastic and tape were used to cover all horizontal surfaces including floors, table tops, and window sills (Figure 11). This preparation of the building significantly impacted the amount of labor required for the sealing work. While there are no photos showing the floor after sealing, the building operator was generally pleased with the condition of the building. Figure 11shows a photo of a floor that was not protected during the aerosol installation since the building was slated for demolition. The photo shows a clear layer of sealant deposition on the floor.
