FINAL REPORT

Lightweight and Compostable Packaging For the Military

ESTCP Project WP-201218

August 2018

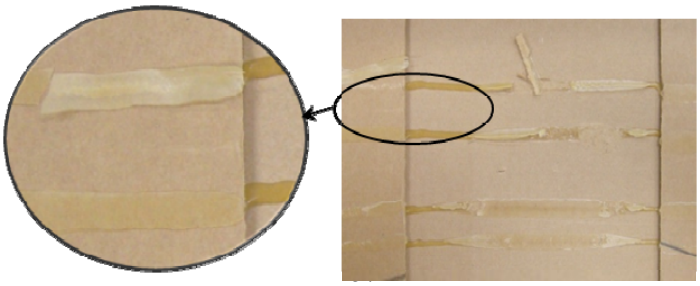
A. Adhesive Failure; -Failure Mode 1: No Fiberboard Damage, Failure Mode 2: Flap came loose. Note: Only be seen in Full Inspection of pallet.

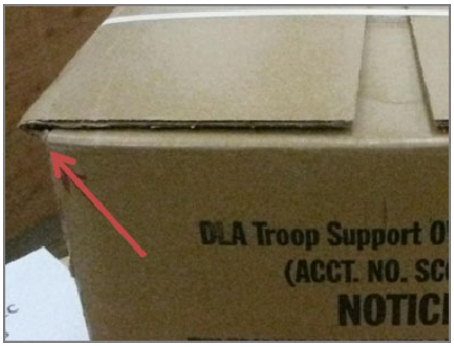
F. Flaps Pushed Out Flap does not conform to corner of the box. Most likely also result in excessive gap width.

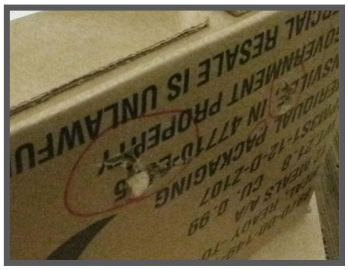
G. Puncture Hole in box. Any time internal packaging was visible. Any small or large dent in packaging, localized in a circular shape.

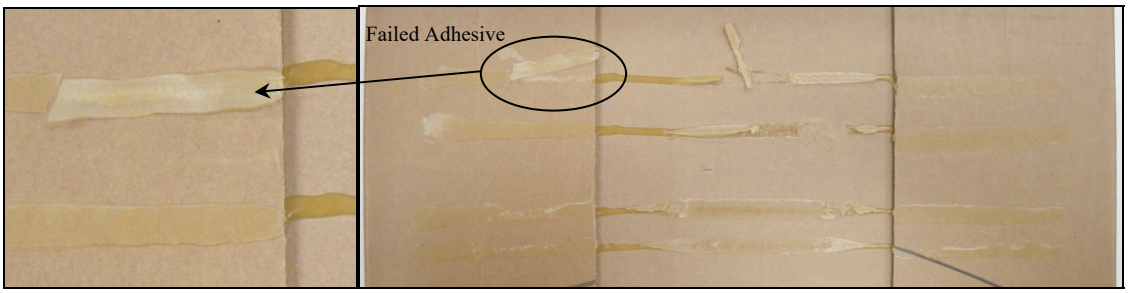
Figure 53. Adhesive application onto corrugated container (Note the failure of adhesive to bond to coated material)

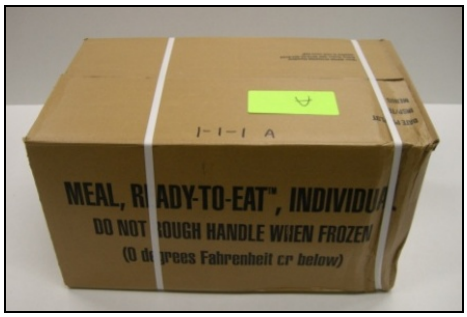
Figure 114. Crushing of the corrugated container during transit and or during material handling, pallet overhang was the primary cause of this type of damage

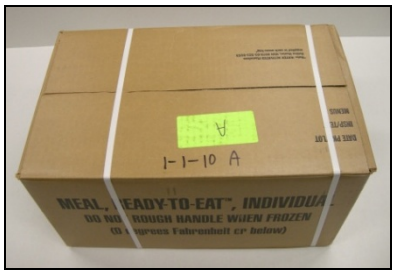
Figure 116. Minor flaps pushed out due to over-packing of corrugated case

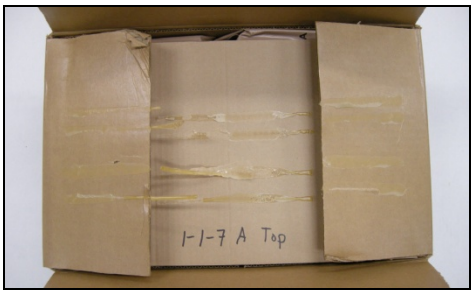
Figure 120. Adhesive failure on the top flaps during the assembly trial run

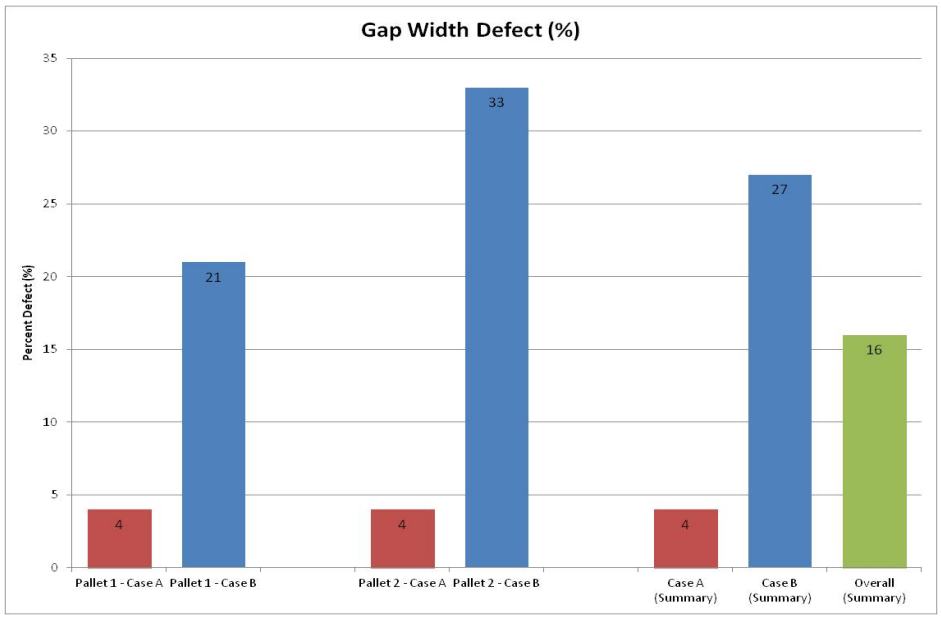
Figure 121. Percent defect based on excessive gap width (containers with 0.75 inch or greater gap between the major flaps are failed)
