# FINAL REPORT

## Low VOC Barrier Coating for Industrial Maintenance

## ESTCP Project WP-0301

November 2007

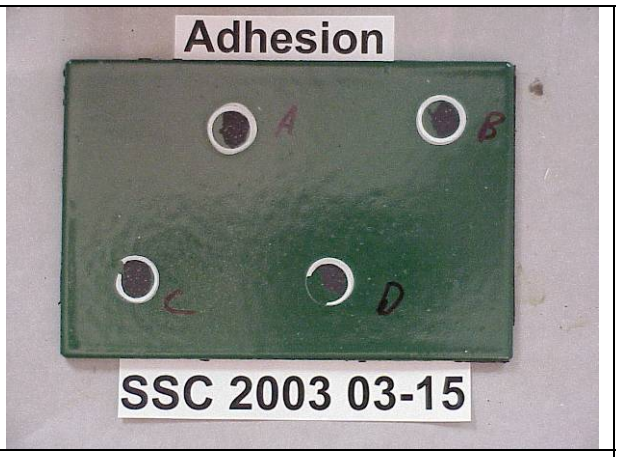
**FIGURE 16.** Adhesion Test Sample of the LVBC/AZT System.

NTPEP testing included formula characteristics of the LVBC/AZT coating system as well as laboratory and field panel testing (Figures 15 and 16). Results of these analyses are presented in Appendix D and summarized in Table 4-3. Of special significance are the sag resistance, salt fog, and cyclic weathering tests. Both the LVBC and AZT coatings failed these tests. Since

these tests are predictors of long-term performance, it will be critical to track the actual long-term performance of the applied demonstration coatings.

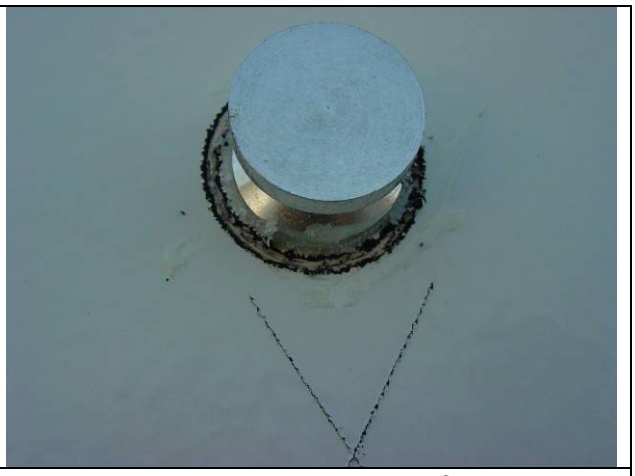
| **FIGURE 17.** Tank 2003 One Year After Application of LVBC/AZT System. | **FIGURE 18.** Adhesion Testing of the Coating After One Year. |

| Performance Criteria | Expected Performance Metric | Performance Confirmation Method | Actual Results | | |
|---|---|---|---|---|---|
| - Corrosion | No more than 0.1 % | ASTM D 610 (% of TSA[1]) | 0.03% | 0.03% | 0.03% |
| - Cracking/Checking | No less than 8 | ASTM D 660, ASTM D 661 (% area) | 10 | 10 | 10 |
| - Dirt Pick-Up | No less than 8 | ASTM D 3274 (% of TSA) | 8 | 10 | 10 |
