FINAL REPORT

Field Validation of Visual Cleaning Performance Indicator (VCPI) Technology

ESTCP Project WP-0410

AUGUST 2007

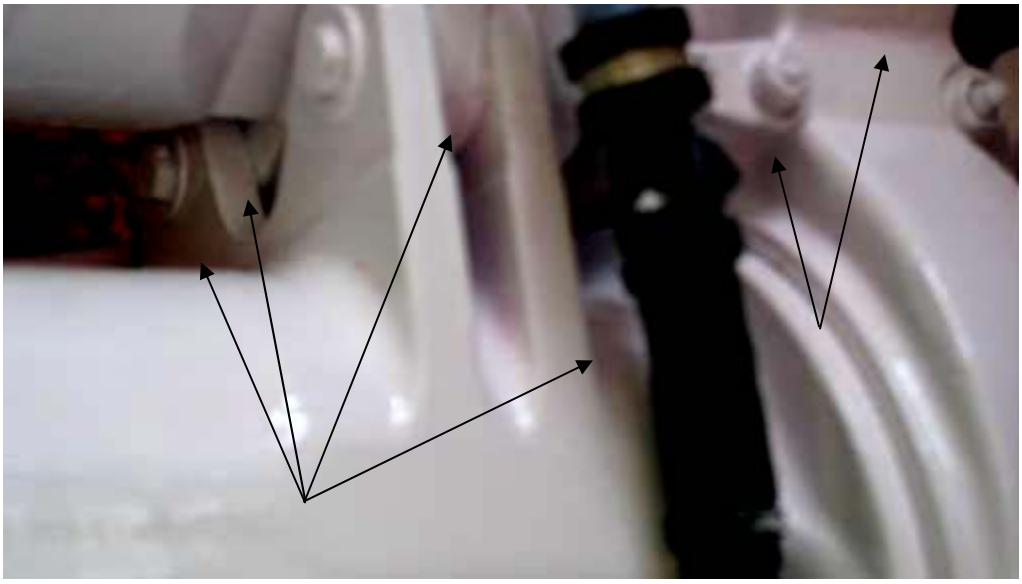
Post-demonstration visual inspections confirmed that there were numerous small areas on unmasked and painted landing gear components that were labeled with the red colored VCPI dye. As shown by the arrows in Figure 7, these typical areas visually “stood out” because the topcoat color on the landing gear components was high-gloss white.

Figure 7. VCPI Staining of Forward Landing Gear Components.

Numerous areas on the parts were stained. In addition to the localized staining of these component parts, there was a significant staining of the hanger floor (see Figure 8) immediately below and adjacent to the aircraft. Production personnel also complained about the heavy staining of their coveralls and boots. The staining issue represented a major drawback for the technology demonstration, especially with the difficulty in removing the stains from the white colored topcoat on the landing gear components. The A-10 management team and production supervisor overseeing the demonstration did not want to incur the cost and downtime associated with stripping, cleaning, masking, and repainting the stained gear components. Fortunately, a COTS chemical solvent was identified and used on clean white cotton clothes to safely remove the red stains. No loss of coating gloss or damage to the white topcoat was evident throughout the cleaning operation.

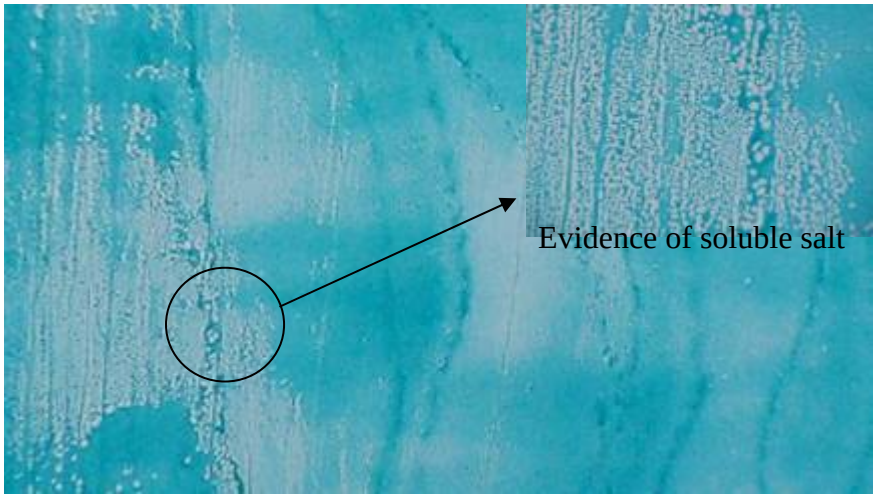
Figure 9. Application of VCPI Test Solution to Section of Hull on USS Halyburton

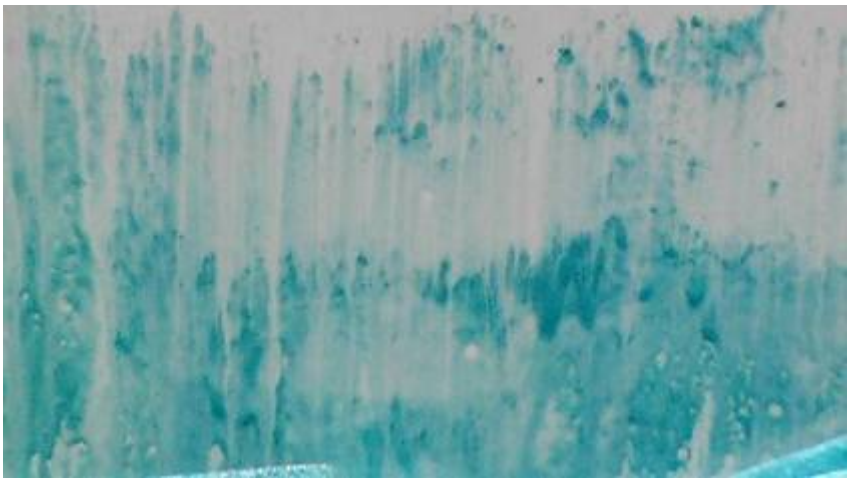
The effectiveness of labeling soluble salt contaminant with VCPI is shown for a second area within the test section in Figure 11.

Figure 11. Post-rinse VCPI Labeling of Soluble Salts on Hull of USS Halyburton

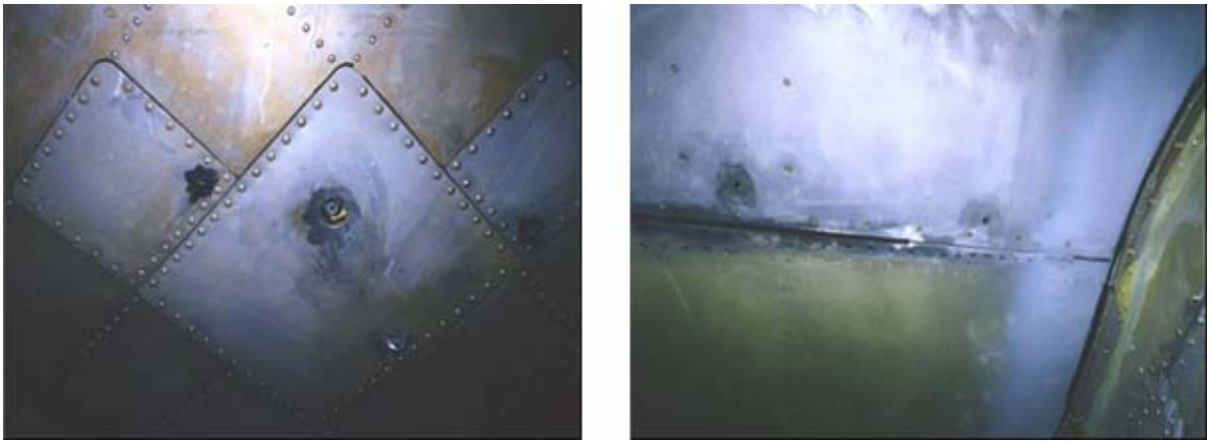
Figure A9. Typical Hydrophobic Contamination on Underside Surfaces of A-10 Wings

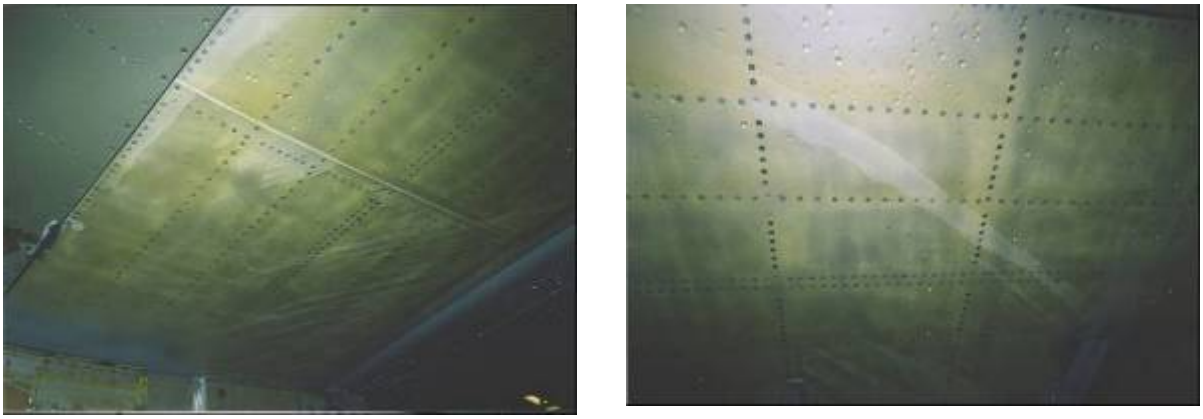
Figure A10. Underwing Surfaces of A-10 Wing After Alkaline Soap Wash and Water Rinse

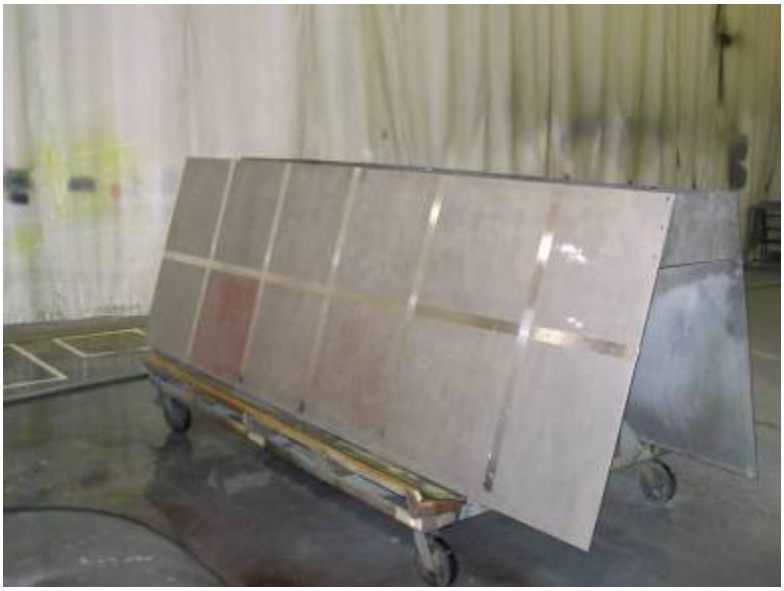
6. The panel and each segment were then inspected; see Figure D18. The control areas, and the PreKote®-labeled area, A-5, showed no labeling. The lube oil-labeled area in segment A-2 was strongly colored. The grease-labeled area in segment A-4 was also readily detected. The hydraulic fluid-labeled area in segment A-3 was only slightly colored. A portion of the silver tape used to separate the segments was removed. A very pale pink coloration of VCPI-labeled hydraulic fluid contaminated area can be seen below the area where the tape was placed. See Figure D19A.

Figure D18. Panel After Rinsing
(Top and Segments A-1 and A-6 are Controls.
Segments A-2: Lube Oil, A-3: Hydraulic Fluid;
A-4: Grease; A-5: PreKote®

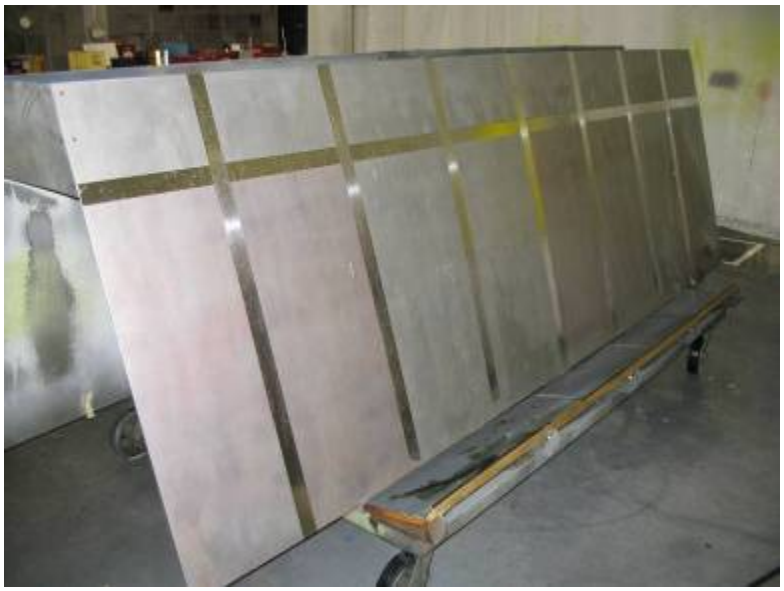
17. Standard duration PreKote® scrubbing did not remove all of the lube oil (segments B-1 and -2) nor all of the grease (B-4 and -5). It completely removed the residual hydraulic fluid and PreKote®. A slight pink VCPI color remained on B-1 and -2 and B-4 and -5; see Figure D25.

Figure D25. VCPI-Label Indicated the Lube oil and Grease Contaminated Segments had Not Been Completely Cleaned

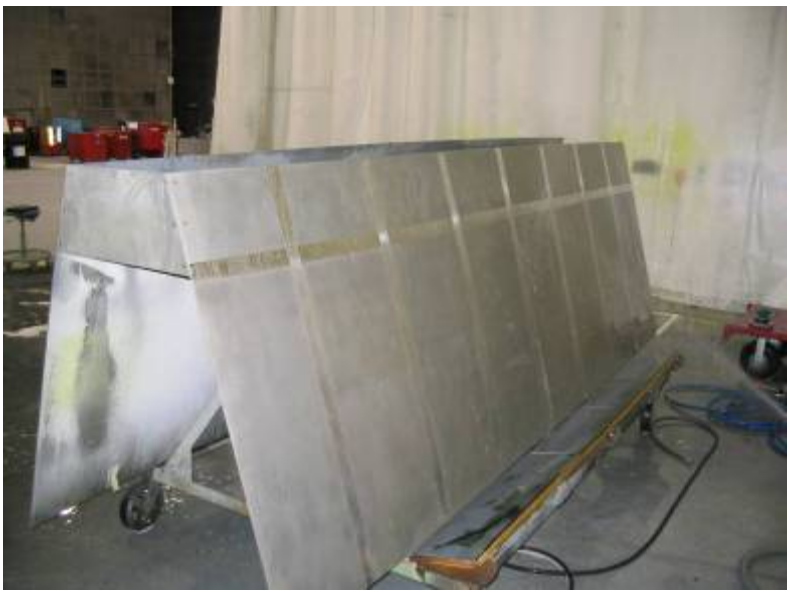
18. The entire panel was re-power scrubbed (17 seconds per segment). This removed all color from the VCPI labeling; see Figure D26.

Figure D26. Panel Shows No VCPI Label after Extended Power Scrub, but Surface Still Contaminated
(Water is being sprayed on the surface to check for water break)

19. The solution was re-sprayed with VCPI solution and rinsed. The VCPI solution did not appear to label these residual contaminants. But upon closer inspection and water break testing, it was observed that the VCPI solution achieved some cleaning on its own. After VCPI application and rinsing, the formerly contaminated surface was water break free!
