FINAL REPORT

Robotic Laser Coating Removal System

ESTCP Project WP-0526

JULY 2008

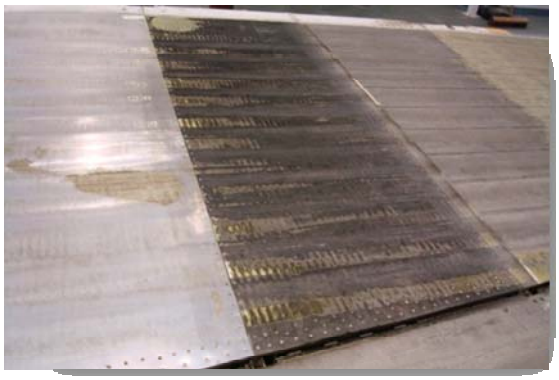
Figure 3-8: Detail of Damage to Magnesium Substrate

During stripping of the rudder it became apparent that one section of the part was made of a different substrate than aluminum. After stripping was completed, it was revealed that this section was a magnesium substrate. Conversations with the operators and OC-ALC personnel revealed that this substrate is found occasionally on the different parts that are processed. This substrate is not one of the substrates that had been identified for this project, so no optimized laser parameters had been developed for safe processing on magnesium. A picture of the substrate after processing using the current parameters is provided in Figure 3-8.

Because it is not known if this substrate will be encountered prior to processing, a method for determining its presence is needed. AFRL Non-Destructive Inspection (NDI) personnel have advised the project team that detection of magnesium can be accomplished using an eddy current conductivity meter. Because there are currently no laser operating parameters for magnesium substrates that will not damage the substrate, it is recommended that RLCRS operators take conductivity measurements of the main sections of the parts prior to processing. Sections that are found to have a magnesium substrate can be masked or the entire part can be routed to traditional chemical stripping areas. Details of the full set of calculated results for the demonstration of the KC-135 rudder are provided in Table 3-7.

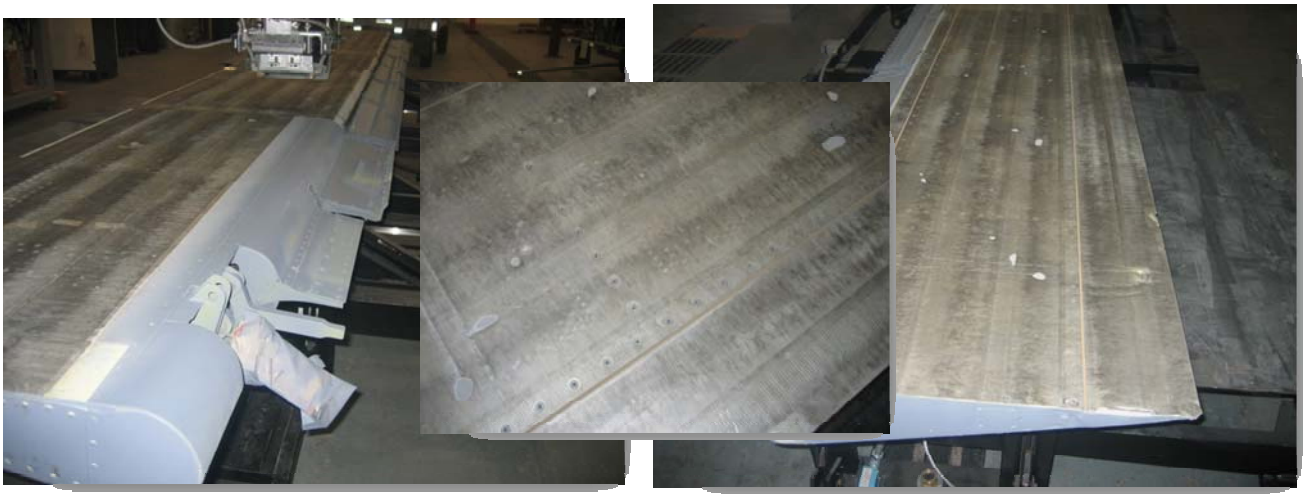
Figure 3-12: KC-135 Outboard Aileron after Processing Using the RLCRS

The stripped surfaces of the part were completely free from coating and showed no visual indications of damage. The calculated results of this demonstration are detailed in Table 3-9.

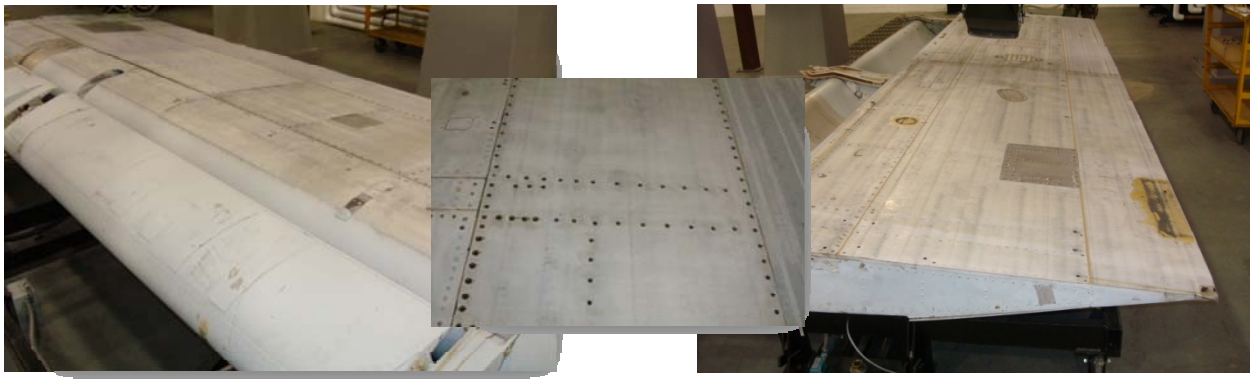
Figure 3-14: KC-135 Outboard Flap after Processing Using the RLCRS

The stripped surfaces of the outboard flap were completely free from coating and showed no visual indications of damage. It would be possible to increase the surface area stripped on the

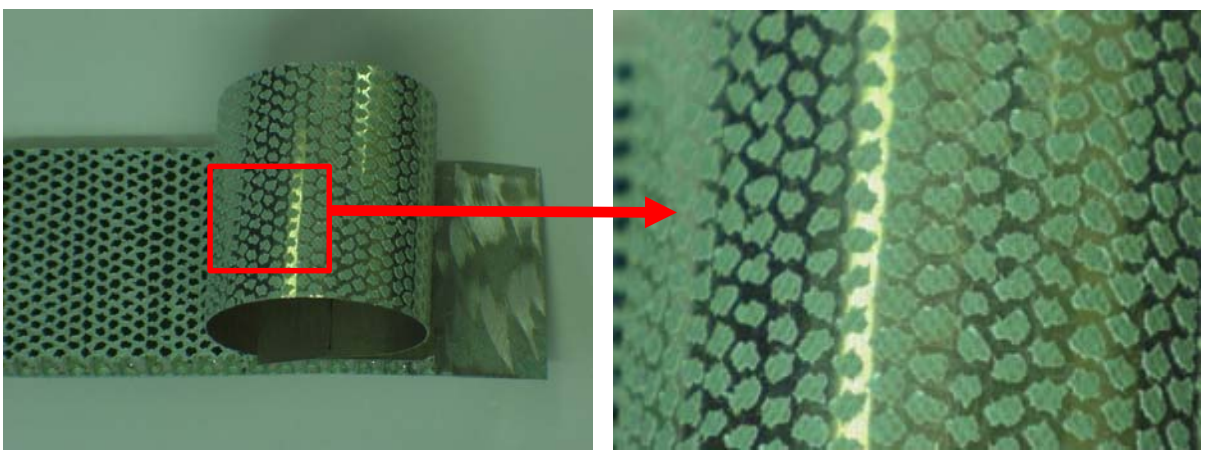
Figure 6. Peel Sample Showing Adhesive Failure

Following testing, an examination of the failed peeled surfaces showed that a defect in the manufacturing of the honeycomb structures was present. All of the test specimens showed that a lack of proper surface preparation prior to bonding the core structure to the face sheet led to adhesive failures, thereby invalidating peel results. A photograph of the failure is provided in **Figure 6**. Because of the original manufacturing defect, no conclusions can be reached regarding peel strength debit resulting from any of the depainting operations.

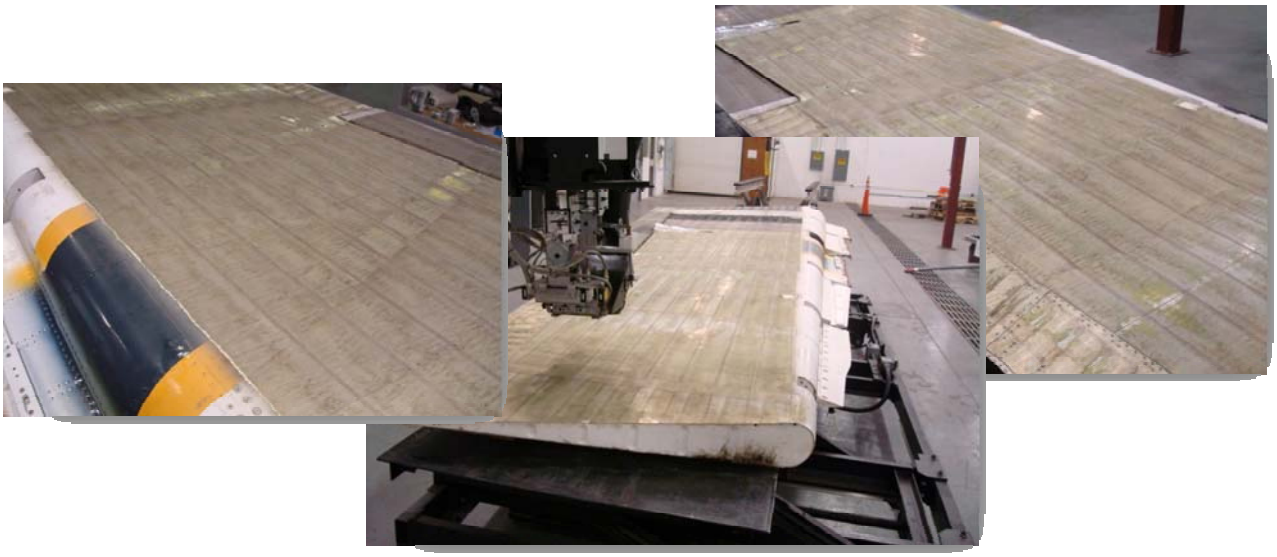
Figure 16. KC-135 Rudder After Processing Using the RLCRS

It took six passes and 180 minutes to strip the coating from each side of the rudder. In total, 390 minutes were spent preparing and processing this part. The coating on this part was difficult to remove and atypical for what is usually processed at OC-ALC. When a typical coating is encountered, this time is expected to be reduced. Pictures of the stripped surfaces are provided in **Figure 16**.

A small amount of primer was left in the areas where the striping and lettering was present. A decision was made to leave these small areas to be stripped using the handheld lasers as part of touch-up operations instead of performing a sixth pass over the entire surface.

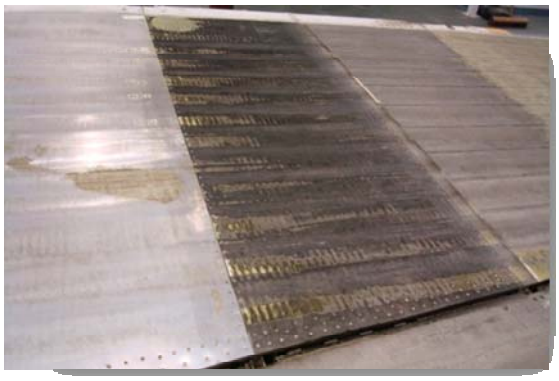
Figure 17. Detail of Damage to Magnesium Substrate

During stripping of the rudder it became apparent that one section of the part was made of a different substrate than aluminum. After stripping was completed, it was revealed that this section was a magnesium substrate. Conversations with the operators and OC-ALC personnel revealed that this substrate is found occasionally on the different parts that are processed. This substrate is not one of the substrates that had been identified for this project, so no optimized laser parameters had been developed for safe processing on magnesium. A picture of the substrate after processing using the current parameters is provided in **Figure 17**.

Because it is not known if this substrate will be encountered prior to processing, a method for determining its presence is needed. AFRL Non-Destructive Inspection (NDI) personnel have advised the project team that detection of magnesium can be accomplished using an eddy current conductivity meter. Because there are currently no laser operating parameters for

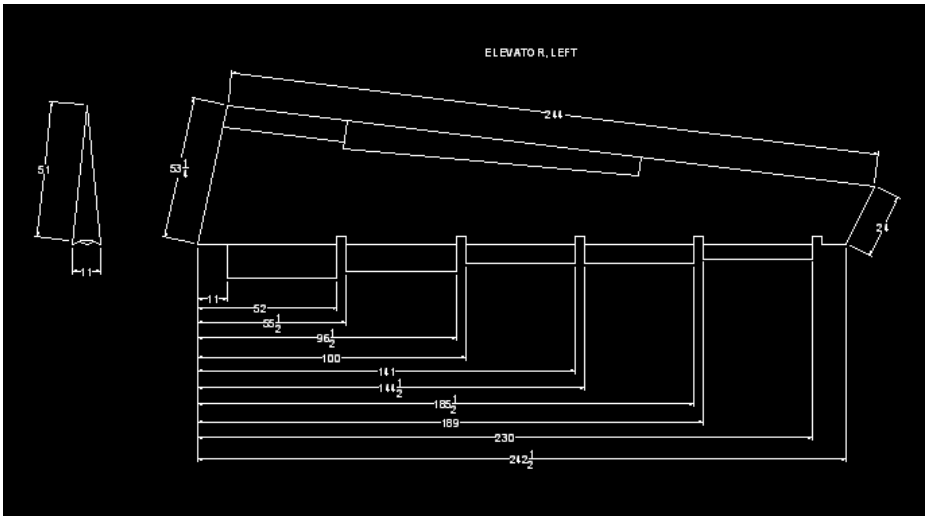
Figure 19. Dimensional Drawing of KC-135 Elevator

The flap was measured, and a dimensional solid model of the part was produced in order to determine the total surface area requiring stripping. A diagram of the drawing that was produced is provided in **Figure 19**. Total surface area of the part including both ends and sides is approximately 154 ft^2. Approximately 126 ft^2 of this surface area was accessible for coatings removal by the RLCRS.

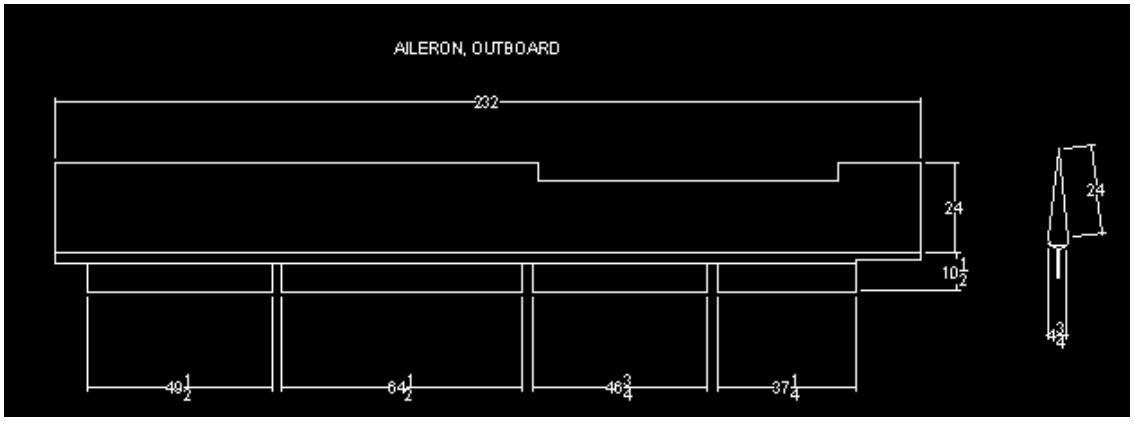
Figure 22. Dimensional Drawing of KC-135 Outboard Aileron

The aileron was measured, and a dimensional solid model of the part was produced in order to determine the total surface area requiring stripping. The drawing that was produced is provided in **Figure 22**. Total surface area of the part, including both ends and sides, is approximately 106 ft^2. Approximately 77 ft^2 of this surface area was accessible for coatings removal by the RLCRS.

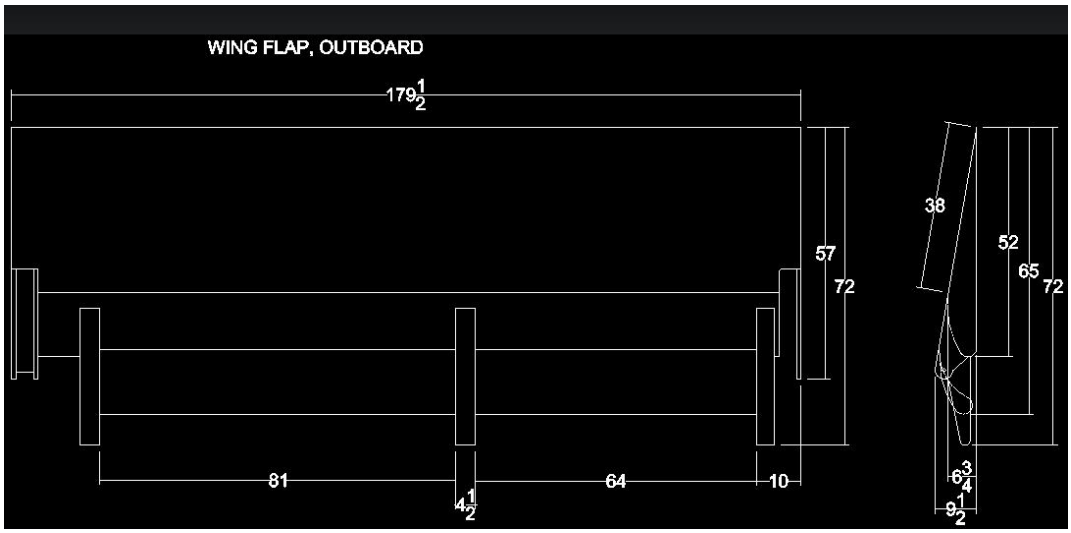
Figure 25. Dimensional Drawing of KC-135 Outboard Flap

The flap was measured, and a dimensional solid model of the part was produced in order to determine the total surface area requiring stripping. A diagram of the drawing that was produced is provided in **Figure 25**. The total surface area of the part including both ends and sides is approximately 182 ft^2. Approximately 120 ft^2 of this surface area was accessible for coatings removal by the RLCRS.

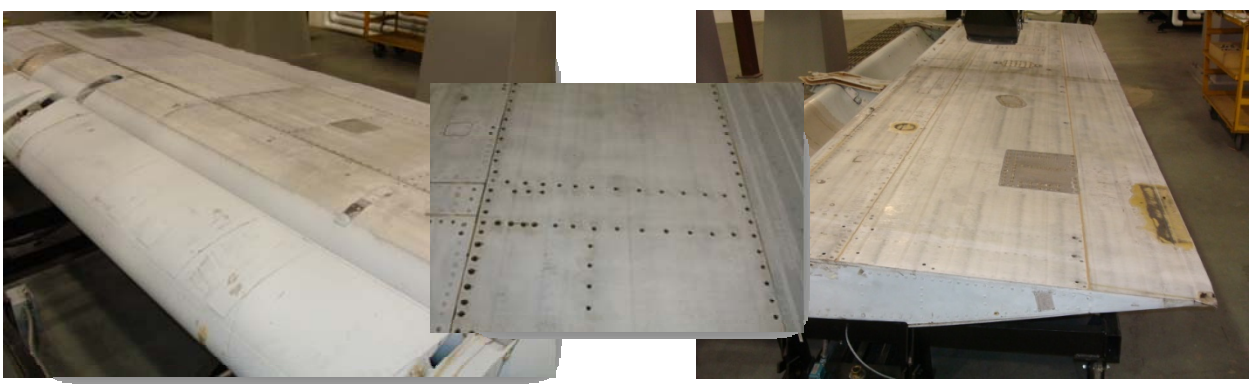
Figure 26. KC-135 Outboard Flap after Processing Using the RLCRS

Laser stripping of this part took 3 passes for each section and totaled 65 minutes for each side. When the positioning and masking steps are included, the part took a total of 140 minutes to process. Pictures of the stripped surfaces are provided in **Figure 26**.

The stripped surfaces of the outboard flap were completely free from coating and showed no visual indications of damage. It would be possible to increase the surface area stripped on the top side of the part by constructing a small amount of flashing between the leading edge and the main body of the part. This would enable the system to process the concave area in front of the part. The calculated results of this demonstration are detailed in **Table 29**.
