ESTCP
Cost and Performance Report

(CP-9503)

Fury: Robotic In-Situ Inspection/Condition Assessment System for Underground Storage Tanks

August 1999

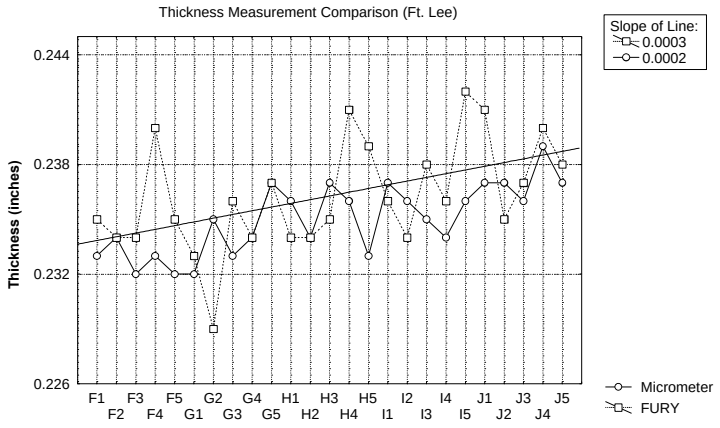
Figure 3. Mechanical vs. Fury Thickness Measurement (Bottom, Middle)

The *in-situ Fury* and *ex-situ* micrometer measurements are shown in Figures 3 through 5. Laboratory analyses of the three 5x5 grid pattern readings were performed in accordance with ASTM G46 **[8]**. In addition, MRI performed independent ultrasonic measurements on a different grid system in accordance with an EPA procedure for the field evaluation of USTs. The comparison of the measurements is given in Table 1. The external hand held ultrasonic measurements taken by MRI **[9]**, which were almost identical to those called for by NLPA 631**[4]**, were, when considered alone, inadequate to determine the tank's condition. In fact, no measurement indicating a remaining wall thickness less than 50% of the original value (nominal 0.375 in.) was found. *Fury*, however, found several locations with wall thickness below 0.15 in. (see Figure 6).

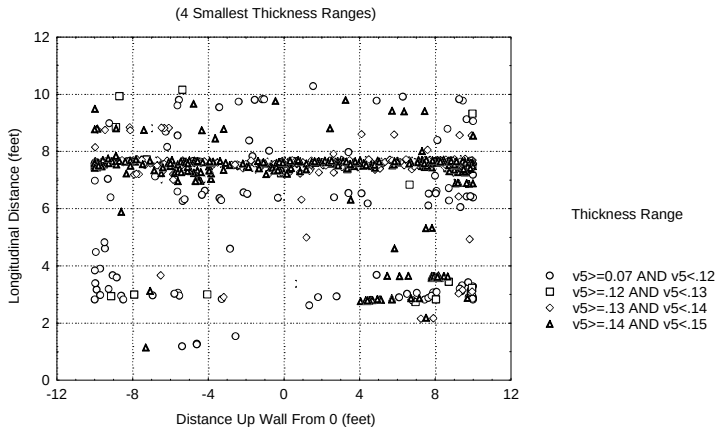
One of the main advantages of the *Fury* robotic system is its ability to rapidly collect data while the unit is in motion. Virtually all of the data from Fort Lee were taken during the last day of a week-long effort after a number of other validation tasks had been completed. Table 2 shows the results of a statistical analysis for the full data set as separated into tank wall and end caps (which typically have a larger initial wall thickness). The *Fury* data can be displayed in a number of ways. With position coordinates associated with each measurement, the positions of the thinnest measurements can be displayed. Figure 6 shows the four thinnest ranges of measurement for the curved tank wall (displayed as if viewed from above and opened to each side from a longitudinal top seam). A feature along a lower circumference approximately eight feet from the southern end cap is evident.

Figure 6. Location Distribution of 1,000 Thinnest Wall Thickness Measurements

This feature was visually confirmed after the tank was removed. One possible explanation is that during installation a lifting strap caused some initial damage which over time led to differential corrosive attack.

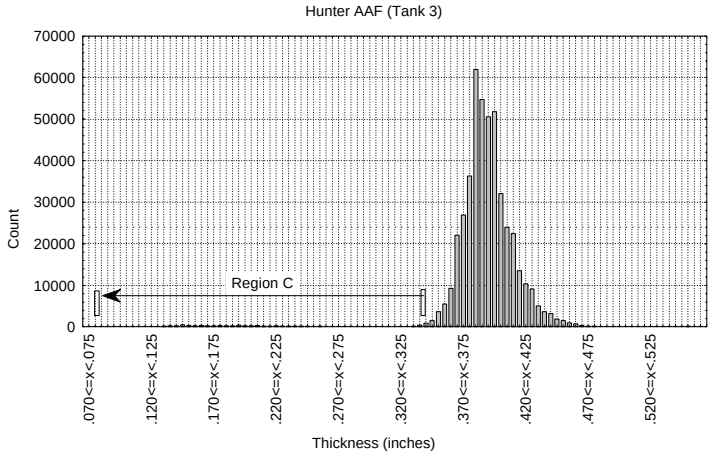
Figure 7. Tank 3 Thickness Distribution

Fury collected in excess of 940,000 measurements from three USTs at Hunter Army Airfield. Acquiring the necessary data for each tank required less than 4 to 8 man-hours on-site time. Table 3 summarizes the results obtained after correction for an internal epoxy coating. The data were sorted according to thickness. Table 4 shows the results of an analysis of the 500 thinnest measurements (the so called "extreme values"). Histograms showing the number of measurements within successive ranges of wall thickness are shown in Figures 7 - 12. For each tank, these histograms show the overall distribution of thickness followed by a smaller region labeled C to show the data values at the thinnest end of the distribution. Tank 3 had approximately 71% of all data points between 0.345 and 0.395 in. For the smallest values approximately 0.04% of all data were between 0.070 and 0.100 in. Tank 4 had approximately 82% of all data points between 0.340 and 0.395 in. The smallest values for tank 4, ranging between 0.070 and 0.100 in., contained approximately 0.01% of all data points. Tank 5 data values fell mainly between 0.350 and 0.395 in., comprising 74% of all data points. The smallest values for this tank constituted approximately 1% of the data between 0.070 and 0.100 in. Tank 5 had the smallest values of all tanks with 0.35% of the total thicknesses residing at 0.070 in. The histogram for Region C for tank 5 (Figure 12) shows the exact number of data points for this thinnest region of the tank wall.

The *Fury* inspection showed that Tanks 3 and 4 were in good shape while Tank 5 clearly showed a large number of observations at the lower thickness ranges. These observations combined with the findings from the external corrosion evaluation procedures, as required by ASTM ES40-94 **[5]**, indicated that tanks 3 and 4 were considered suitable for upgrade while tank 5 was not. From a corrosion engineering viewpoint, the character of the wall thickness histograms is intriguing. It may be that, as a tank undergoes the accumulated damage of corrosive degradation, the condition represented by Figures 8 and 10 evolves more toward a condition represented by Figure 12.

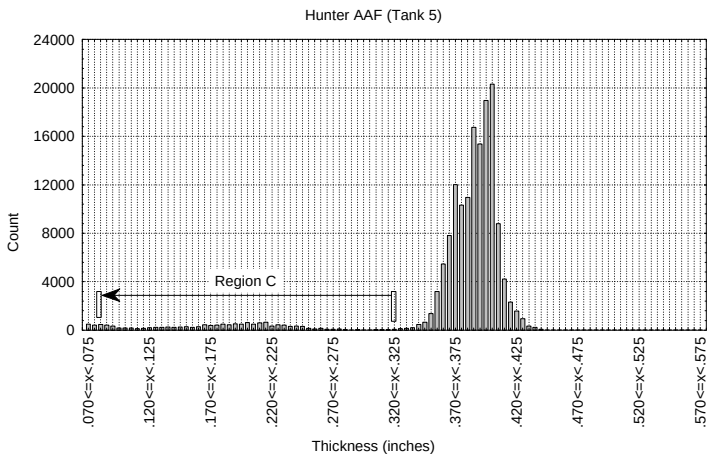
Figure 11. Tank 5 Thickness Distribution

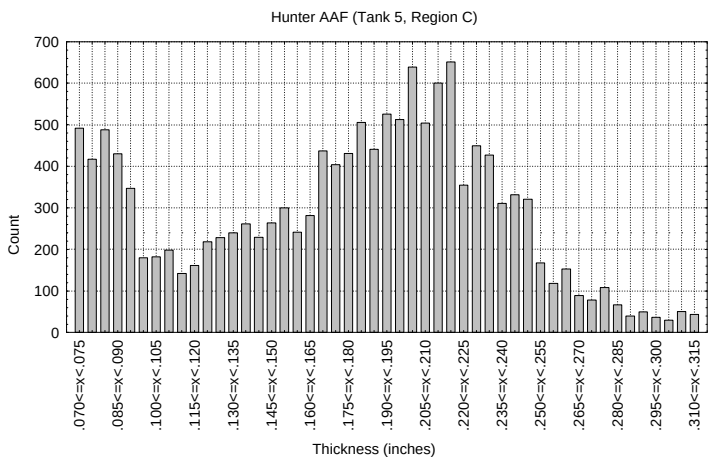
Figure 12. Thickness Distribution of Region C in Tank 5
