FURY: A REMOTE UNDERGROUND STORAGE TANK INSPECTION/ASSESSMENT SYSTEM

USACERL
Champaign, IL 61826 USA
1-800/USA-CERL

29 June, 1998

ESTCP
ENVIRONMENTAL SECURITY TECHNOLOGY CERTIFICATION PROGRAM

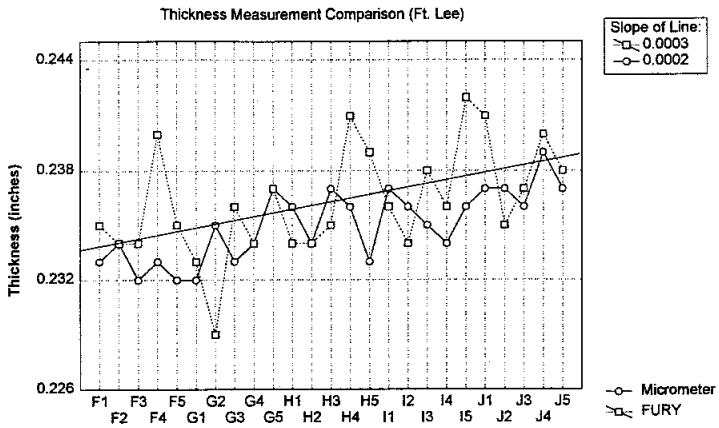
One of the most critical comparisons was that of the Fury in situ ultrasonic thickness measurements to other reference methods. Three 5x5 square grids with 10 cm. spacing were located near the center bottom, one approximately one half the distance to the end cap near the bottom, and one on one end cap. These test grids were marked out with wax pencil and stamp markers. Each measurement location was circled using a vibrating engraver and a robot template positioner. The template was used to assure that in-situ comparison measurements with a hand held ultrasonic thickness gauge were taken from exactly the same position. Both the robot sensor and the hand held thickness gauge were calibrated on the same step block before and after each group of measurements. After the tank was pulled the grids were cut out of the tank, sectioned, and the same measurements were performed using a standard mechanical micrometer capable of an accuracy of 1/1000 of an inch. The in situ Fury and laboratory micrometer measurements are shown in Figures 3 through 5.

Figure 3. Bottom, Middle Mechanical vs. Fury Thickness Measurement

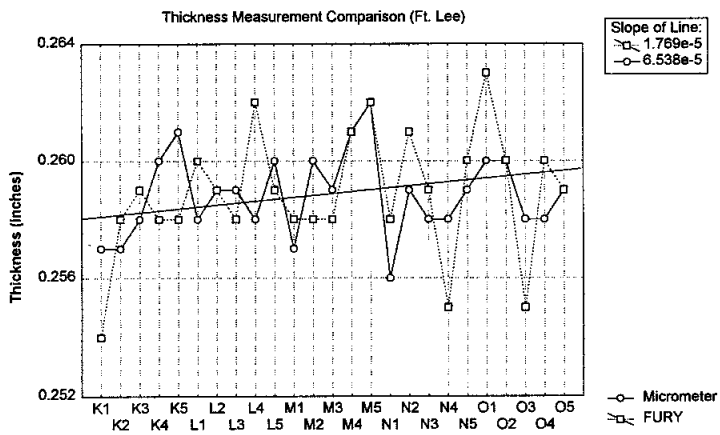
Figure 4. Bottom, Quarter Mechanical vs. Fury Thickness Measurement

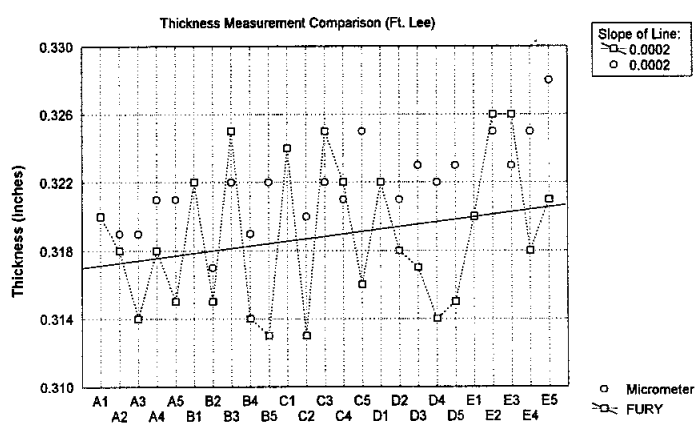
Figure 5. End Cap Mechanical vs. Fury Thickness Measurement

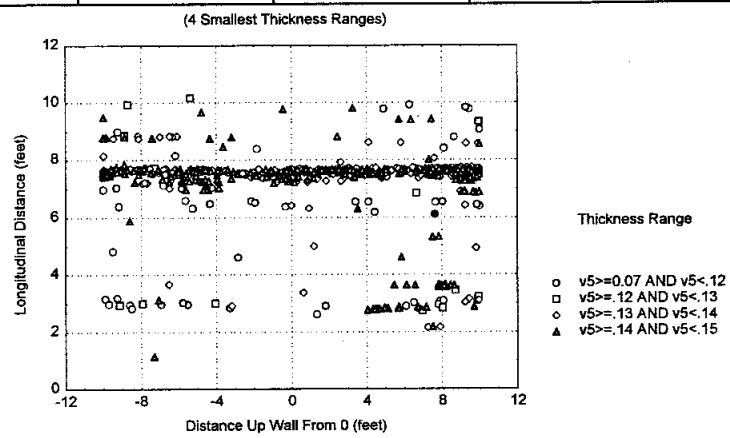
Figure 6. Location Distribution of 1000 Thinnest Wall Thickness Measurements

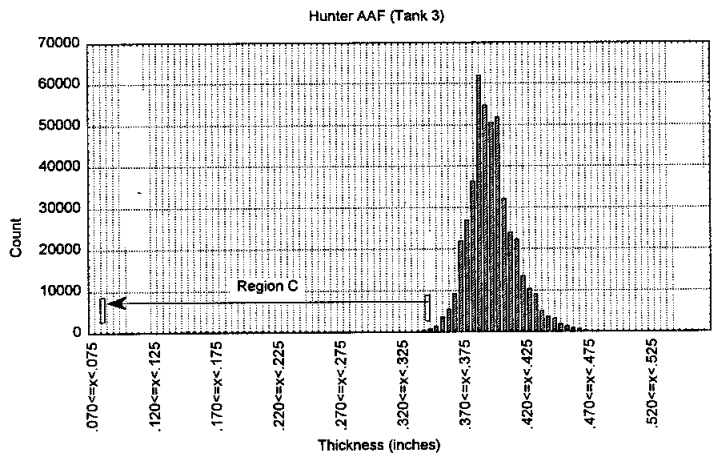
Figure 7. Thickness Distribution in Tank 3

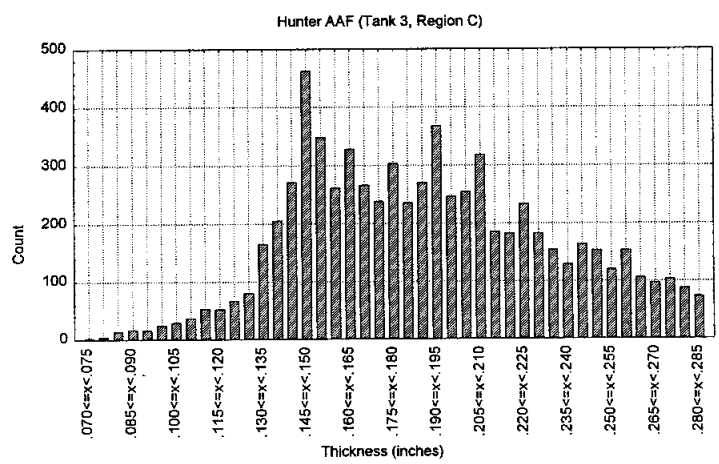
From a corrosion engineering viewpoint the character of the wall thickness histograms is intriguing. It may be that as a tank undergoes the accumulated damage of corrosive degradation the condition represented by Figures 8 and 10 evolves more toward a condition represented by Figure 12. The statistics of these so called "extreme values" (e.g., the thinnest measurements) is currently being examined. The potential benefits include a further improvement in knowing a tanks condition, with either an equal or lesser amount of data, as well as a greater understanding of the degradation process itself.

Figure 8. Thickness Distribution Region C in Tank 3 (Figure 5)

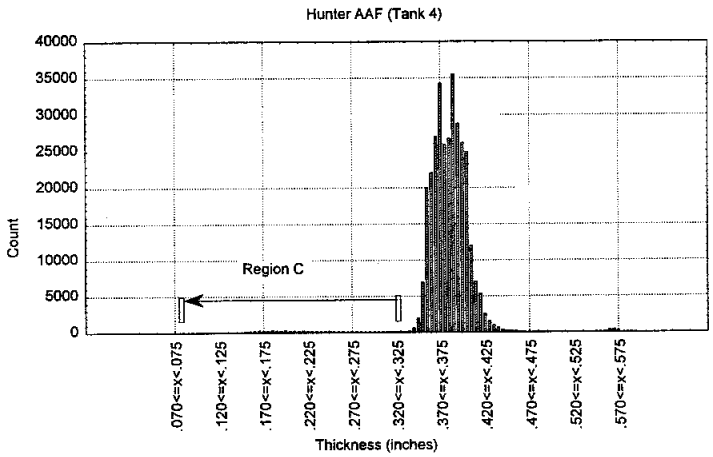
Figure 9. Tank 4 Thickness Distribution

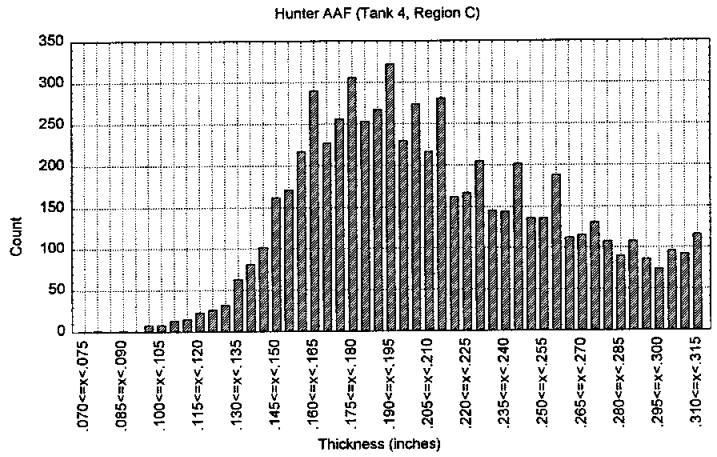
Figure 10. Region C Thickness Distribution in Tank 4 (Figure 7)

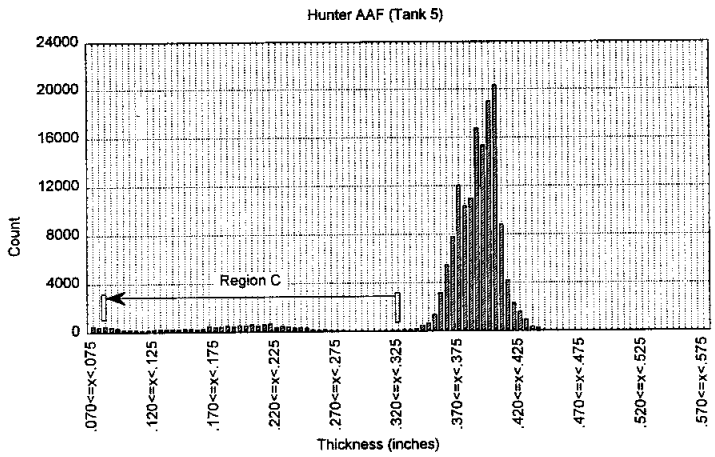
Figure 11. Tank 5 Thickness Distribution

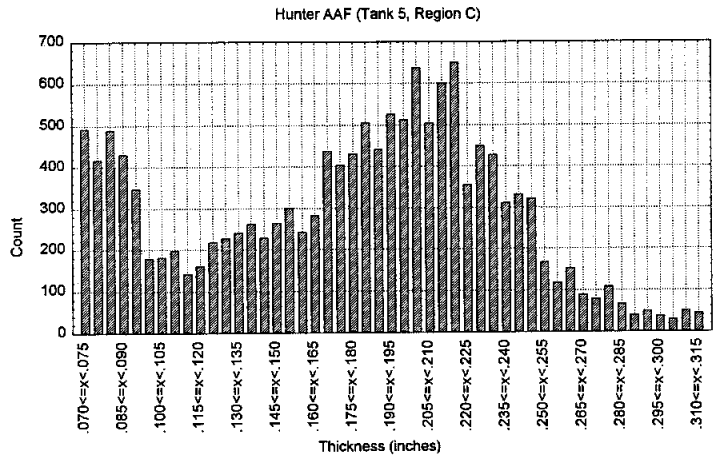
Figure 12. Region C Thickness Distribution Tank 5, (Figure 9)
