ESTCP Cost and Performance Report

(EW-200813)

BUILDING INTEGRATED PHOTOVOLTAIC (PV) ROOFS FOR SUSTAINABILITY AND ENERGY EFFICIENCY

April 2013

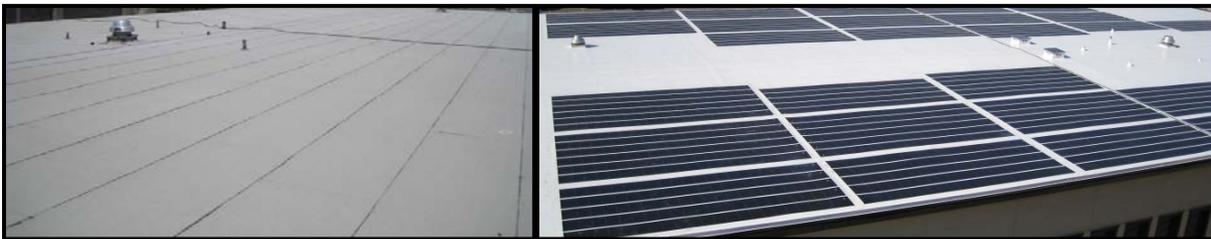
Building 228 at Site III (MCAS Yuma) is a 14-foot, single story, wood-frame building built in 1943 with a 9,270 ft² roof. The roof was in good physical condition and has one large exhaust vent with several small vents around the center (Figure 7, left). There was no indication that the thermal properties of the roof were compromised, so the BIPV roof system was installed on top of the existing roof. The pre-existing antennae cable was re-laid across the BIPV roof and held down by PVC strips so that the cable will not interfere with any of the solar panels or wear out the PVC membrane. The 20.6 kW of PV laminates cover about 36% of the roof (Figure 7, right).

Figure 7. Before (left) and after (right) photos of Building 228 at Site III (MCAS Yuma).

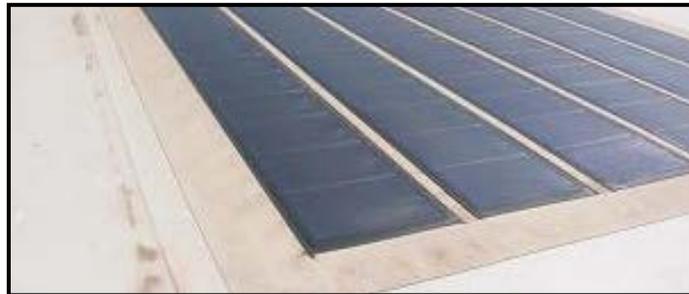
the six-inch requirement, which is needed to reduce the risk of water penetration. Reflectance results are shown in Table 7. October 2011 values were not attained due to the unexpected removal of the ladder needed to safely transport the instrument. However, visual inspections indicated that the soiling had decreased by October 2011. This determination is further supported by the PV conversion efficiency analysis that is presented in the next section. Despite the soiling, the Site III (MCAS Yuma) BIPV roof appeared to have aged well (Figure 20).

Figure 20. Photo of Site III (MCAS Yuma) in October 2011, 16 months after installation.
