NRL/MR/6120--97-7957

# Control of Lead in Drinking Water

13. ABSTRACT ( <i>Maximum 200 words</i> )  This report describes the installation of an NRL-developed epoxy lining in the drinking water distribution system in three buildings. Water was sampled before and after installation of the lining; the sampling data was interpreted after several confounding factors were identified and allowed for. Improper installation of the lining in one of the buildings led to its premature failure, and this was documented and analyzed. The lining is shown to be effective in preventing leaching of lead into drinking water. This technology is recommended as a routine method for excluding lead from drinking water distribution systems in buildings, and guidance for use in establishing contracts to install the lining is provided.

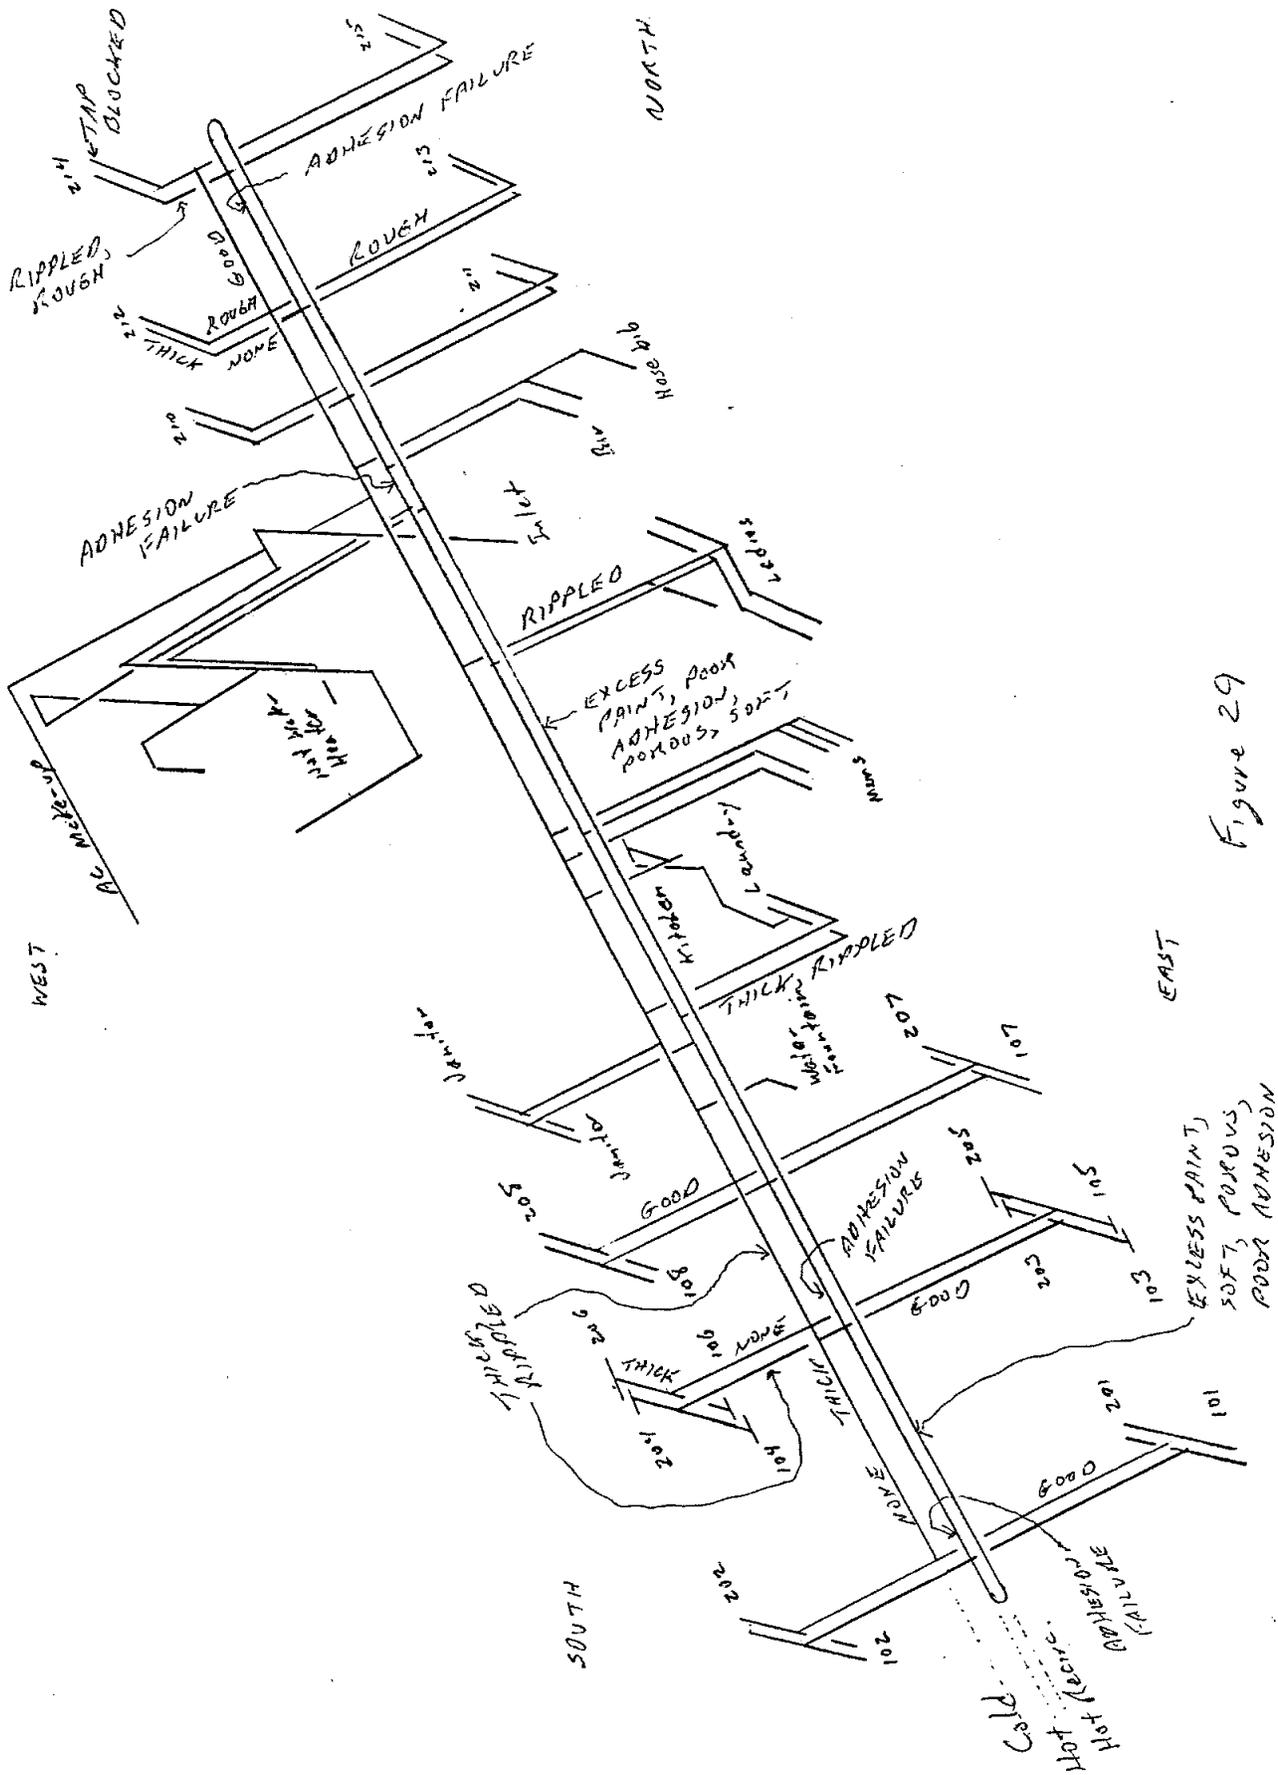
Figure 29 summarizes the observations of the lining in the piping in Building A93.

3. The piping was lined in three sections. Work in the north and mid-sections is adequate but contains minor defects such as variations in paint thickness, rippling of the paint surface, and a rough finish characteristic of grit entrapment. Large areas of the paint in the south end of the building are defective and are responsible for the blockage of the entire piping system.

4. During installation of the lining, air velocity through the mains was frequently insufficient to create the proper surface roughness for paint adhesion, especially at the top of the larger pipes. In many sections of larger pipe, there is no surface roughness at all on the top of the pipe. A rough surface is essential for painting copper and because it was not produced, paint detached from the top surface in some sections of pipe. Most significantly, however, air velocity was insufficient to remove dust from blast cleaning operations.

5. A critical error in this work was that dust from blasting was left in the hot water recirculating line at the south end of the building.
  - a) When paint was added, dust and paint combined to form a viscous paste which entrained air and formed an excessively-thick, poorly-adhering, porous crust. This was most severe in the hot water recirculating line at the south end of the building.
