Final Report

ENERGY REDUCTION USING EPOXY COATINGS FOR SEALING LEAKING COMPRESSED AIR SYSTEMS

**Energy and Water Project
EW 201517**

Naval Facilities Engineering and Expeditionary Warfare Center

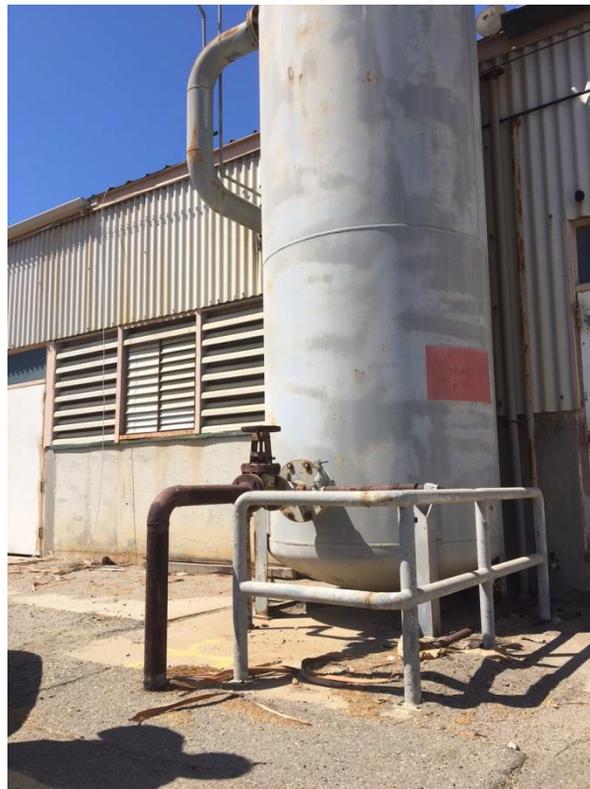
Figure 3. CED Receiver Tank near Building 814

Due to its age and proximity to the Pacific Ocean, (air moisture and high ground water table) much of the CED facility is in fair condition, showing considerable signs of paint wear and external corrosion. The receiver tank located near building 814 originally installed in 1952 has external rust and is in need of fresh coat of paint as shown in Figure 3. The above ground adjoining pipeline (abandoned) has also considerable external rust but appears to be serviceable. The underground pipelines connecting buildings 813, 814 and 815 are thought to be the same age as the receiver tank and are not accessible without digging. The condition of the inside of the underground lines could not be effectively ascertained in some cases due to its construction with multiple elbows and length limitations of the cameras. Where camera inspection was possible the pipeline mostly appeared to be a relatively good shape with the exception of the 1-1/2-inch pipe from 814 to 815. This pipeline had a fair amount of tuberculation. See Figures 4 and 5.

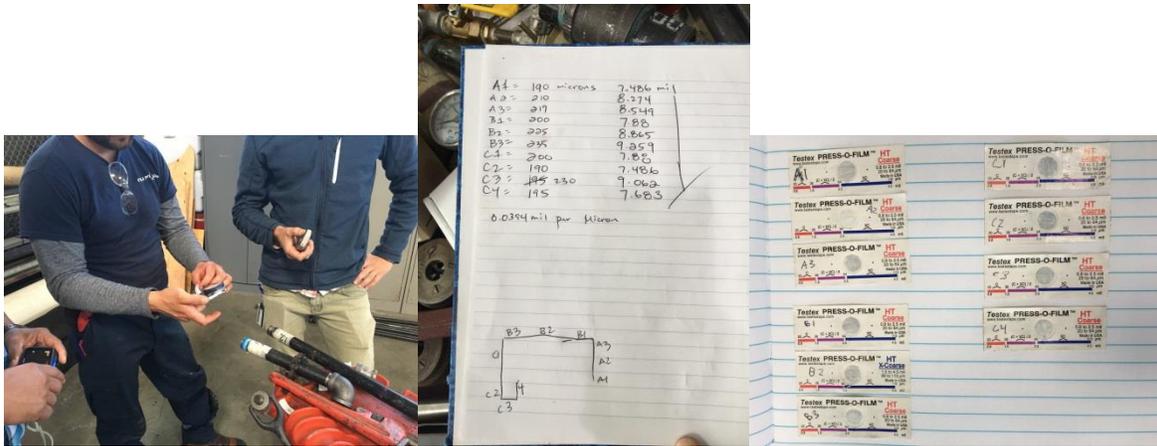
Figure B9. Anchor Tooth Measurement for Pipe Segment no. 12 Cross-Sections.

- After the rust and scale are removed, the pipeline is flushed thoroughly using hot compressed air.
- The anchor tooth was measured at the end of pipeline to make sure that the garnet created the necessary roughness on the internal wall surface for the epoxy to grab onto and form a uniform coating throughout the pipeline. NRL/MR/6120—94-7629 recommends an anchor tooth of 2 to 3 mils. Nu Flow, on the other hand, typically wants to see an anchor tooth of 4 to 5 mils. Pipe segment no. 12 was used to measure the anchor tooth throughout the pipe length. Based on the instrumentation used by Nu Flow to measure anchor tooth, pipe segment no. 12 achieved an anchor tooth of more than 5 mils throughout the pipeline. Figure B8 shows the instruments used by Nu Flow to measure anchor tooth as a result of the abrasive garnet and Figure B9 presents the anchor tooth results for the different cross-sections cut away from pipe segment no. 12.

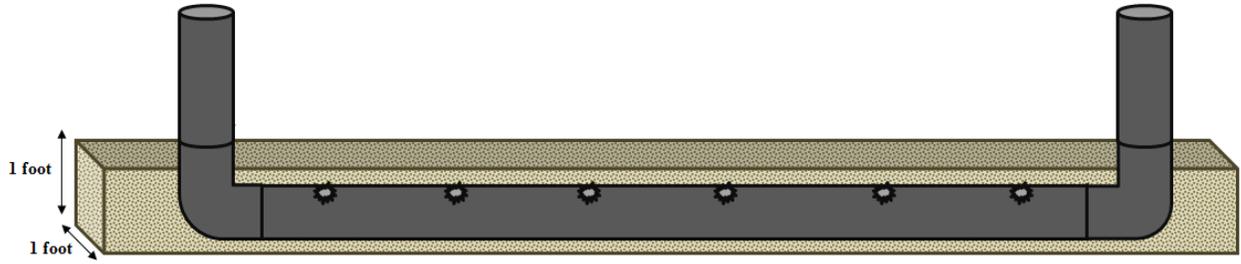
Figure B16. 1" Underground Pipeline with 6 Pin-Holes- 12 o'clock Position (3 of these underground pipelines were built for the 1/4", 1/8" and 1/16" pin-holes).

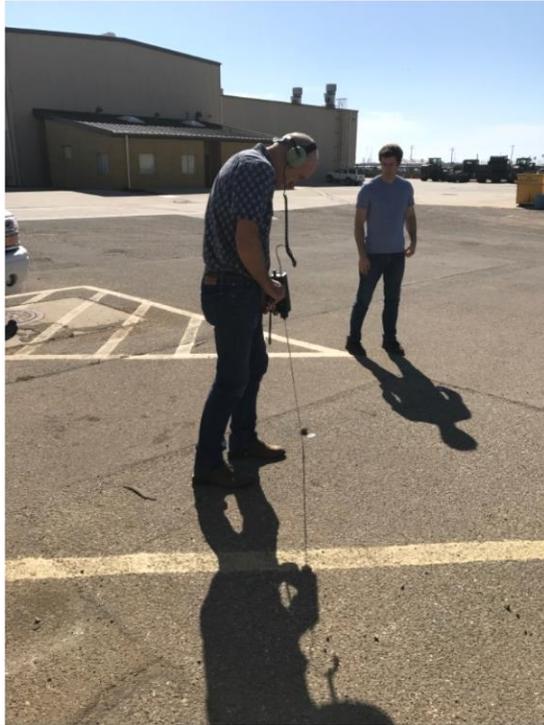
Figure D5 shows EXWC technicians using an ultrasonic leak detection sensor with a surface bridging adapter to determine if the leaks could be identified above ground. The equipment was used a few years ago with some success in a compressed air survey/audit performed at Joint Base Pearl Harbor Hickam, Hawaii. The technician using that technology did detect leaks, but they were not at the locations identified by the camera inspection. The ultrasonic leak detection sensor predicted location of the holes to be approximately 10-20 feet further away.

Figure D5: Picture of technician using ultrasonic leak detection sensor to locate holes.

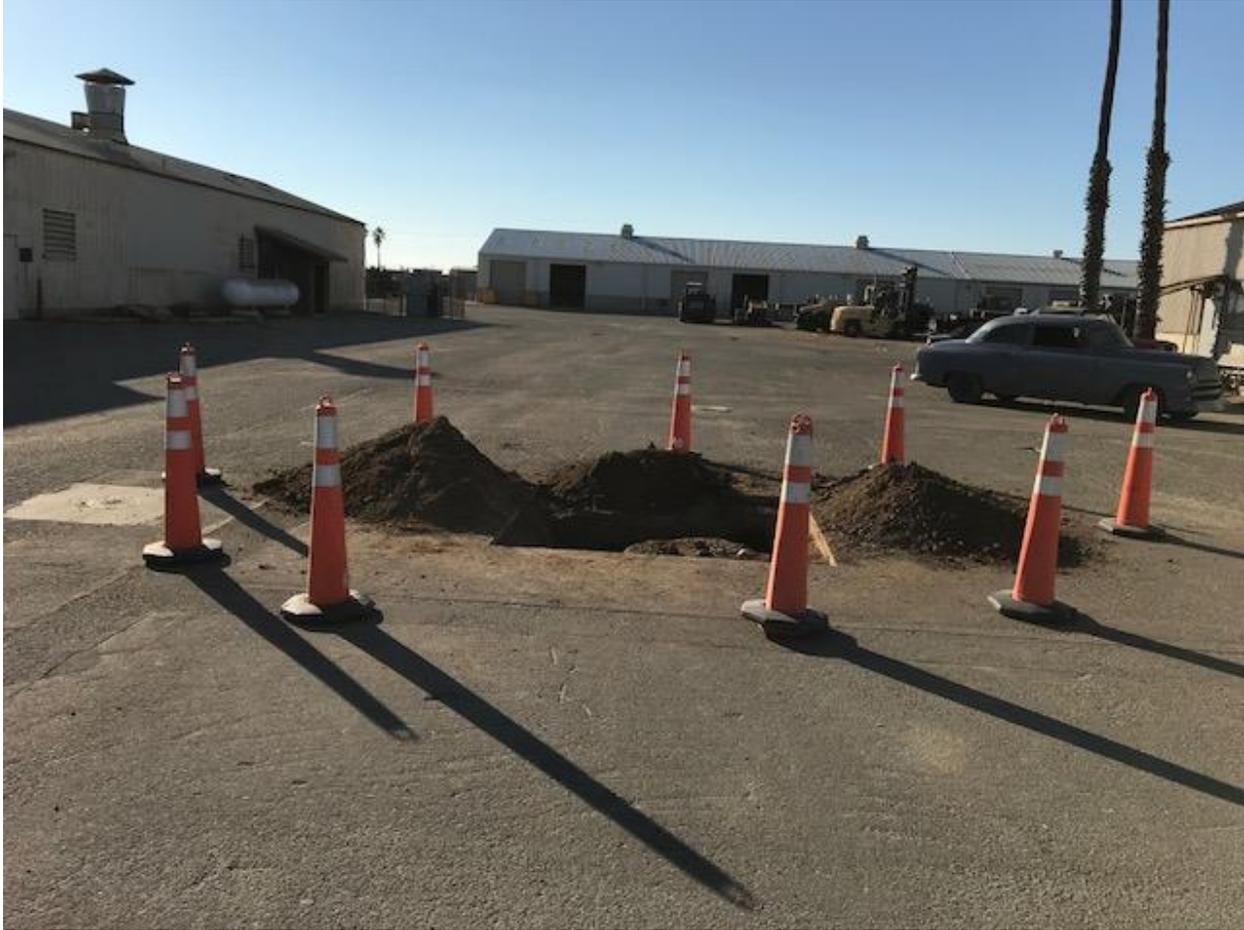
The actual depth of the pipe where the excavation occurred was roughly 40" below grade. This is substantially deeper than the initial elbow fitting found in the inlet at Building 814 which had a depth of about 24". The section of pipe excavated did not have an apparent slope and the initial visual inspection using the camera line did not give any obvious indication of a downward slope. The team assumes that the higher than expected depth is due to a gradual S-curve bend downwards from the initial elbow joint.

Figure D11 displays the exposed damaged pipe and the surrounding area which was marked with hazard cones as establish by safety regulations .

Figure D11. Excavation area marked with hazard cones for safety.

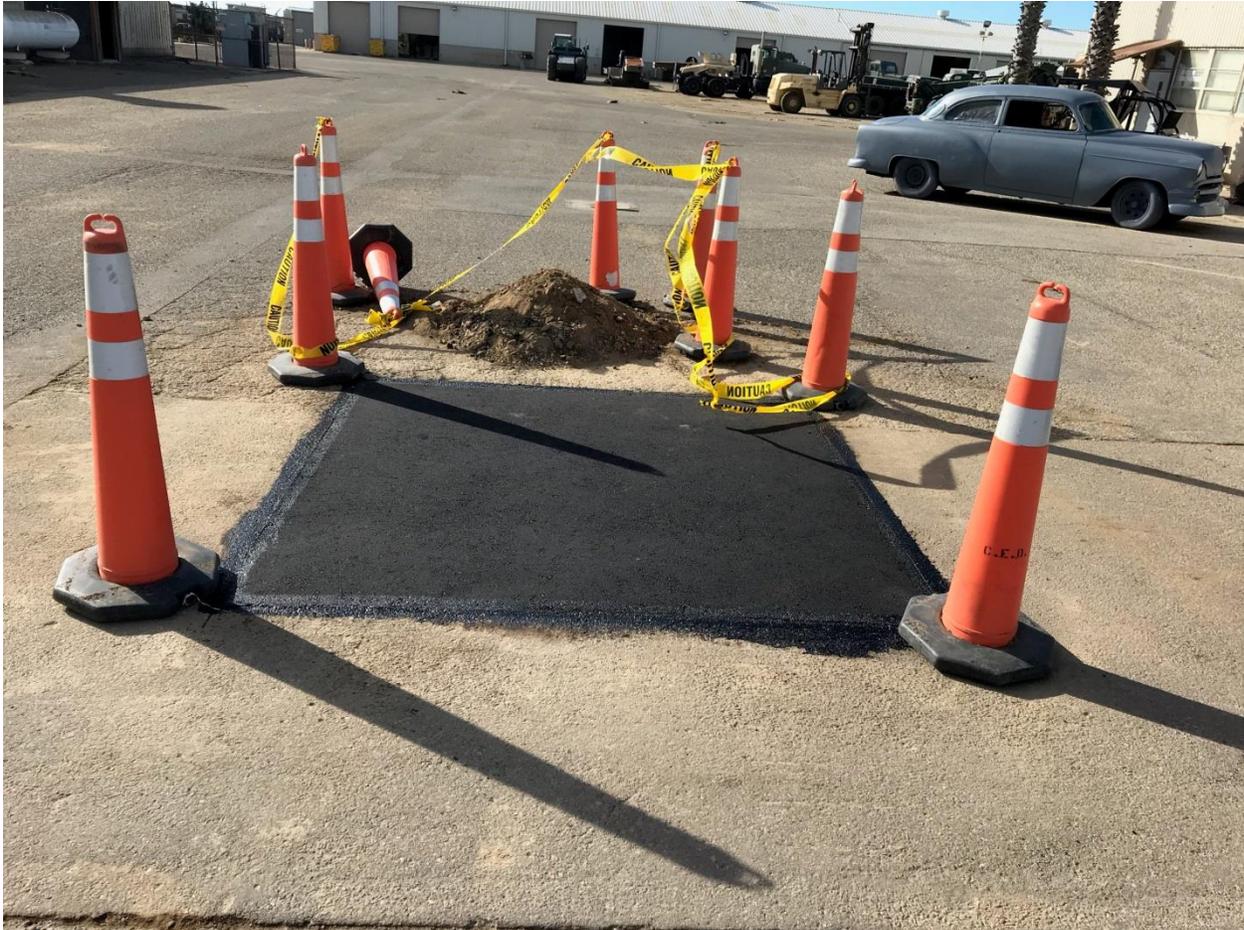
Figure D14 shows the 7'x7'excavated area was filled up with soil as stipulated by pavement regulations and an asphalt patch was poured on the top layer.

Figure D14. Excavated site after asphalt was poured.

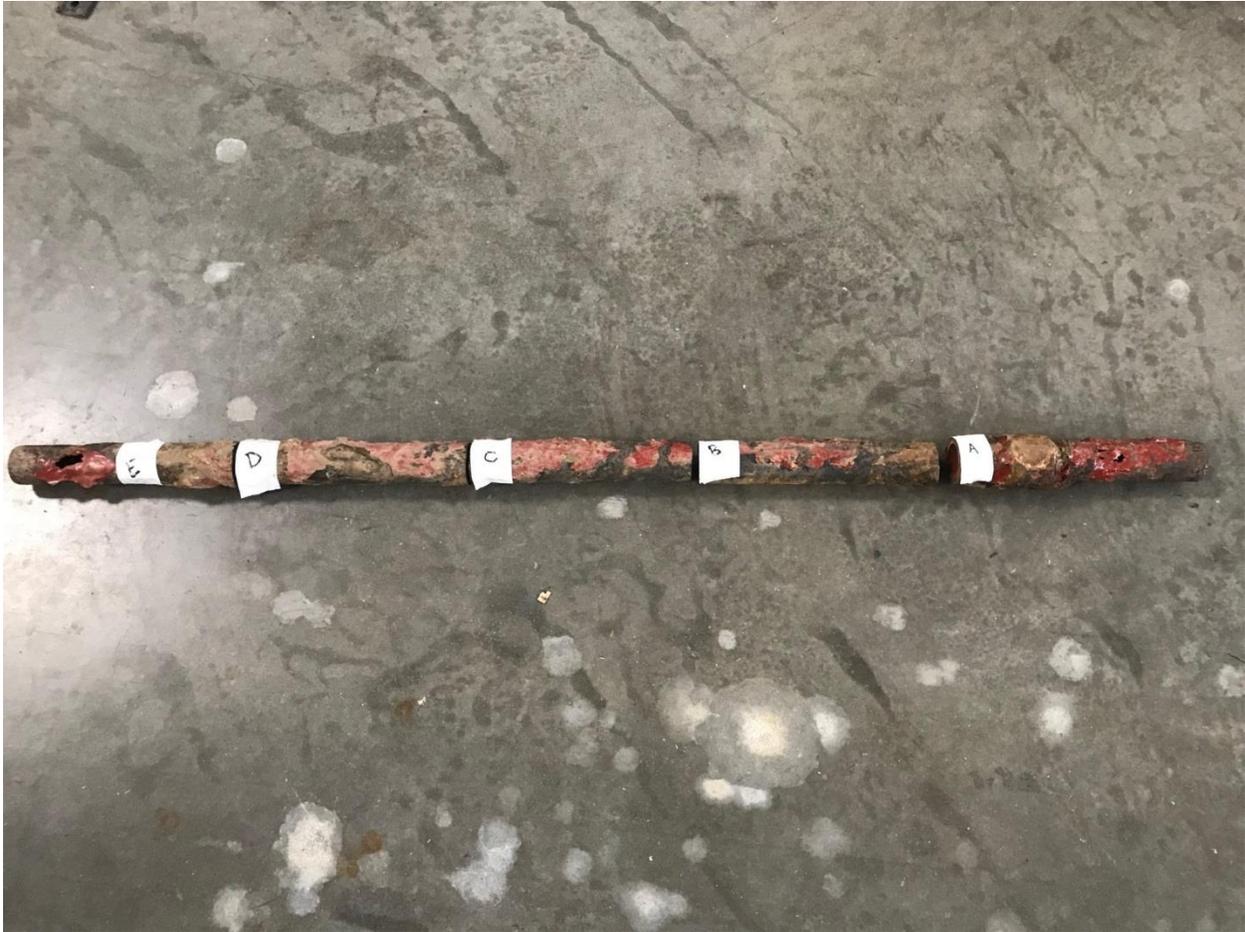
Figure D15 displays the removed underground pipe section that was analyzed in terms of hole-sizes, pipe-wall thickness and epoxy coating thickness. The pipe section consisted of 2-pipe ends and 4-pipe cuts that resulted in segments A (pipe end), AB (cut), BC (cut), CD (cut), DE (cut), and E (pipe-end). A thickness gauge was used to measure the thickness of the epoxy coating and a digital caliper was used to measure the inner diameter and wall thickness of the pipe at the 3, 6, 9, and 12 o'clock positions.

Figure D15: Removed underground pipe section and labeled segments.
