Performance Evaluation of a Pilot-Scale Permeable Reactive Barrier at Former Naval Air Station Moffett Field, Mountain View, California

Naval Facilities Engineering Service Center
Port Hueneme, California

Battelle
. . . Putting Technology To Work

Columbus, Ohio
November 20, 1998

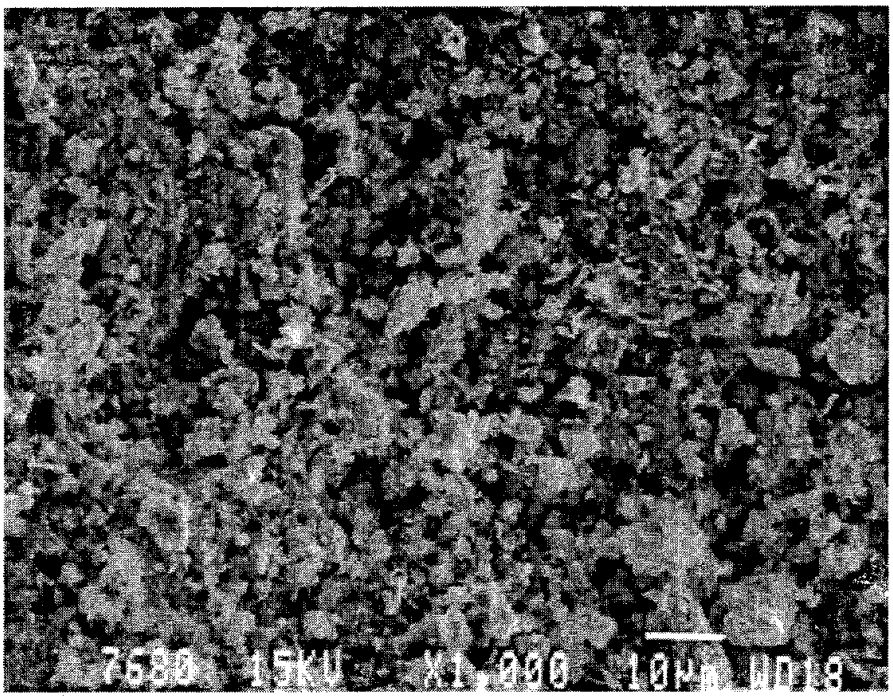
Figure 4-35. SEM Micrograph of Sample C-5 (16 to 19 feet) at 1,000X Magnification

SEM provides high-resolution visual and elemental characterization of amorphous and crystalline phases. This method is suitable for identifying precipitates. SEM results indicate that the surfaces of the iron particles are coated with iron oxides and that the abundance of these oxides is strong on all samples, including the unused iron. Figure 4-34 shows the surface of a typical grain of iron, which is coated with small particles of corrosion products. Figure 4-35 shows the surface of an iron particle under greater magnification (see scale bar on photograph). It can be seen that the particle's surface is comprised of small (<5 μm), irregular particles (possibly iron oxides) and filamentous material (possibly iron hydroxide). Based on these results, it would appear that the extent of corrosion on individual iron particles does not vary significantly with location in the Moffett Field permeable barrier.
