NRL/MR/6170--04-8762

# Validation of HVOF WC/Co Thermal Spray Coatings as a Replacement for Hard Chrome Plating on Aircraft Landing Gear

March 31, 2004

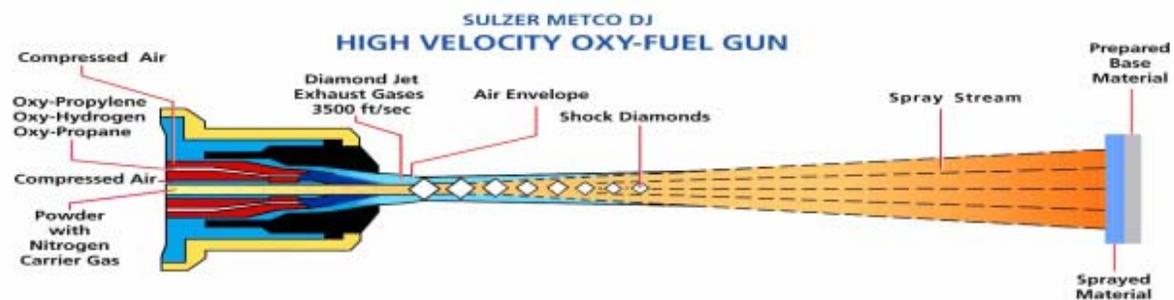
**Figure 2-1. Schematic of HVOF Gun and Process (Sulzer Metco DiamondJet)**

**Technology background and theory of operation:** HVOF is a standard commercial thermal spray process in which a powder of the material to be sprayed is injected into a supersonic flame of a fuel (usually hydrogen, propylene or kerosene) as shown in Figure 2-1. The powder particles are accelerated to high speed and soften in the flame, forming a dense, well-adhered coating on the substrate. The coating material is usually a metal or alloy (such as Tribaloy or stainless steel), or a cermet (such as cobalt-cemented tungsten carbide, WC/Co). The technology is used to deposit coatings about 0.003” thick on original equipment manufacturer (OEM) parts, and to rebuild worn components by depositing layers up to 0.015” thick.

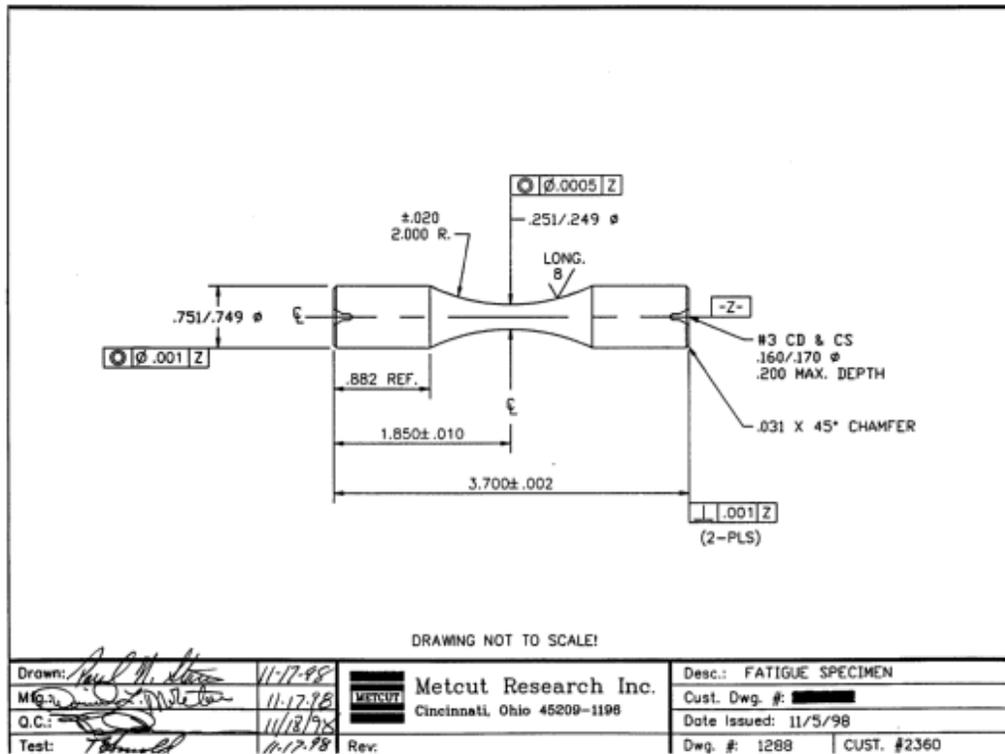
Figure 3-7. Typical Hourglass-shaped Fatigue Bar

Typical fatigue bar shapes are shown in Figure 3-7 and Figure 3-8. The most common designs are the hourglass (which can only be used for load-control fatigue), and the smooth bar. The hourglass bar was used for the bulk of the testing for consistency with existing data in the landing gear community. The hourglass shape is more sensitive to coatings and tends to give a wider separation of curves between coating conditions. Some tests with smooth bars were included to permit correlation with earlier HCAT generic testing. While for 0.003” coatings a small 0.25” diameter bar was used, for 0.010” coatings a 0.5” diameter bar was used to ensure that the bar cross section was much greater than that of the coating. Most testing was done at R=-1 (fully reversed), since that best corresponds with field conditions for military landing gear components. Some testing was done at R=0.1 (tension-tension) for comparison with earlier generic HCAT data and with Boeing test data.

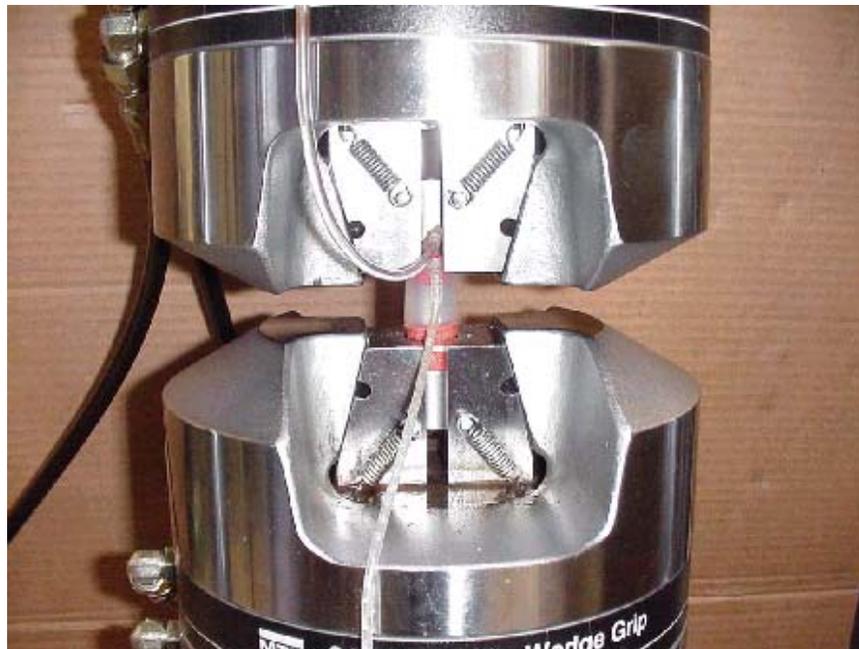
**Figure 3-12. Close-up View of Corrosion Cell Set-up for Fatigue Testing: Small Hourglass Specimen**

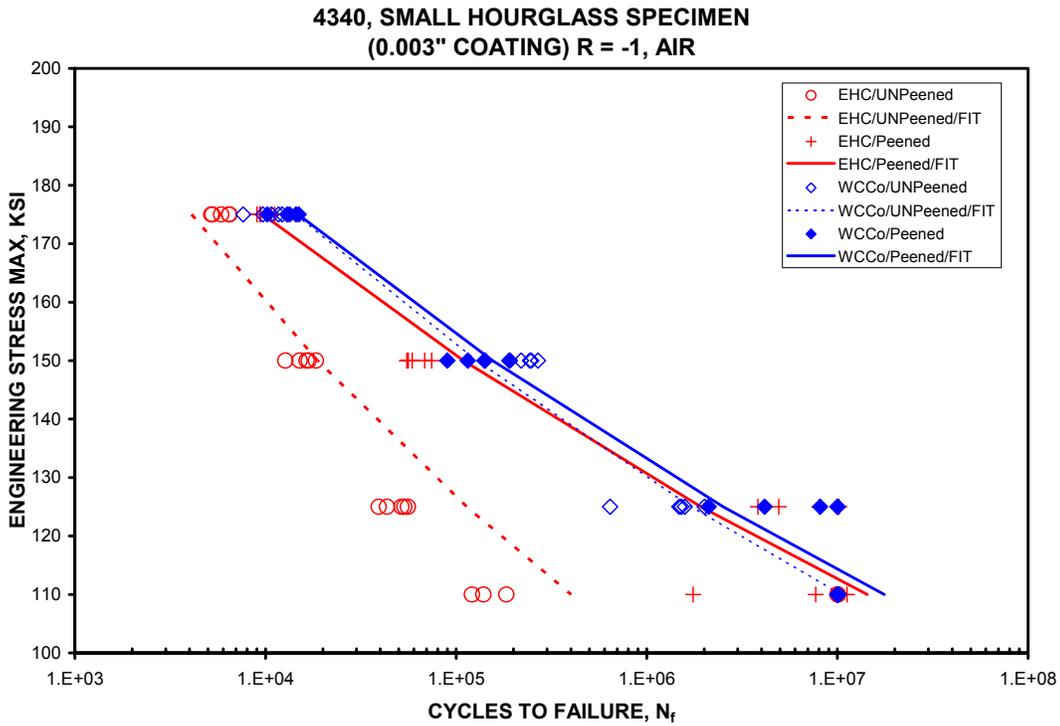
**Figure 3-13. 4340 Fatigue - Hourglass Configuration, Air Environment, R = -1**

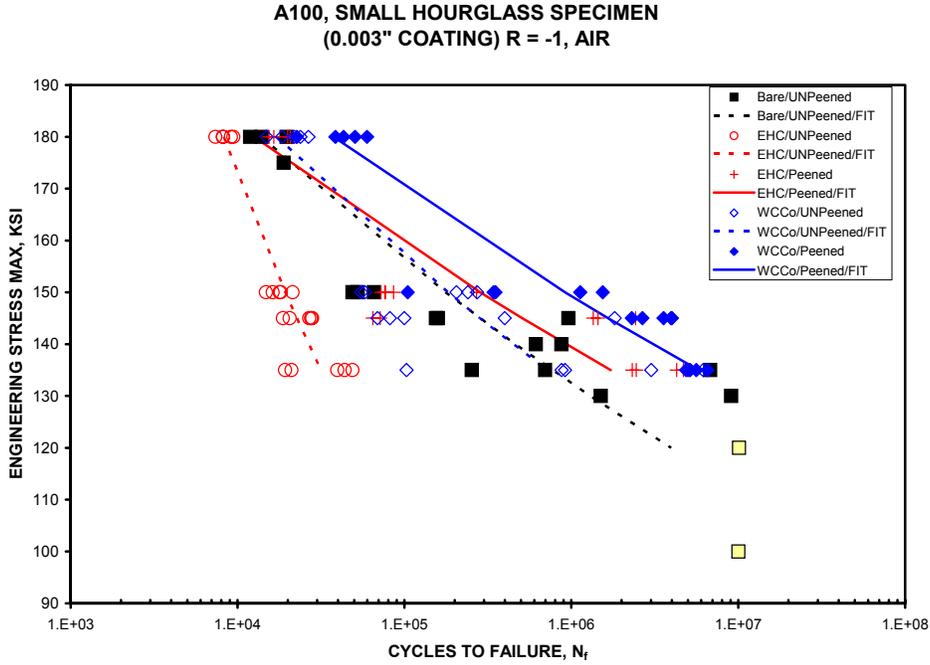
**Figure 3-18. A100 - Unpeened vs. Peened Substrate Comparison, Hourglass Configuration, R= -1, 0.003” Thickness**

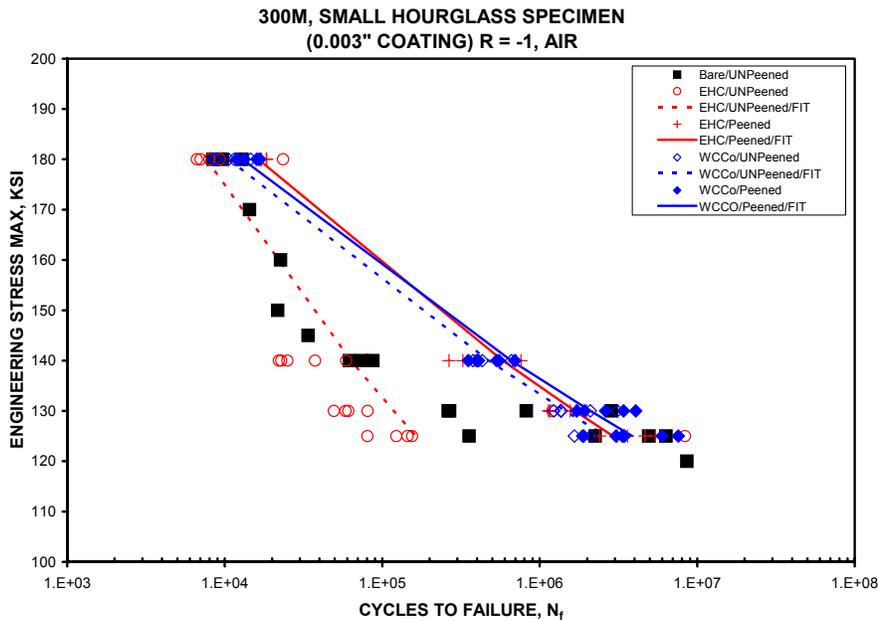
**Figure 3-22. 300M - Peened vs. Unpeened Substrate Comparison, Hourglass Configuration, 0.003” Thickness, R= -1**

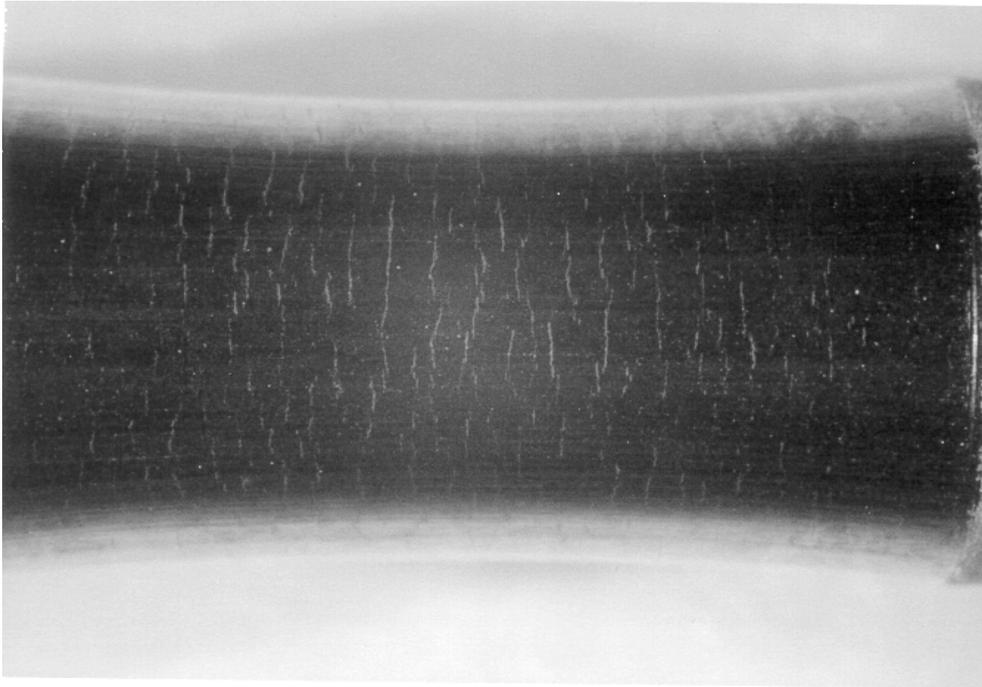
**Figure 3-26. Cracking of HVOF Coating in Central Region of Hourglass Specimen**

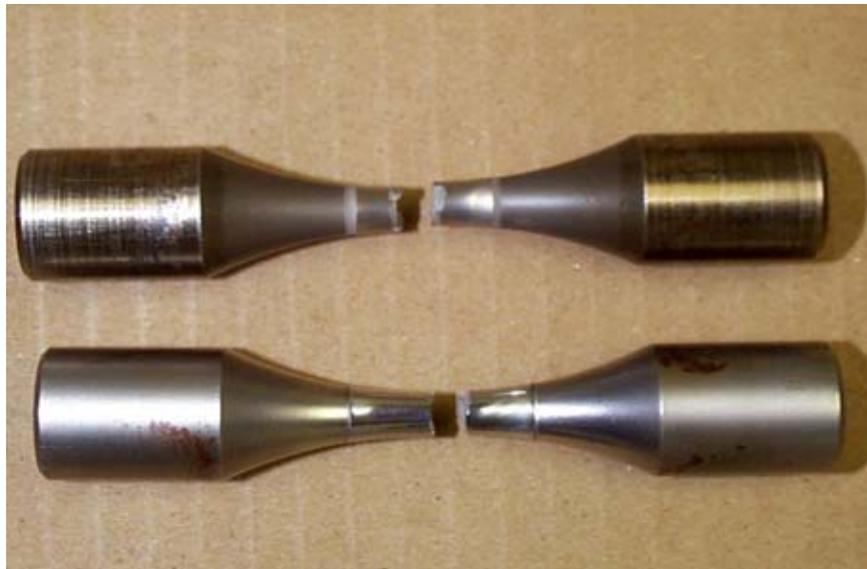
**Figure 3-27. Failed 300M Specimens Showing Spalling in Small Zone Near Fracture Surface**

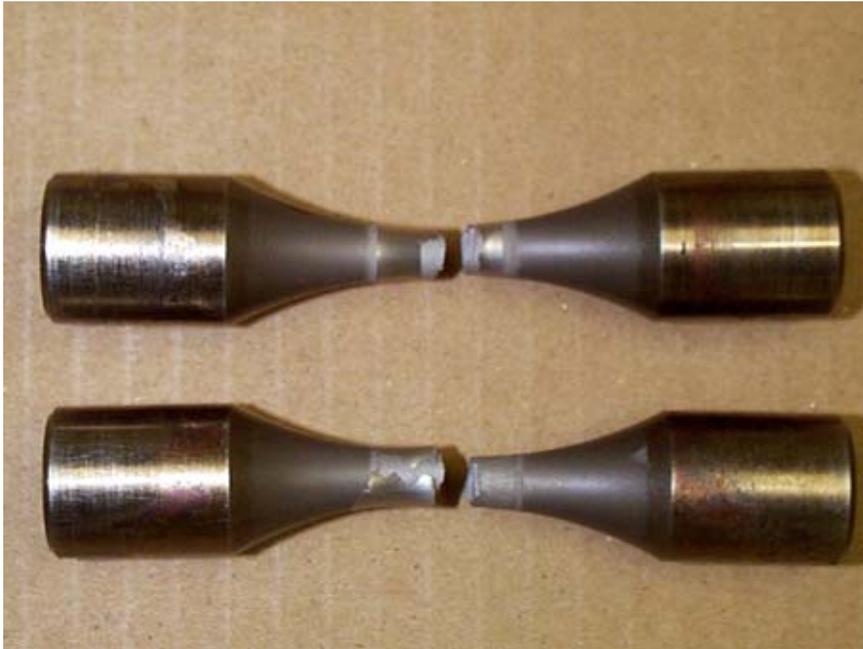
**Figure 3-28. Failed 300M Specimens Showing Total Spallation on Fracture**

For the large hourglass specimens with the .010” coating, spalling was not observed prior to failure, but total spalling occurred on all specimens at failure regardless of the substrate type or test environment.

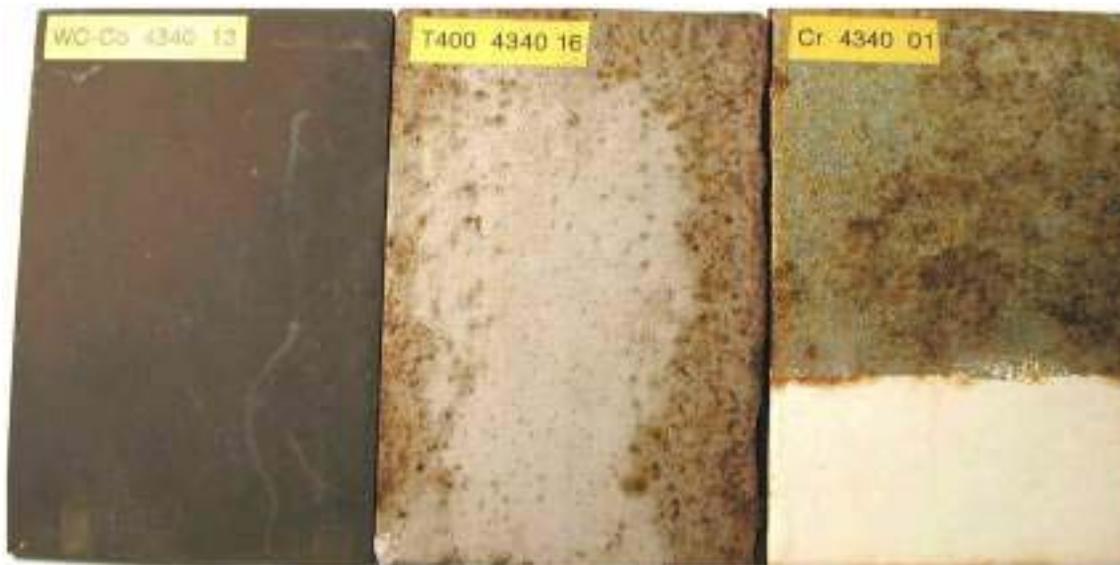
**Figure 3-29. HVOF WC-Co, Tribaloy 400 (T400) and EHC (Cr) on 4340 Steel Following Three-year Atmospheric Exposure (Samples shown prior to cleaning)**

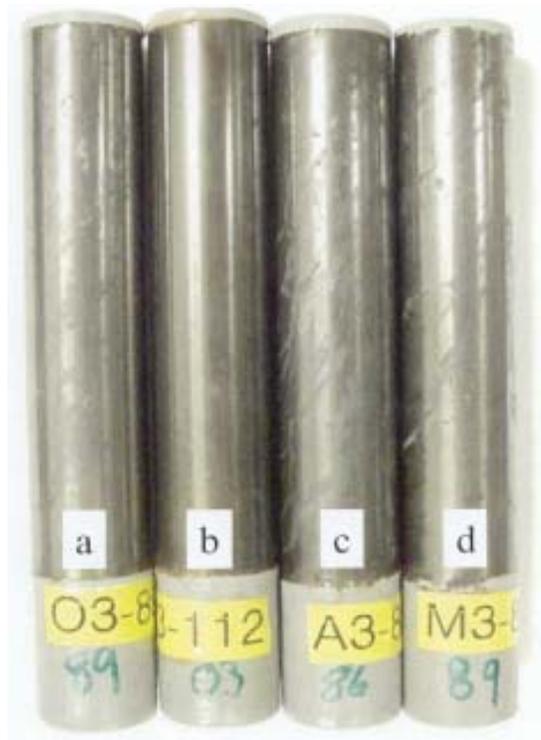
**Figure 3-47. 0.010”-thick HVOF Coatings: a) WC-Co on 4340, b)WC-CoCr on 4340, c) WC-Co on 300M, and d) WC-Co on Aermet 100 After the B117 Test**

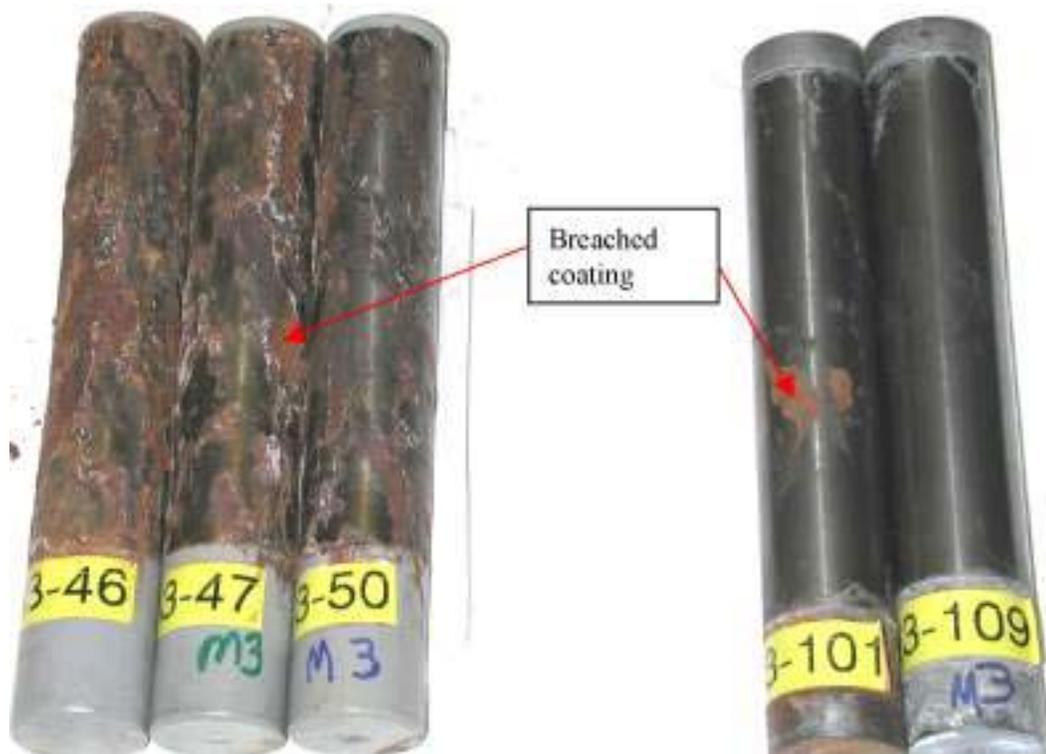
**Figure 3-48. HVOF WC-Co Coatings, 0.003" Thick, Ground, on 300M Steel From the LGJTP Tests, Left, and the Supplemental Tests, Right**

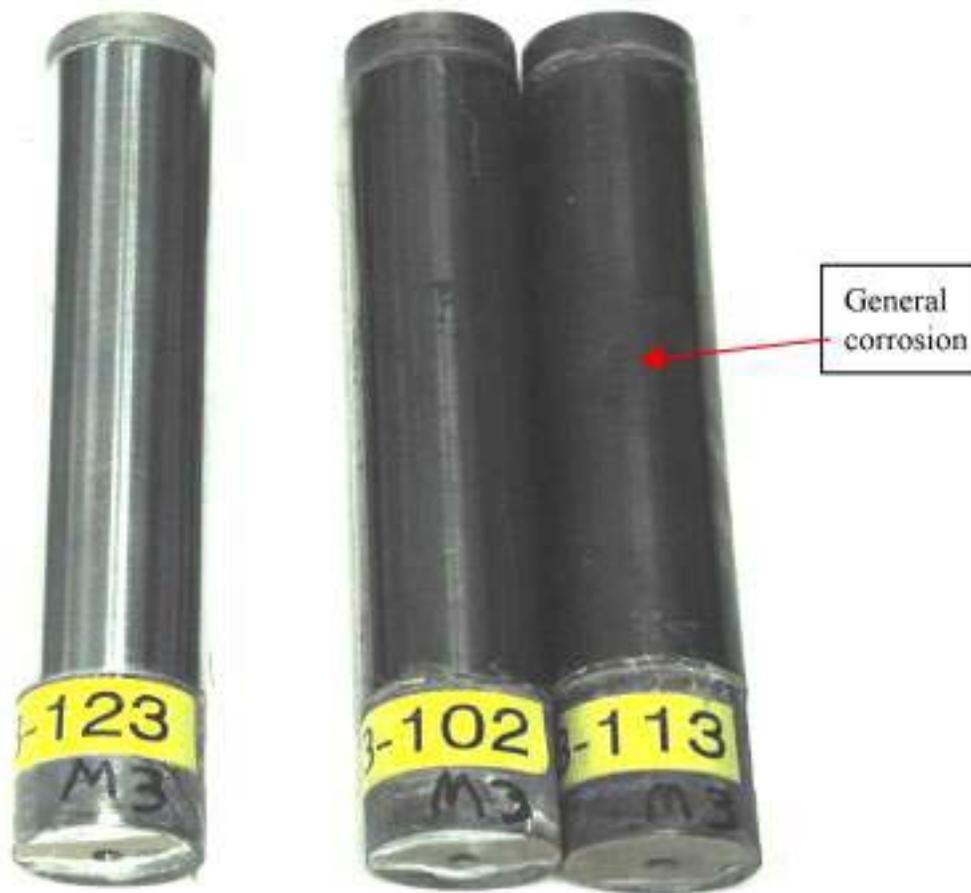
**Figure 3-63. Left: EHC, 0.010”-thick, Ground. Right: HVOF WC-Co, 0.010”-thick, Ground. All on 300M Steel**

3. EHC coatings outperformed either the HVOF WC-Co or WC-CoCr, regardless of thickness in this corrosion test. See Figure 3-62 and Figure 3-63 for comparisons of 0.010"-thick coatings.
4. For 0.010"-thick coatings, the data implies WC-CoCr coatings show improved performance over WC-Co coatings. Additional studies would be necessary to confirm this conclusion since there was one 0.010"-thick WC-CoCr coating that was breached.
5. The 0.003"-thick coatings are suspect in their ability to protect the substrate steel. While 0.003"-thick EHC in this data set did protect the substrate (one sample only was tested in each location), the LGJTP results with multiple samples being tested showed some 0.003"-thick EHC coatings being breached.

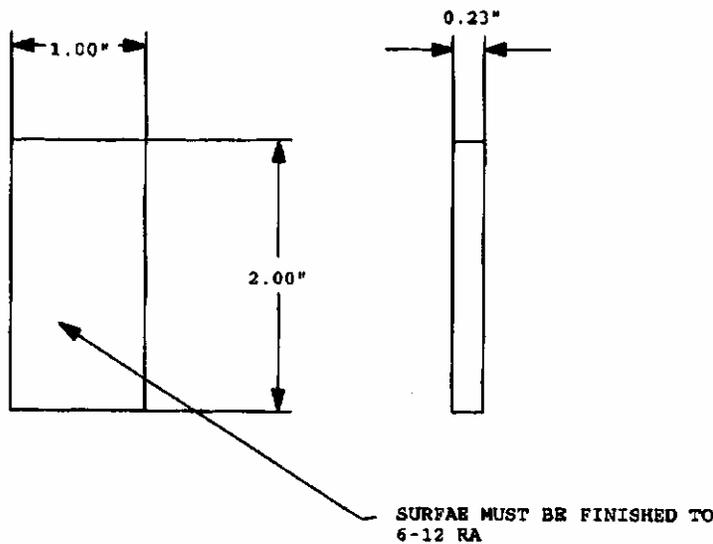
Figure 3-64. a) Fretting Block; b) Fretting Shoe

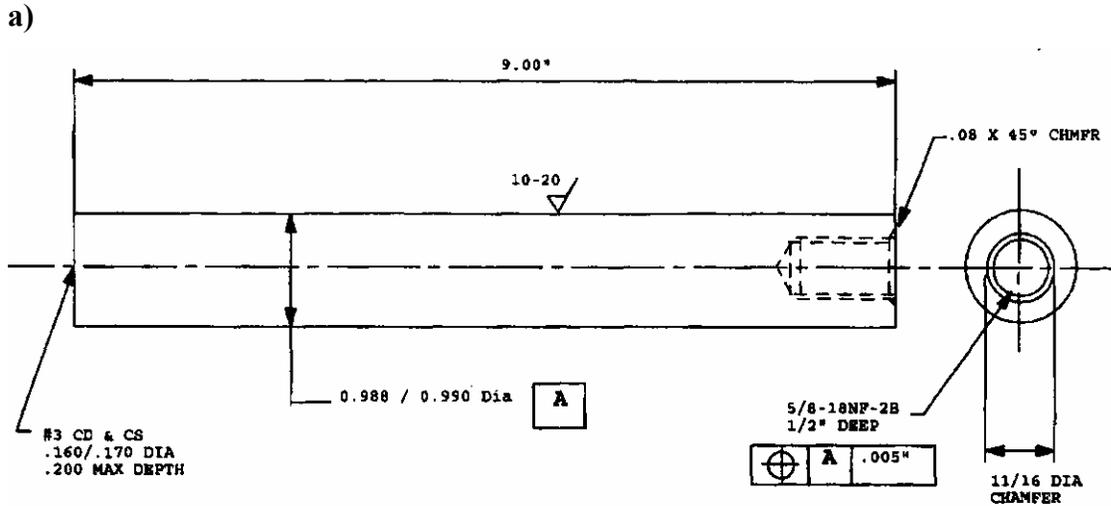
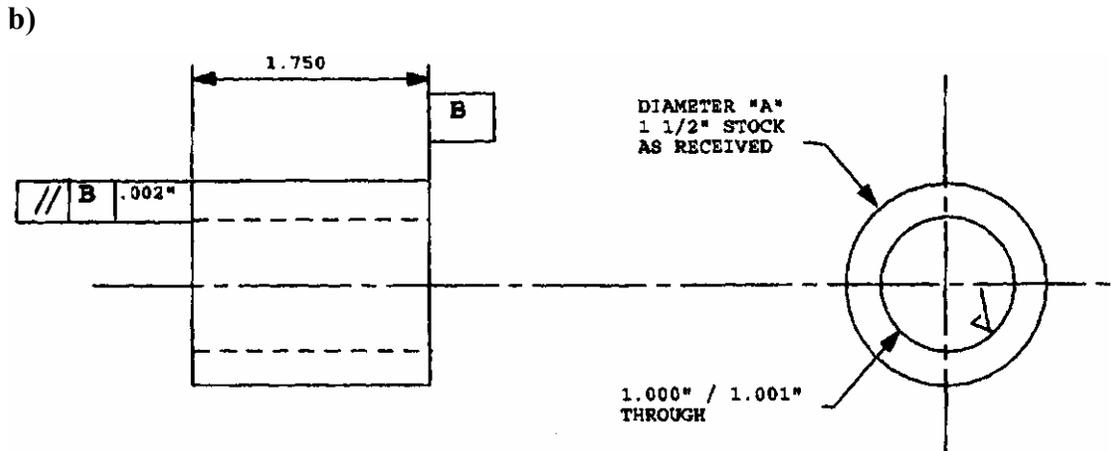
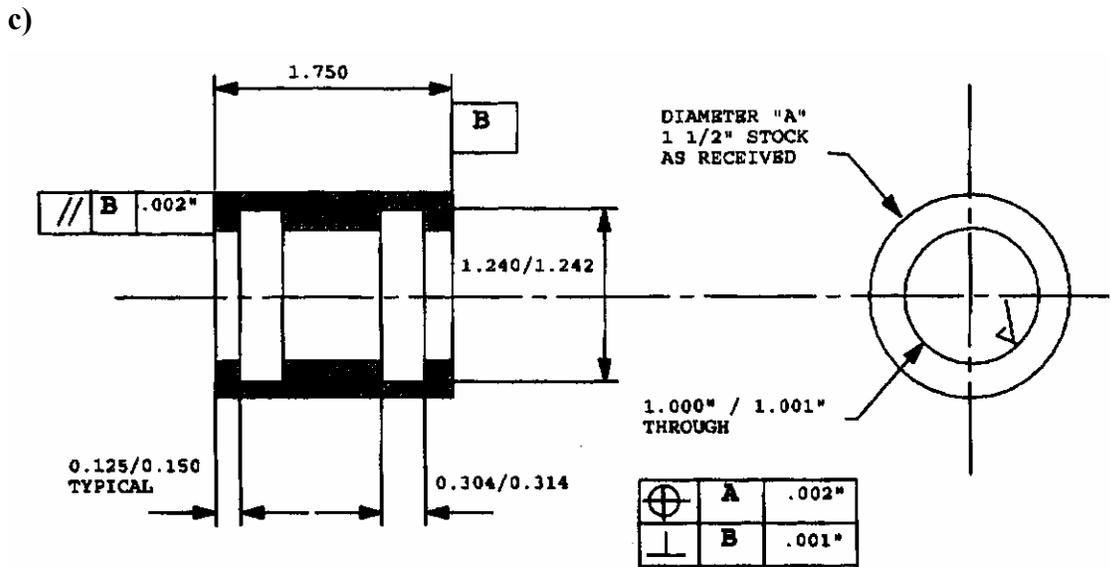
Figure 3-65. Wear Test Rods and Bushings - a) Rod, b) Straight Bushing, c) Seal Groove Bushing

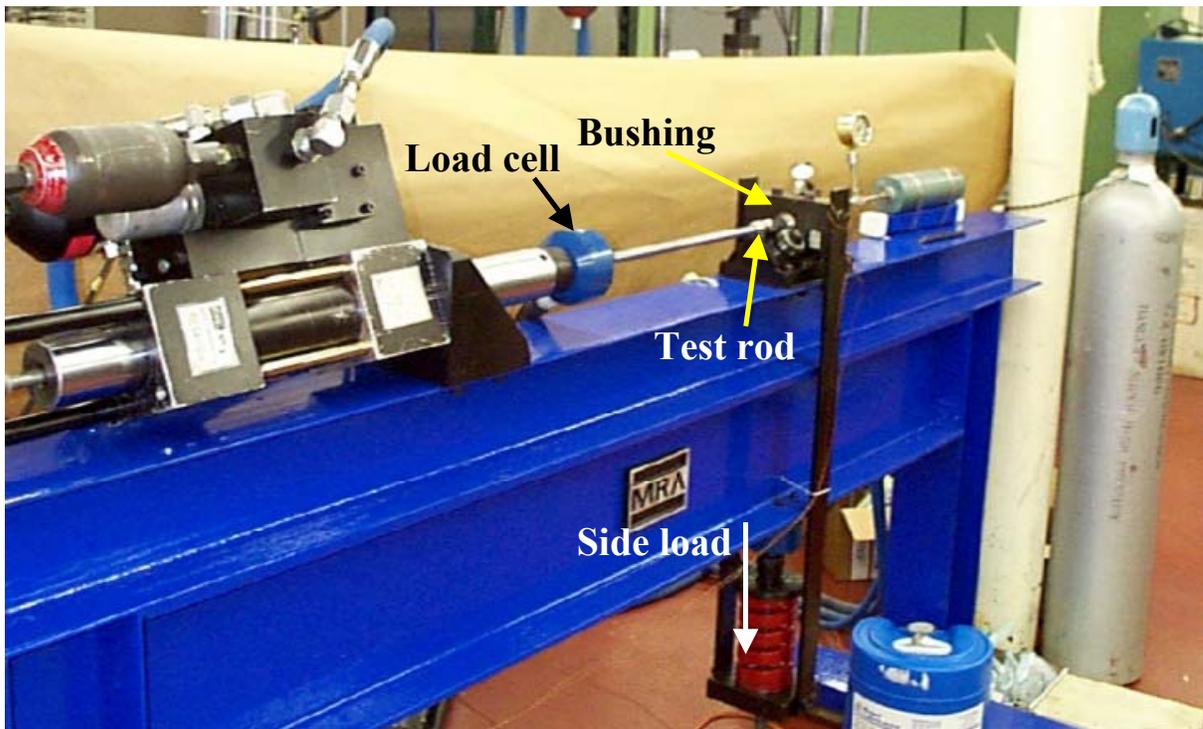
**Figure 3-68. Sliding Wear Test Equipment**

Test conditions were as defined in the test matrices. Hydraulic fluid was added to permit fully-lubricated, starved-lubricated, or unlubricated testing. Under “Full” lubrication fluid was added throughout the test, while under “partial” lubrication lubricant was added only for the first hour of the test, then turned off for the remainder of the test.

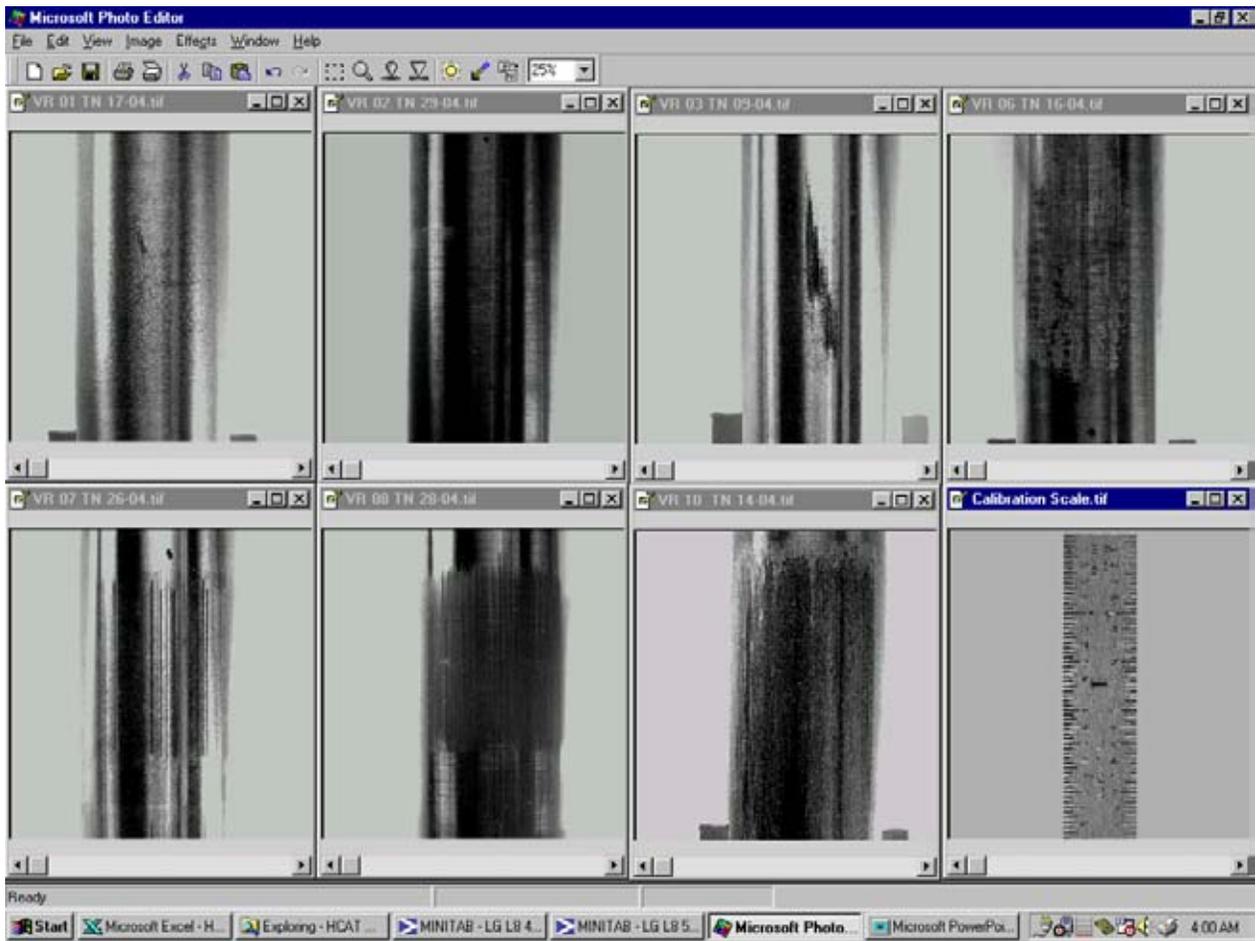
**Figure 3-69. Visual Ranking Standards for Rods, VR 01 to VR 10**

- Weight loss – this was found to be an unreliable method since small amounts of lubricant trapped in the center hole or thread of the rod caused large errors – up to 0.010 gm.
  - Measurement accuracy was tested by making a series of measurements:
    - 0.00006 gm for WC-Co
    - 0.00011 gm for metals and hard chrome
    - 0.00063 for seals and anodized Al
- Visual appearance against standards – this method was used to overcome the problems caused by weight measurement errors due to trapped fluids. The standards are shown in Figure 3-69 and described in Table 3-43. A visual ranking was assigned by the closest match to the standards.

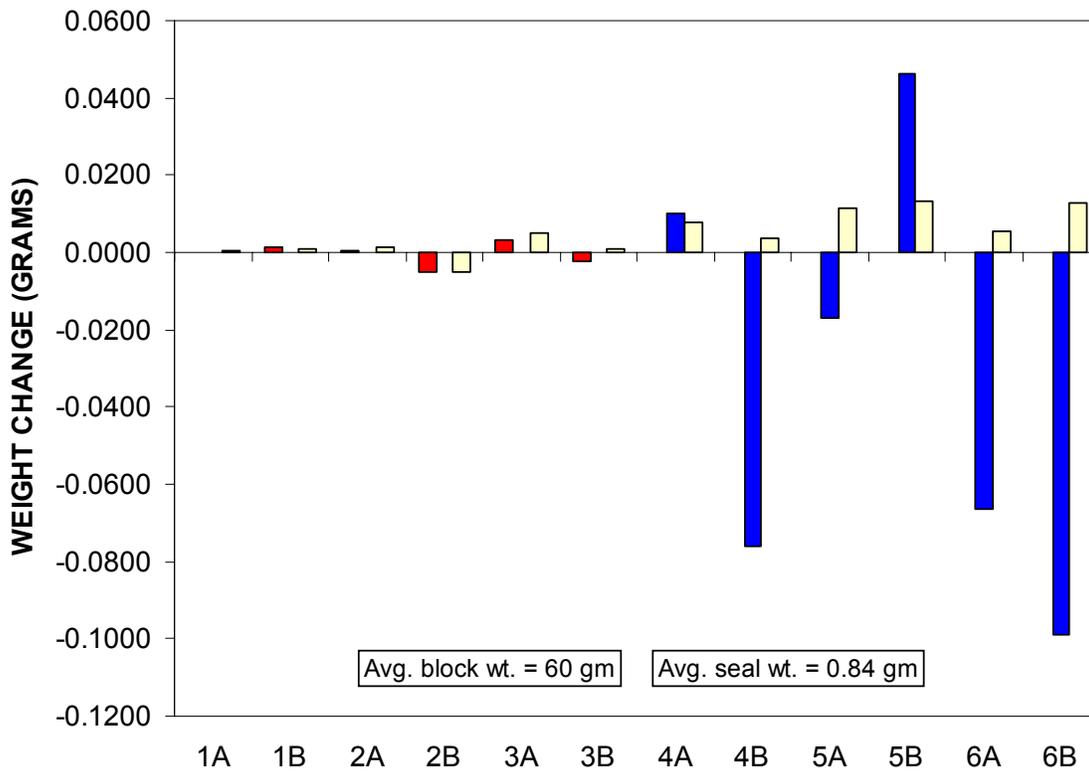
**Figure 3-71. Fretting Wear - L12 DOE Matrix; Yellow Data Wear of Coated Shoe; Red Data Wear of Uncoated 4340 Block; Blue Data Wear of Nitrile Seal**

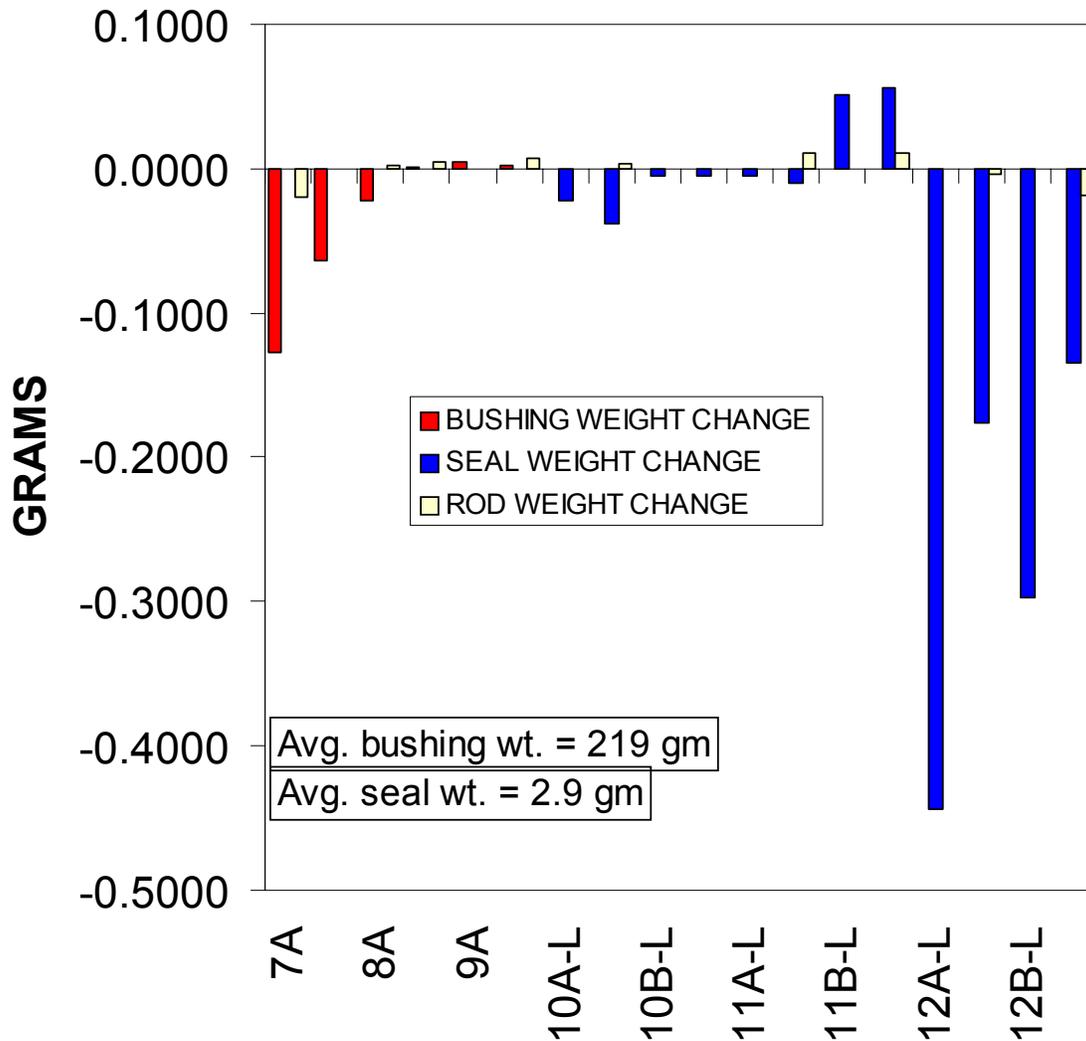
**Figure 3-73. Sliding Wear – L12 Data. Weight Change – Bushing/Seal (Yellow data wear of coated rod; red data wear of uncoated bushing; blue data wear of nitrile seal)**

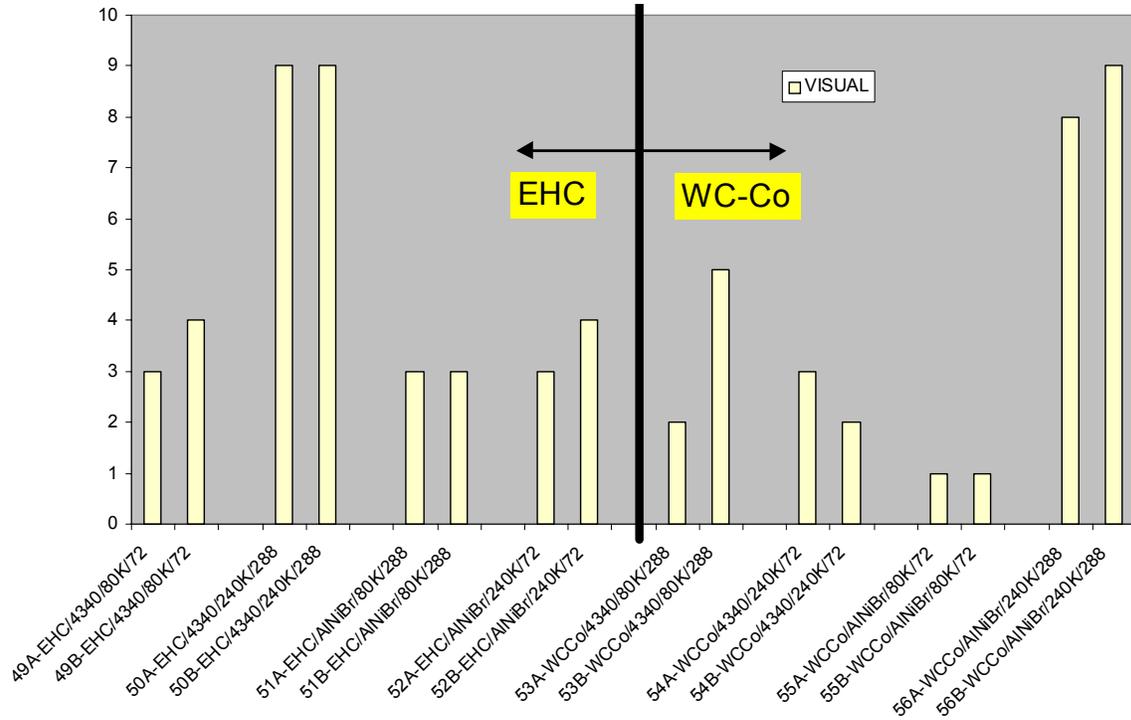
Figure 3-74. Sliding Wear, L8 DOE – Visual Rankings for Baseline Metal Bushings

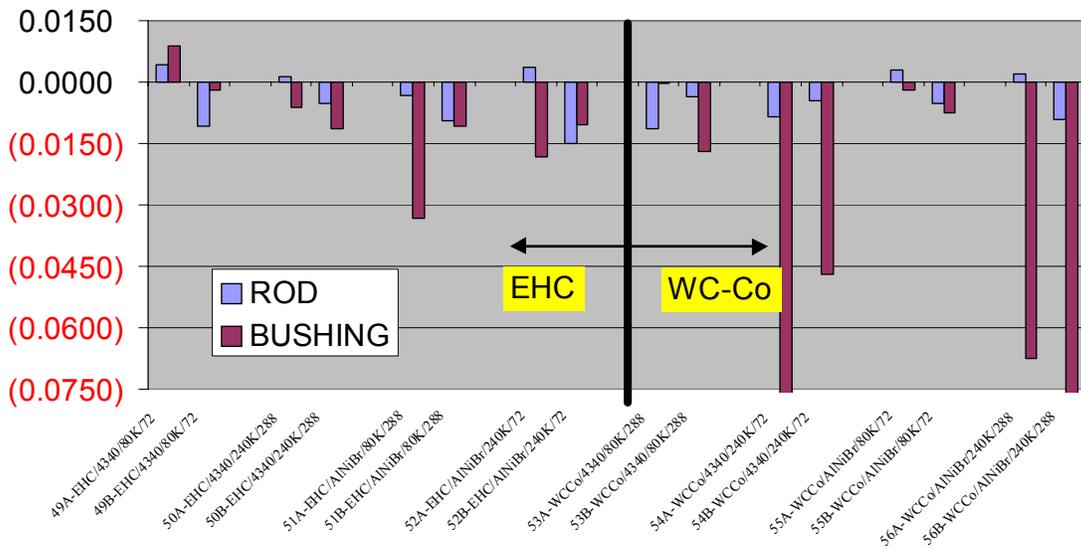
Figure 3-75. Sliding Wear, L8 DOE – Weight Loss for Baseline Metal Bushings

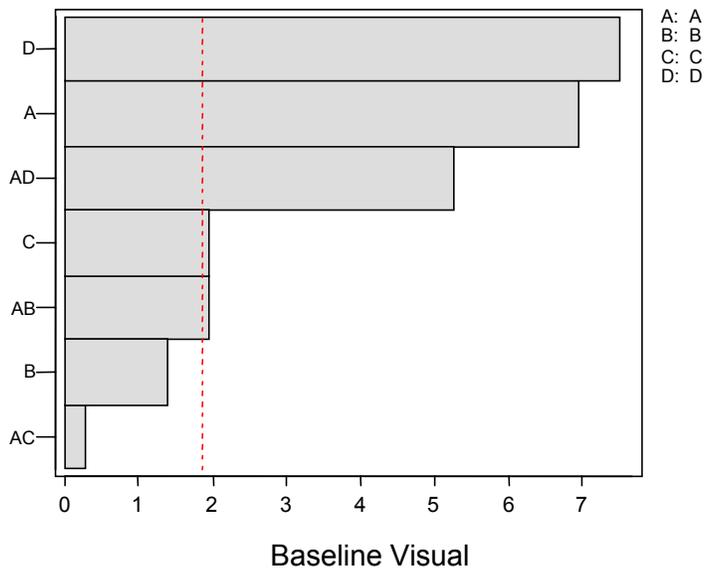
**Figure 3-76. Pareto Chart and Visualization of the Major Effects in the L8 DOE Based on Visual Wear Rating; Only Effects D and A (normal load and number of cycles) are Statistically Significant**

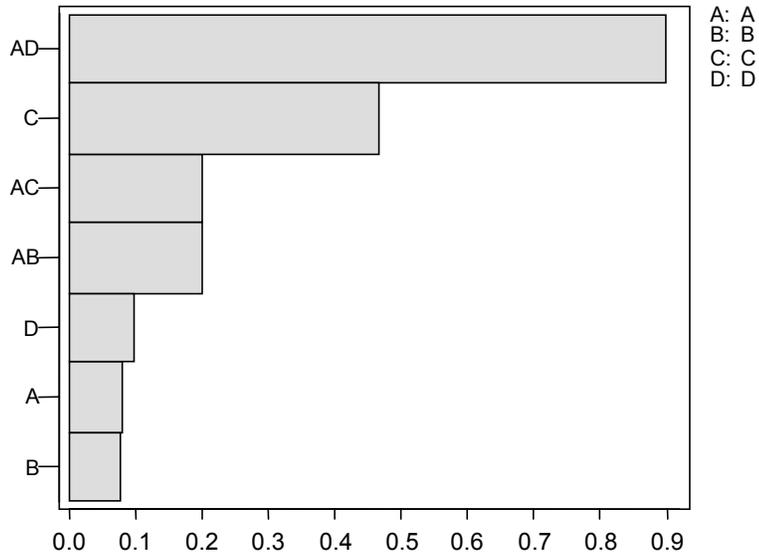
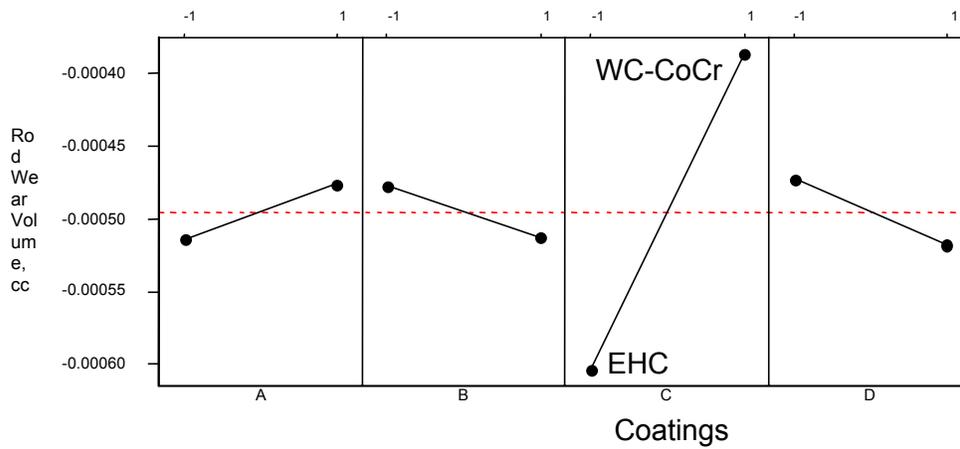
**Figure 3-77. Pareto Chart and Visualization of the Major Effects in the L8 DOE Based on Rod Wear Volume; Only Effect C (coating material) is Statistically Significant**

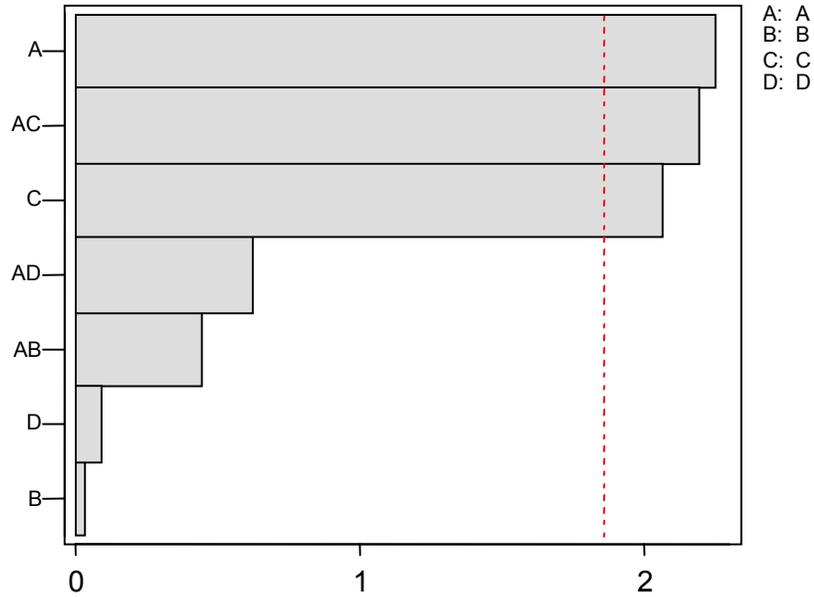
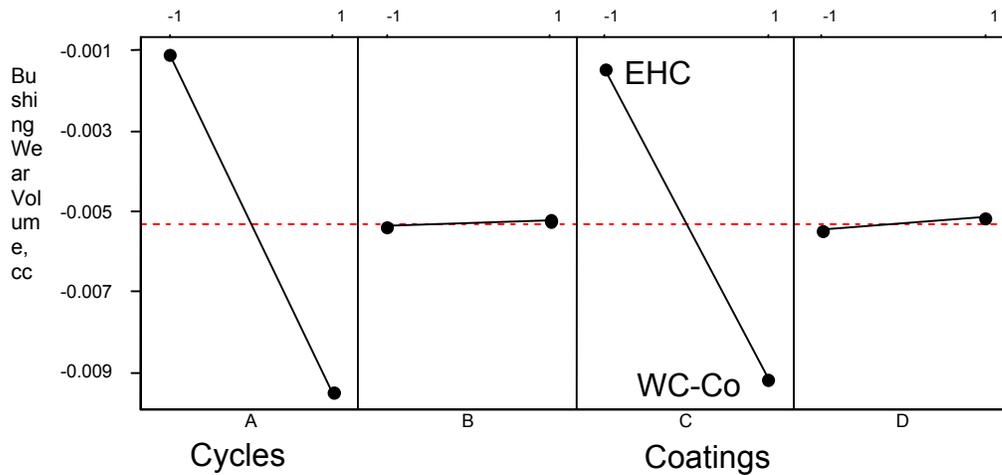
**Figure 3-78. Pareto Chart and Visualization of the Major Effects in the L8 DOE Based on Bushing Wear Volume; Only Effects A and C (number of cycles and coating material) are Statistically Significant**

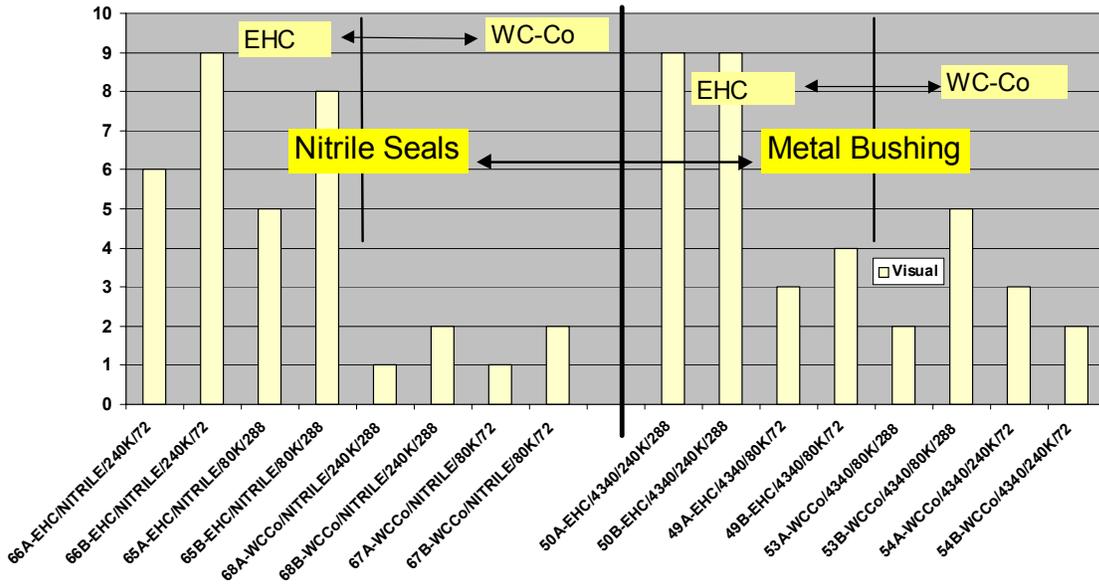
Figure 3-79. L8 DOE Data for 3rd Half Replicate – Visual Ranking for Rod Wear (shows EHC and WC-Co on metal bushings and nitrile seals)

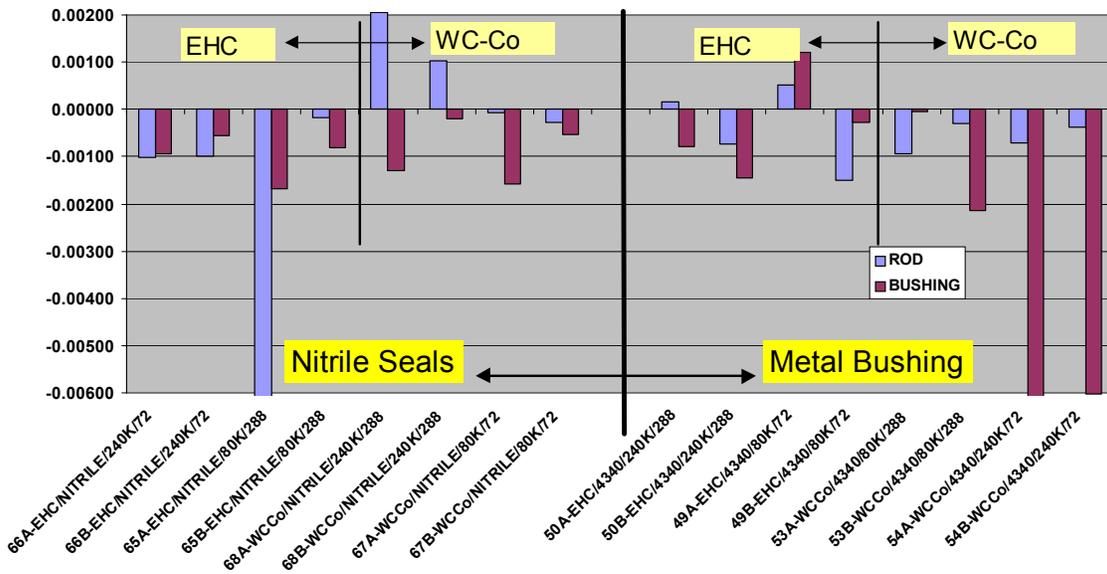
Figure 3-80. L8 DOE Data for 3rd Half Replicate – Weight Loss (shows EHC and WC-Co on metal bushings and nitrile seals)

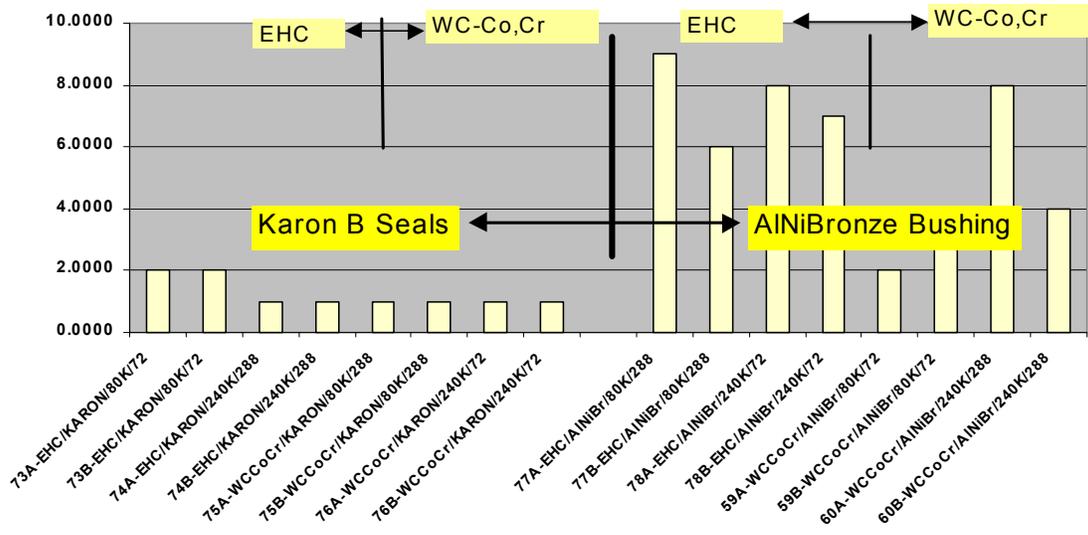
Figure 3-81. L8 DOE Data for 5th Half Replicate – Visual Ranking for Rod Wear (shows EHC and WC-Co on AlNiBronze bushings and Karon B liners)

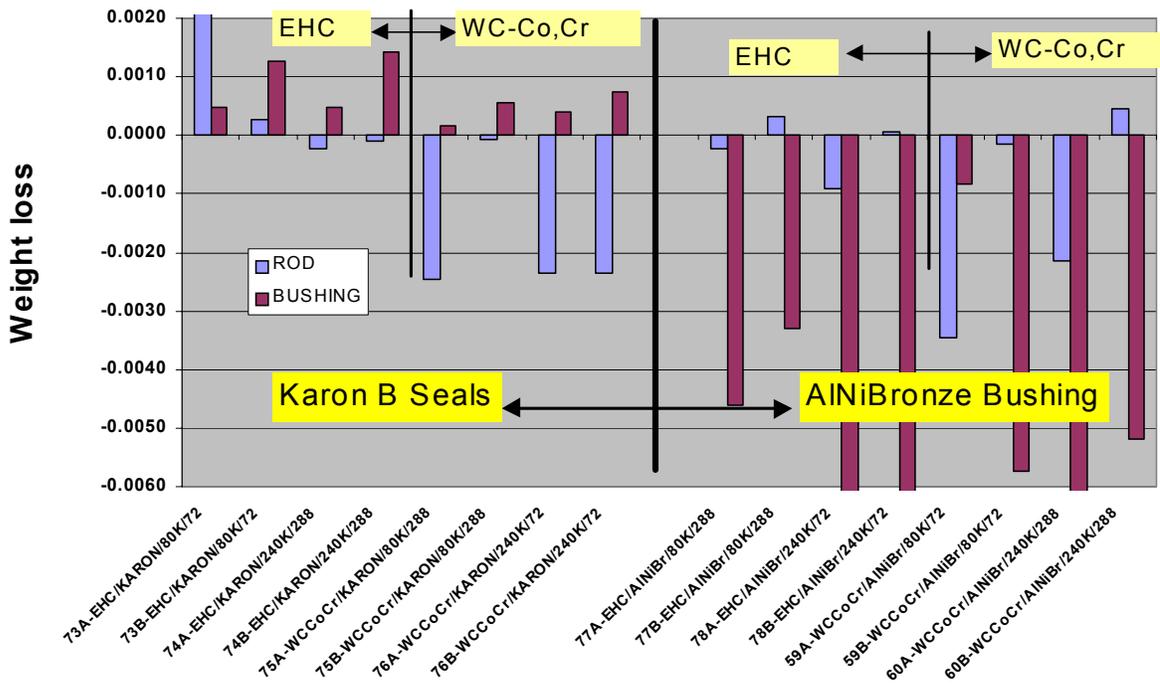
Figure 3-82. L8 DOE Data for 5th Half Replicate – Weight Loss (shows EHC and WC-Co on AlNiBronze bushings and Karon B liners)

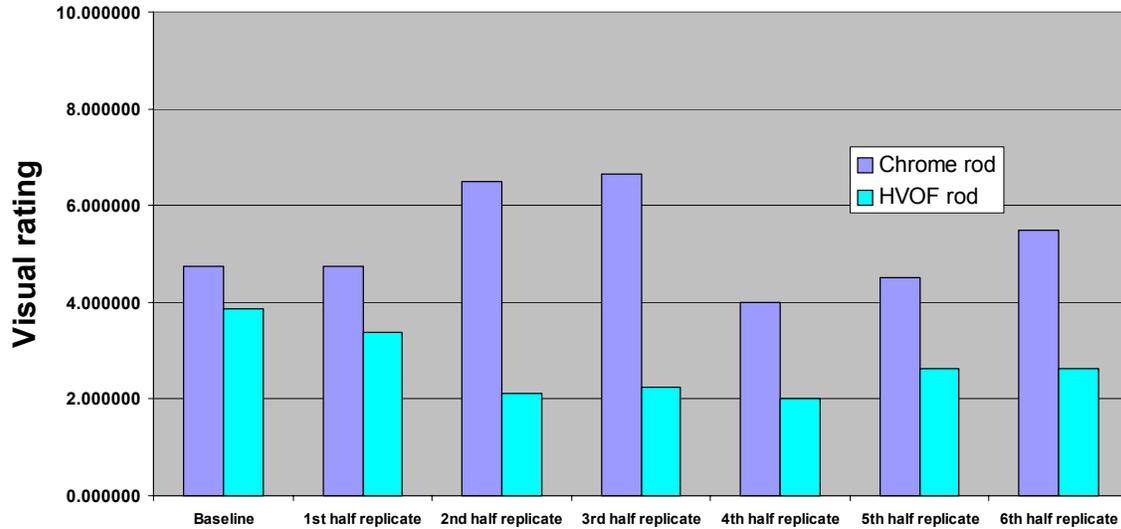
Figure 3-83. Average Rod Wear for L8 Matrix - Visual Rating
