NRL/MR/6170--04-8762

# Validation of HVOF WC/Co Thermal Spray Coatings as a Replacement for Hard Chrome Plating on Aircraft Landing Gear

March 31, 2004

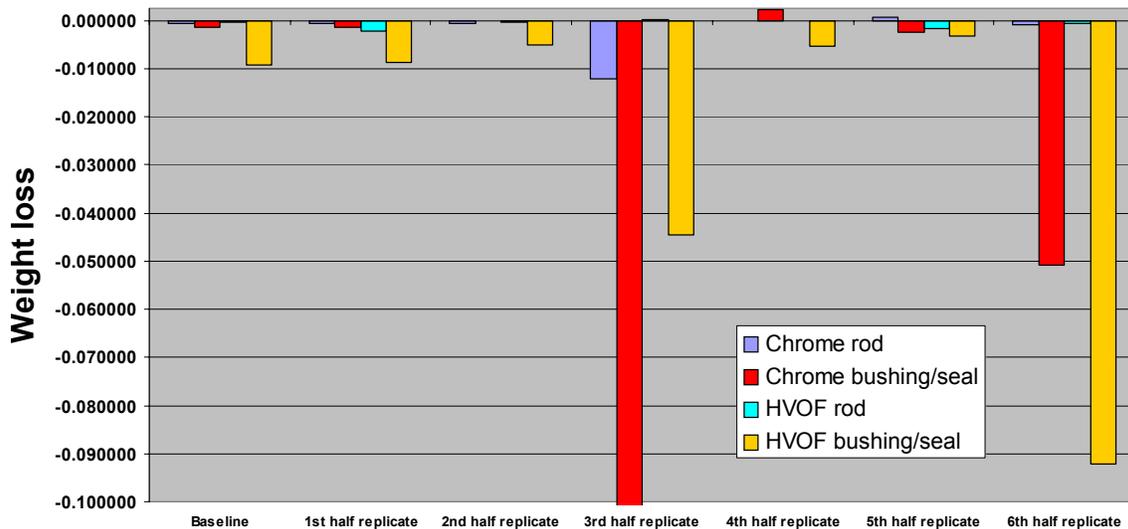
Figure 3-84. Average Rod and Bushing/Seal Wear for L8 Matrix - Weight Loss

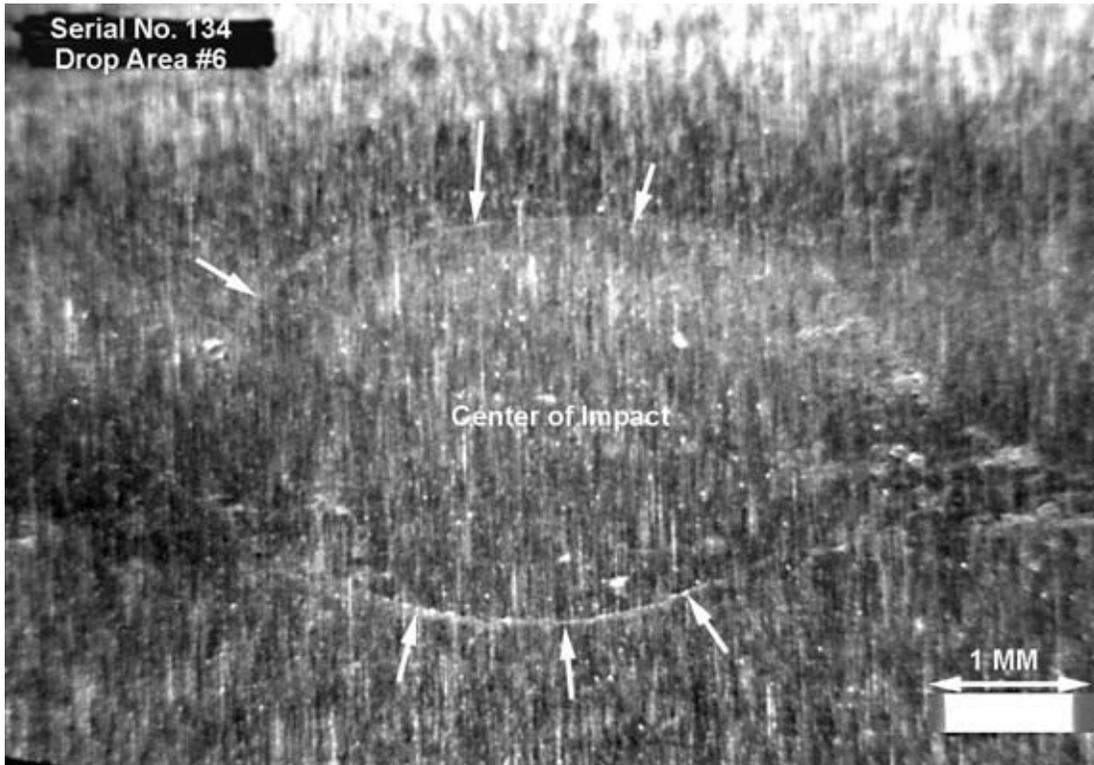
**Figure 3-90. Impact Area on 0.010”-thick WC-CoCr , 72” Drop Height – Grazing Incidence Light (Bar axis is horizontal)**

For all impacts, including up to 50 drops from 72” onto a single point, there was **no visible sign of cracking or coating damage on any sample**. The only observable damage was an approximately 5mm x 2.5mm flattened area. Microscopic observation showed this area to be bounded by circumferential cracks of varying visibility, shown arrowed in Figure 3-90, and often some radial cracking along the bar axis (3 o’clock and 9 o’clock locations in the figure).

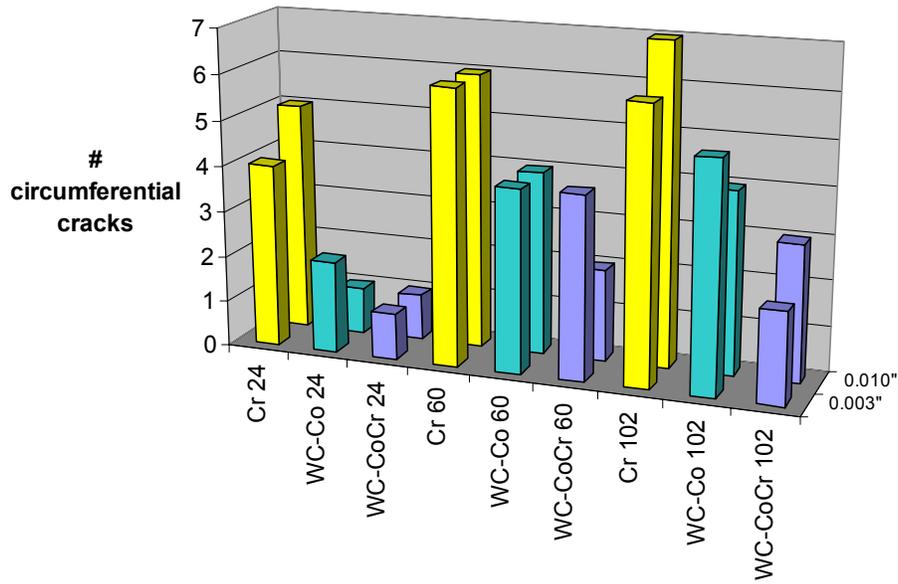
**Figure 3-91. Circumferential Cracking Around Impact Point for 0.003"- and 0.010"-thick Coatings at Different Ball Drop Heights**

Figure 3-91 shows the total number of circumferential cracks, and Figure 3-92 the total number of radial cracks.

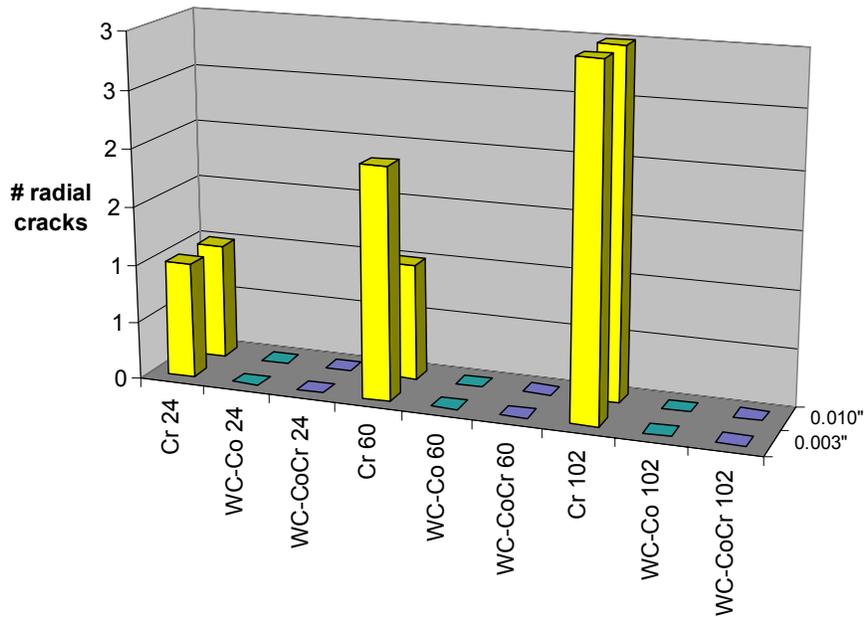
**Figure 3-92. Radial Cracking Along Rod Axis for 0.003"- and 0.010"-thick Coatings at Different Ball Drop Heights**

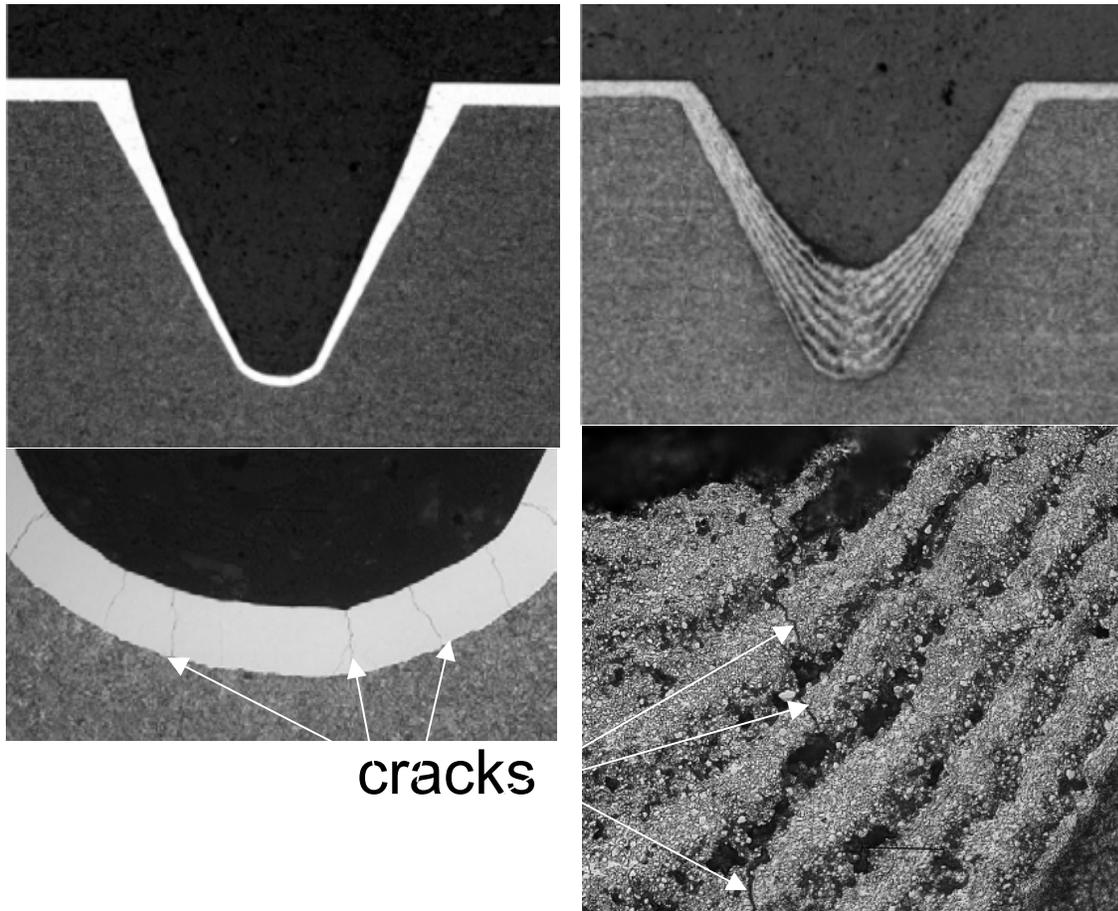
**Figure 3-97. Metallographic Cross Sections of Chrome Plate (left) and HVOF WC-Co After Stressing to 45% NTS in Air (Note also the original layer formation in the HVOF coating)**

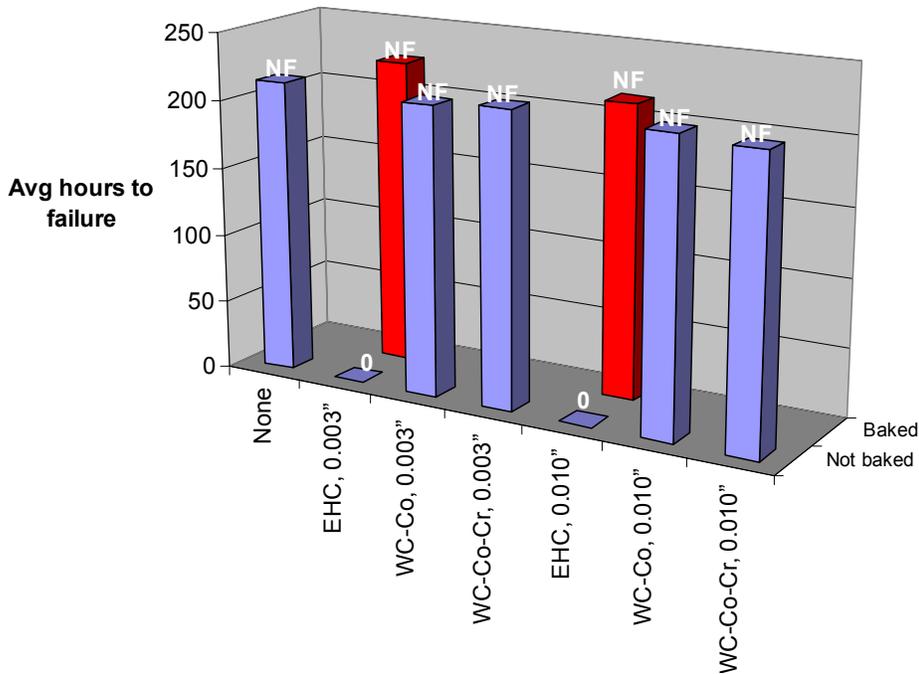
**Figure 3-98. Sequence 1: Average Hours to Failure (NF = No failure in 200hrs), With and Without Hydrogen Bake (All failures in notch)**

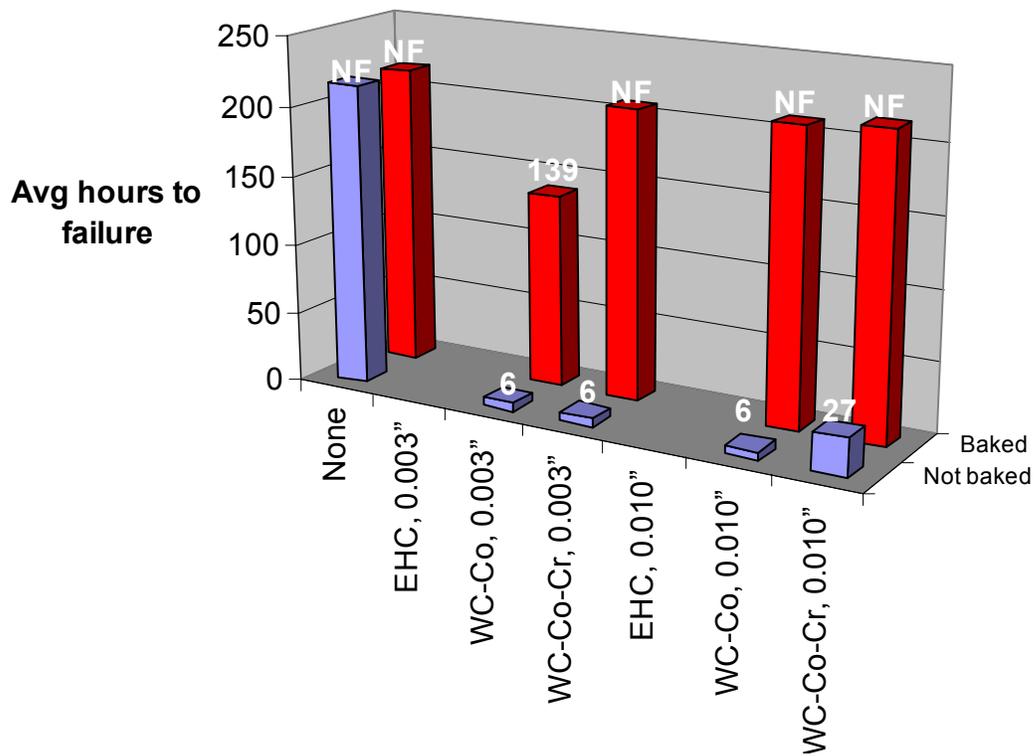
**Figure 3-99. Sequence 2: Average Hours to Failure (NF = No failure in 200hrs), With and Without Hydrogen Bake (Failures occurred on shank at button)**

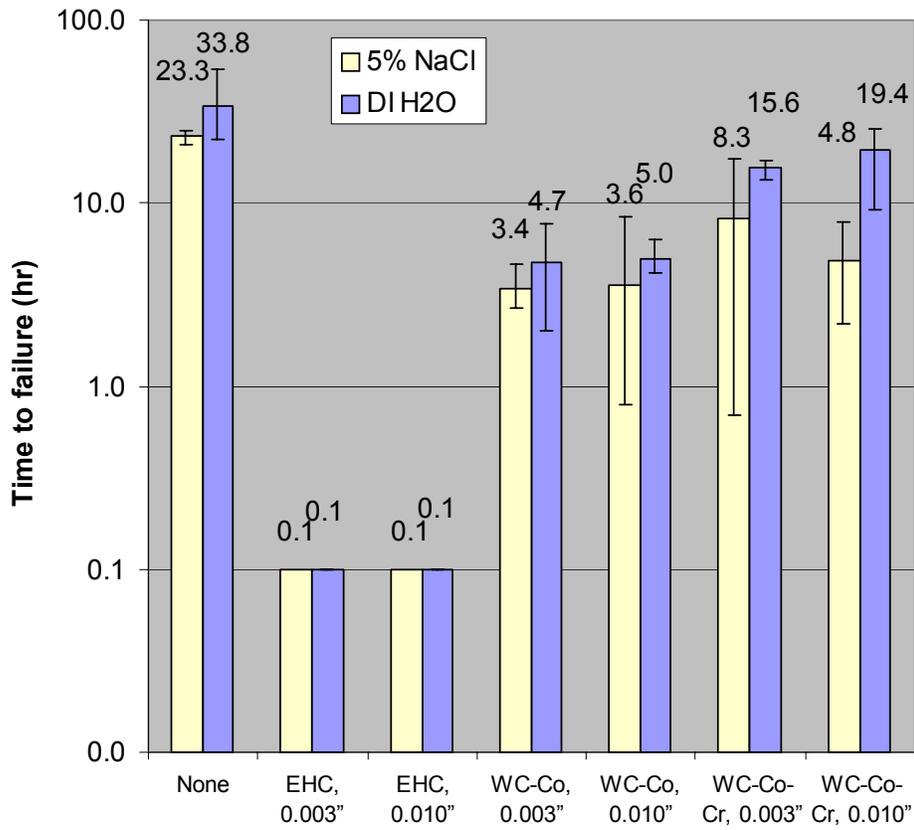
**Figure 3-100. Sequence 3 Average Hours to Failure With No Notch Scribing. (Numbers are average time-to-failure data values – note log scale; error bars indicate high and low values)**

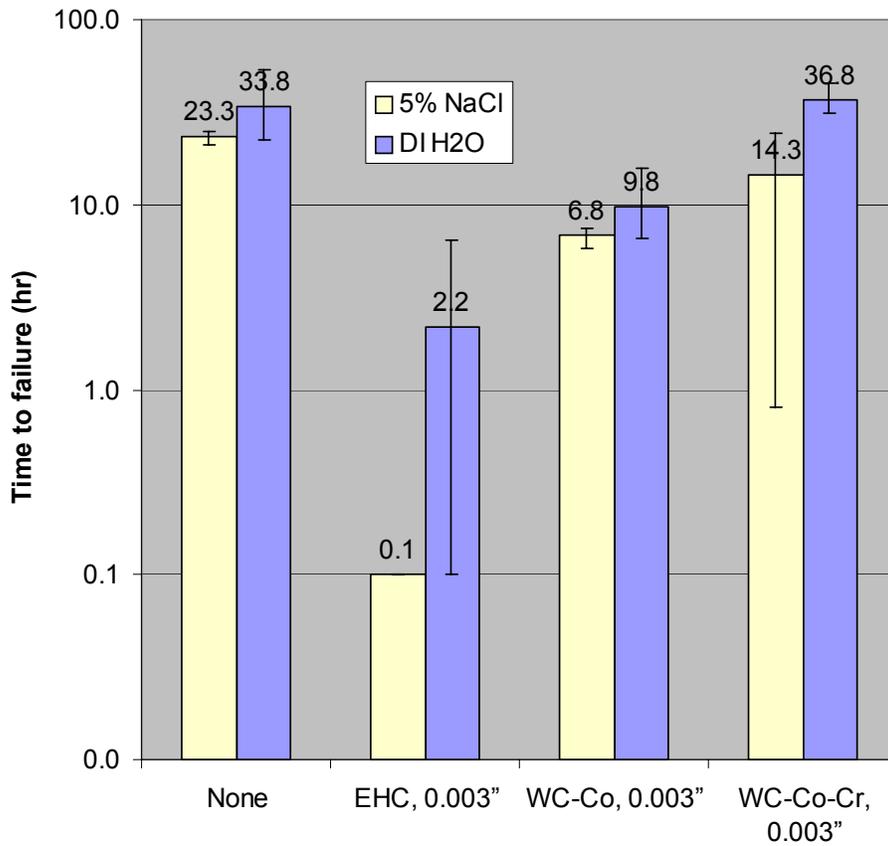
**Figure 3-101. Sequence 3: Average Hours to Failure With Notch Scribed to Expose the Substrate (Numbers are average time-to-failure data values – note log scale; Error bars indicate high and low values) (Note that these tests were run for 0.003"-thick coatings only)**

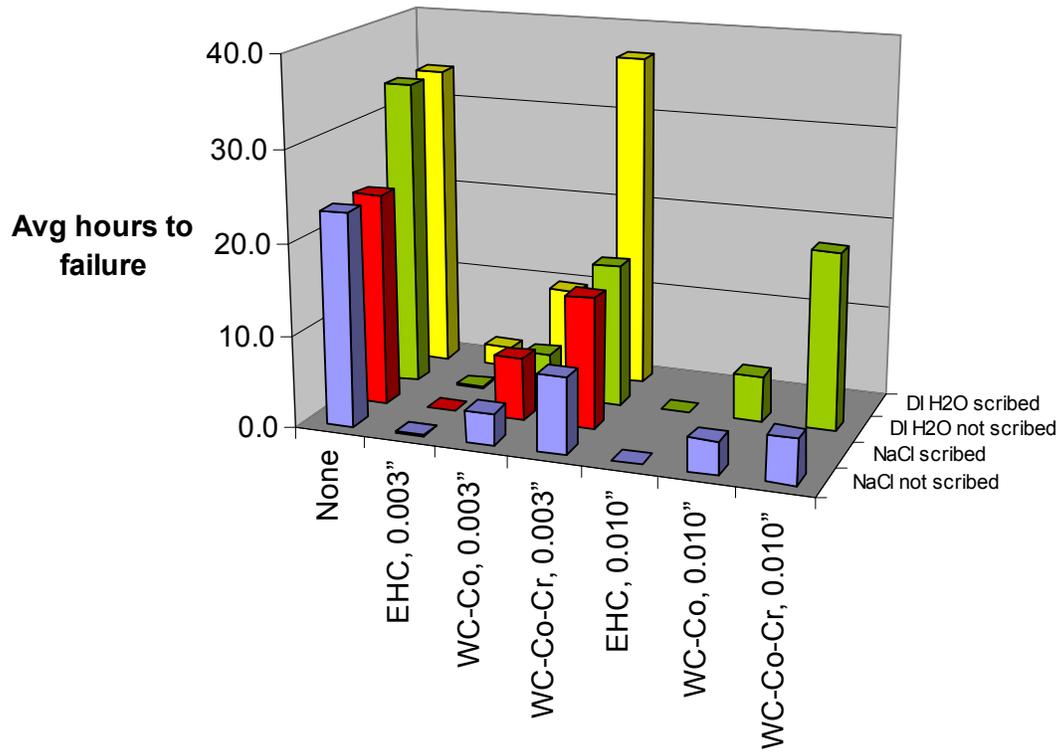
Figure 3-102. Sequence 3 Time-to-failure Data Summary

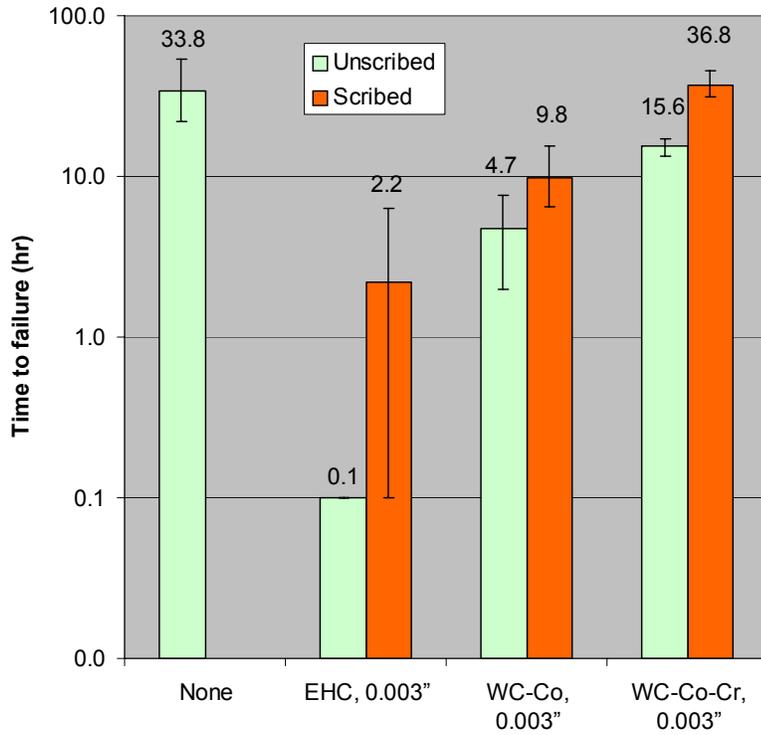
**Figure 3-103. Sequence 3 – Comparison of Time to Failure for Scribed and Un-scribed Specimens - DI Water**

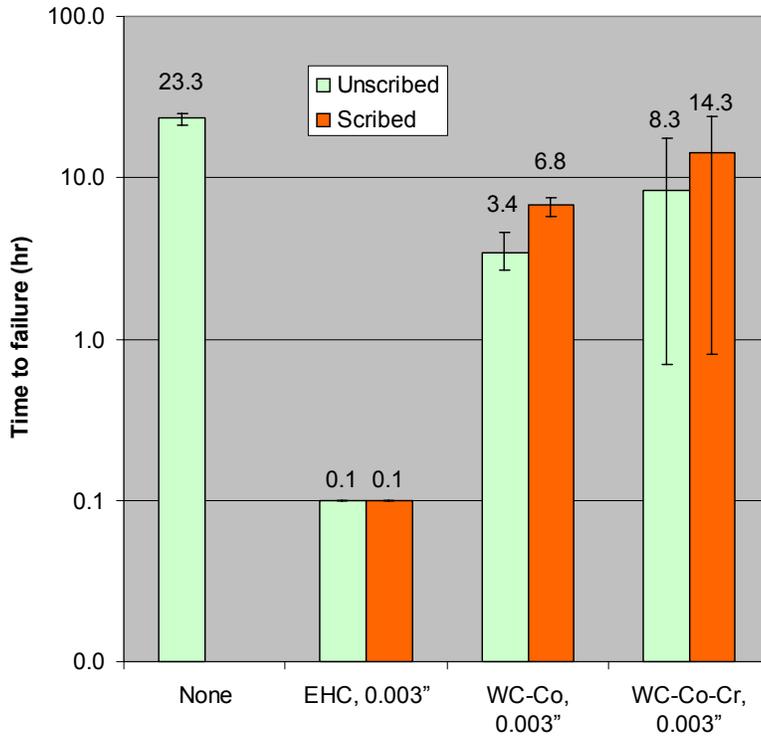
**Figure 3-104. Sequence 3 – Comparison of Time to Failure for Scribed and Un-scribed Specimens - 5% NaCl Solution**

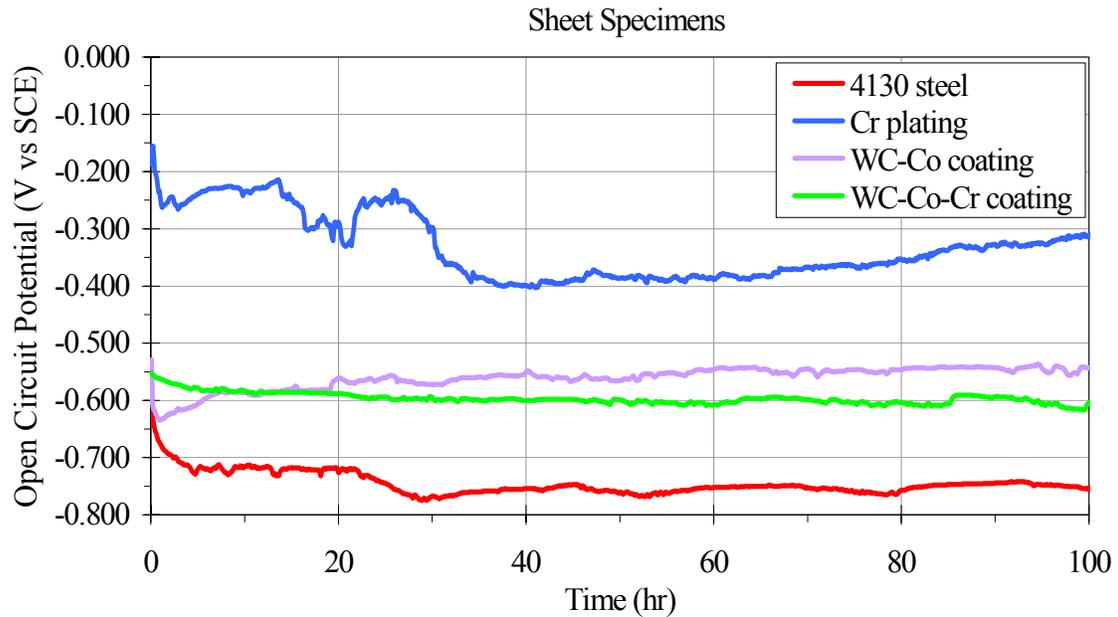
Figure 3-105. Open Circuit Potential for Coated Sheet Specimens in 5% NaCl Solution

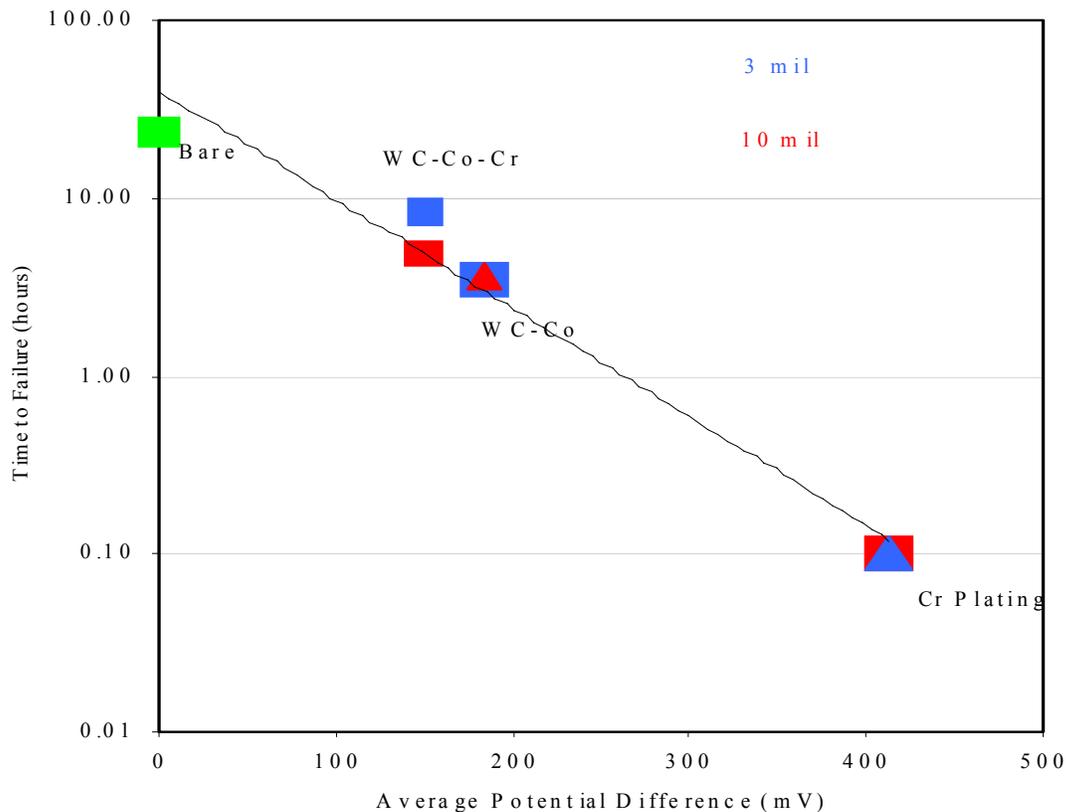
**Figure 3-106. Plot of Log Time-to-failure vs. Average Potential Difference Between Coating and 4340 Substrate in 5% NaCl Solution**

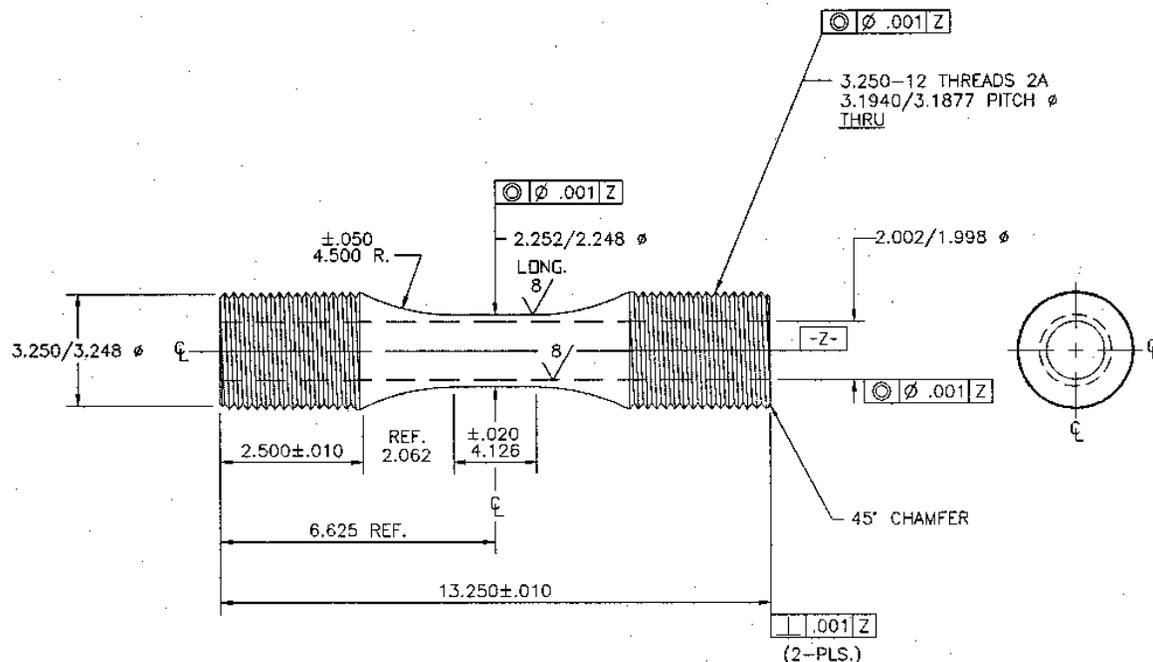
Figure 4-1. HCAT Axial Integrity Big Bar Design (Metcut)

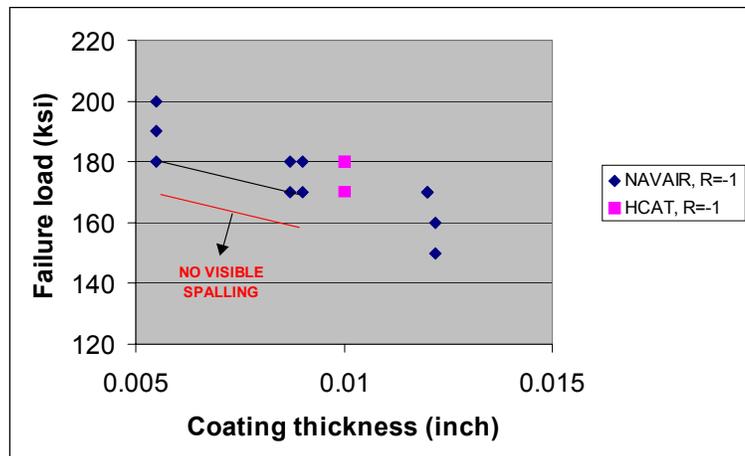
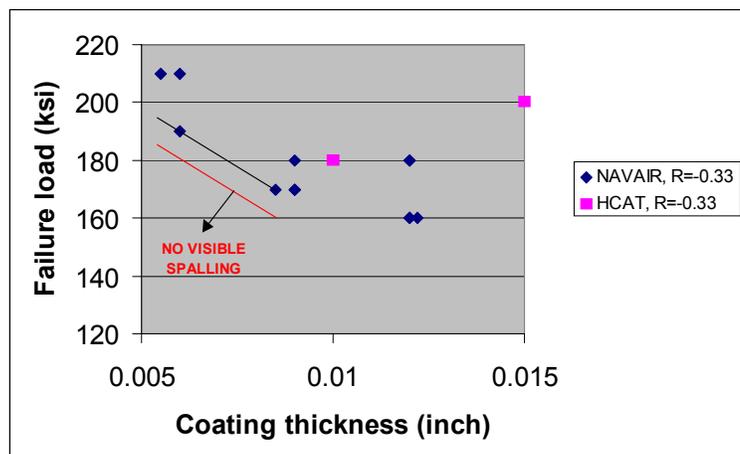
**Figure 4-3. Axial Big Bar Integrity Tests (HCAT and NAVAIR).**

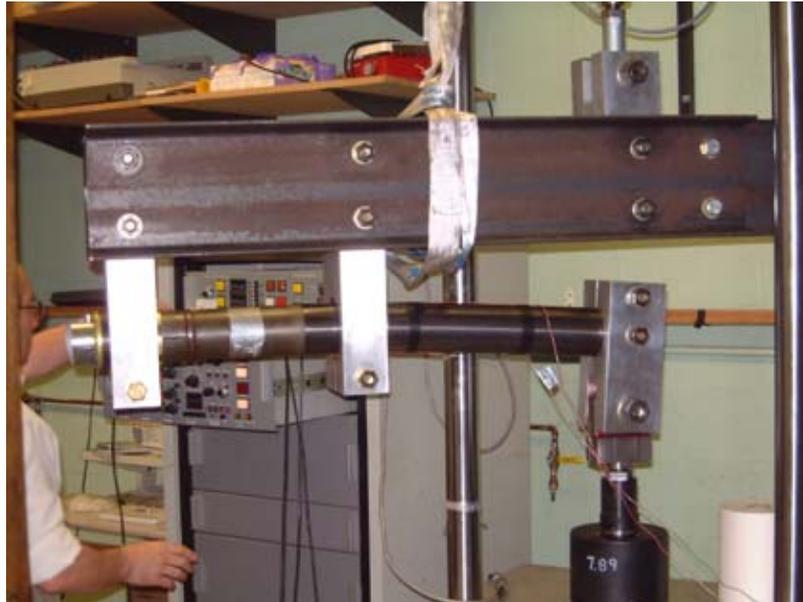
**Figure 4-4. Hill AFB Bend Test Fixture**

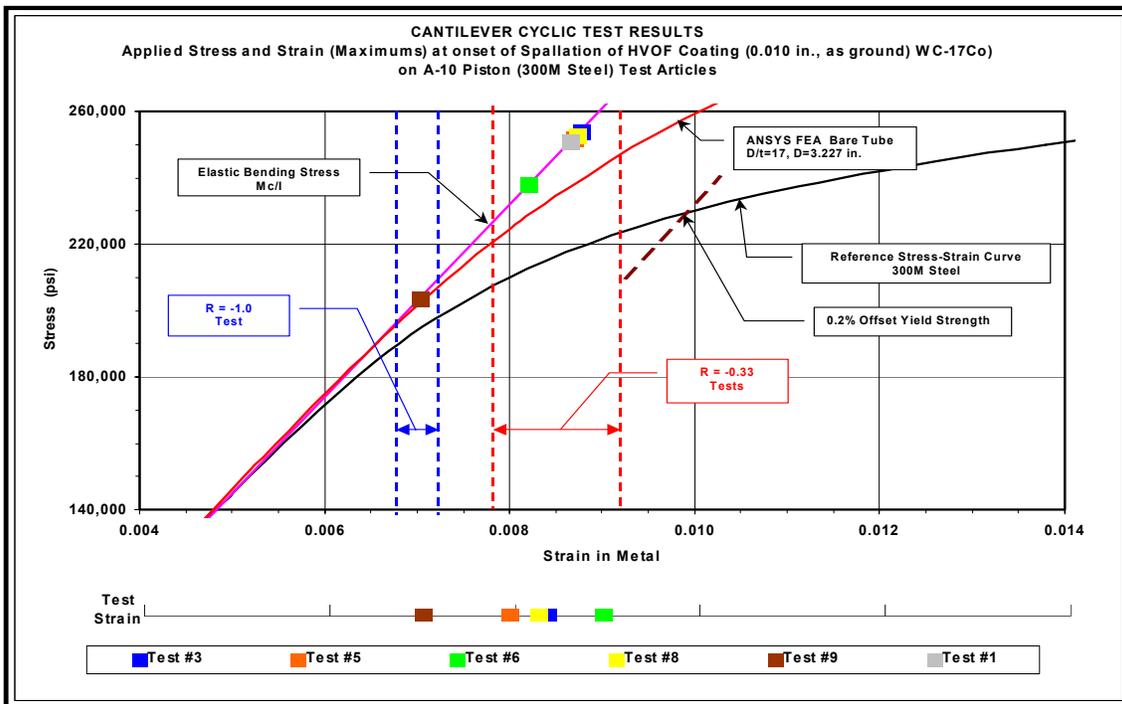
**Figure 4-5. Bend Test Spalling for A-10 Landing Gear Cylinder Under Strain Control (0.010"-thick WC-Co, R= -0.33) (OO-ALC)**

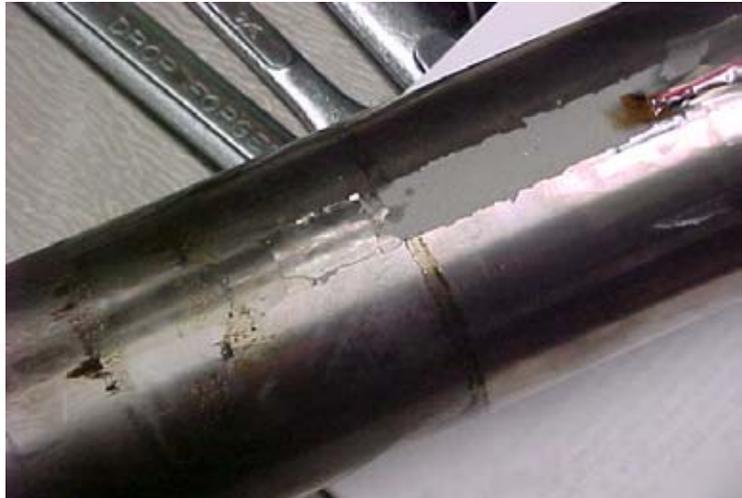
**Figure 4-6. Spallation of a 0.015”-thick WC/CoCr Coating from a Test Cylinder (OO-ALC)**

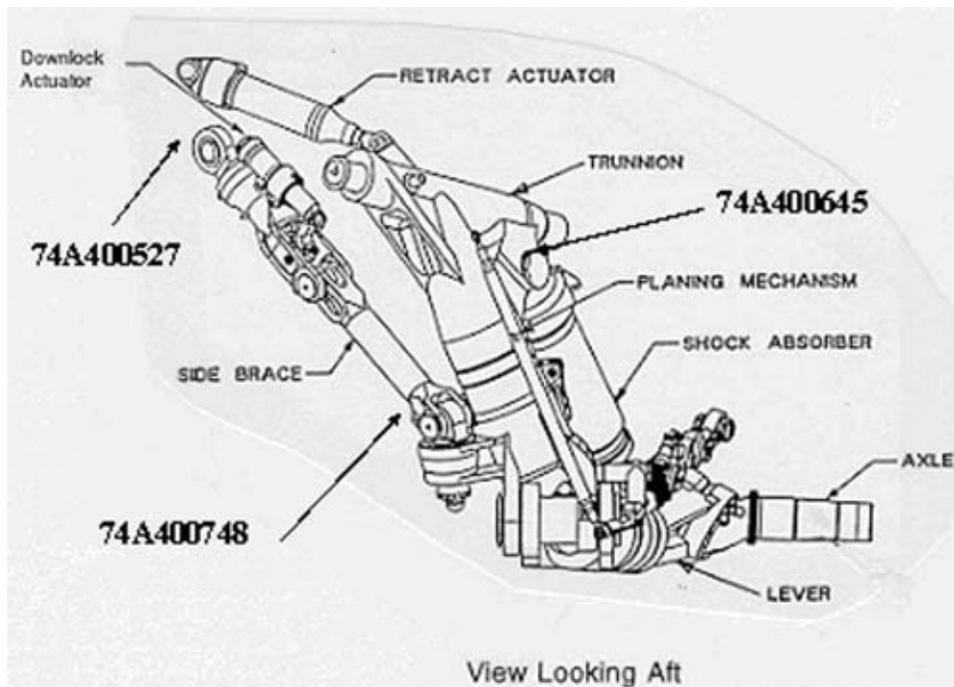
**Figure 5-1. Location of HVOF-coated Pins in Boeing F/A-18E/F Main Landing Gear Fatigue Test**

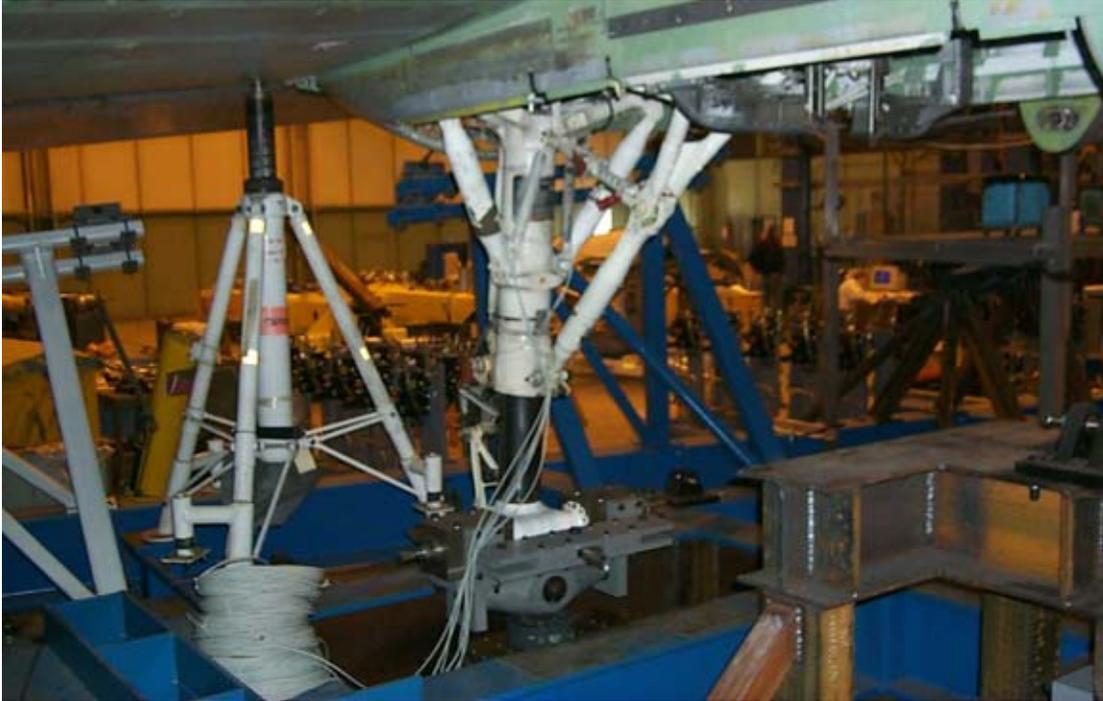
**Figure 5-4. Left-hand MLG Containing HVOF WC/17Co-coated Piston Mounted on P-3C Test Article at Lockheed-Martin in Marietta, Georgia**

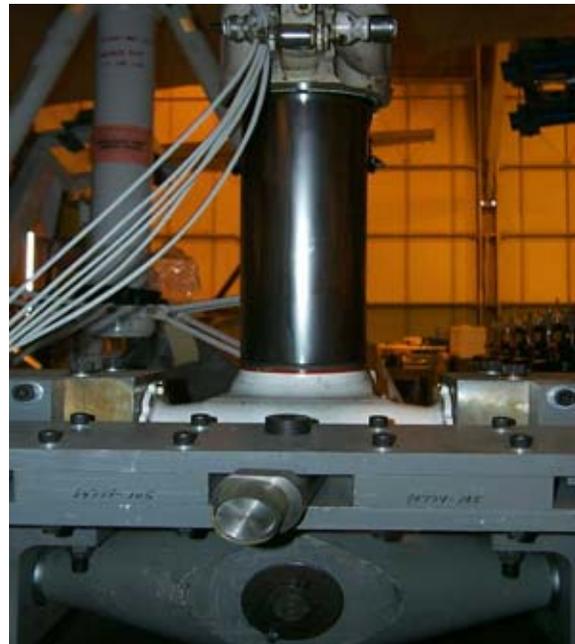
**Figure 5-5. Close-up of HVOF WC/17Co-coated Piston in MLG**

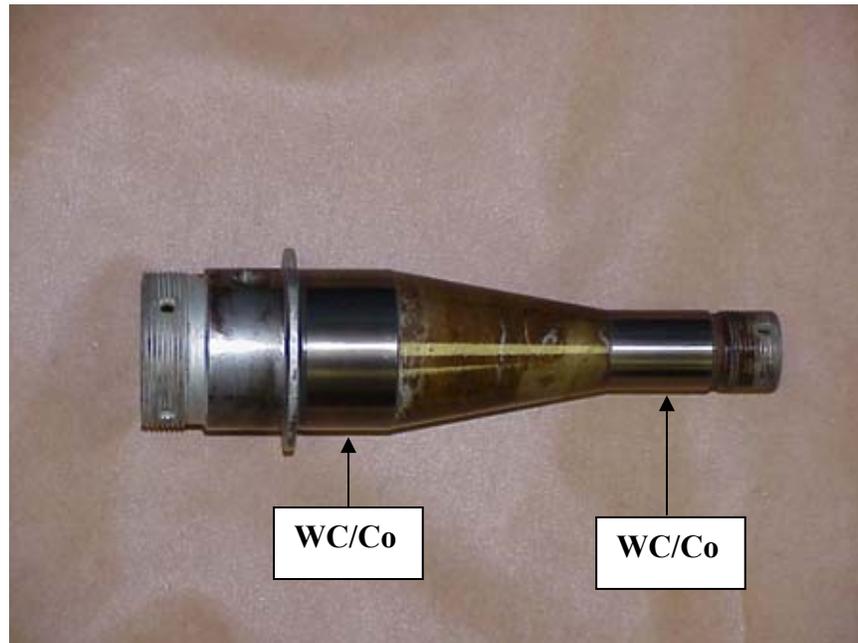
**Figure 5-7. E-6A Uplock Hook Shaft**

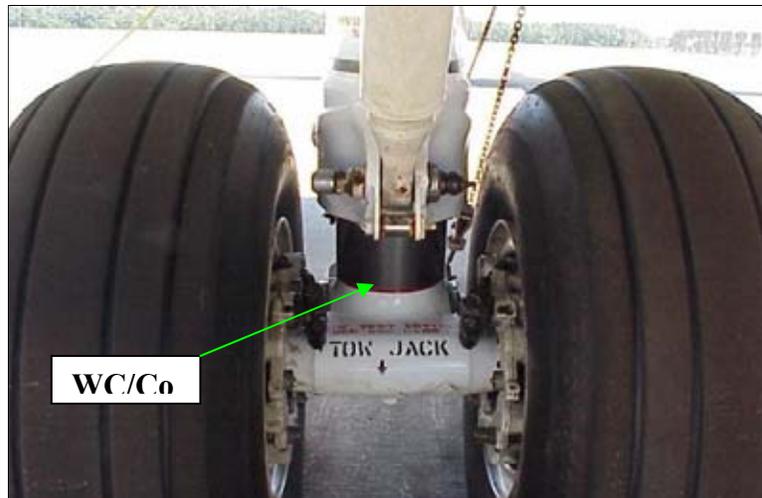
**Figure 5-8. P-3C Main Landing Gear with HVOF WC/17Co-coated Piston Cylinder (indicated) and Axle Journals**

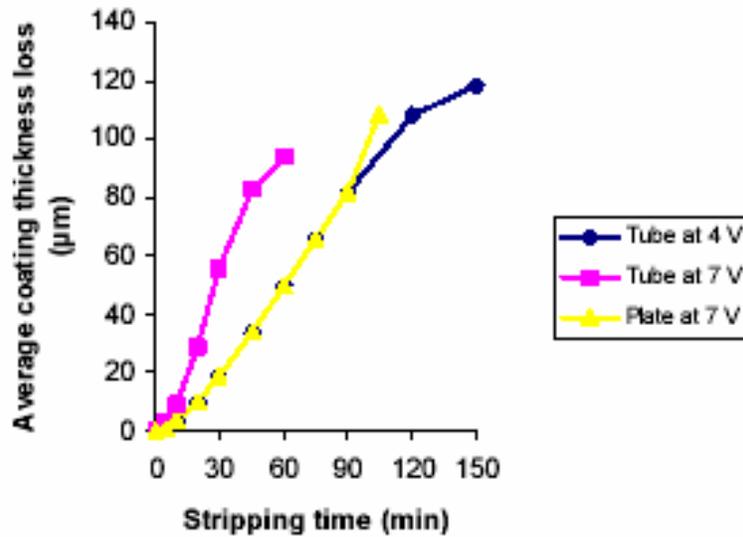
**Figure 6-3. Stripping Rate of WC/CoCr by Type S2-2, Ni Stripper (Heroux Devtek)**

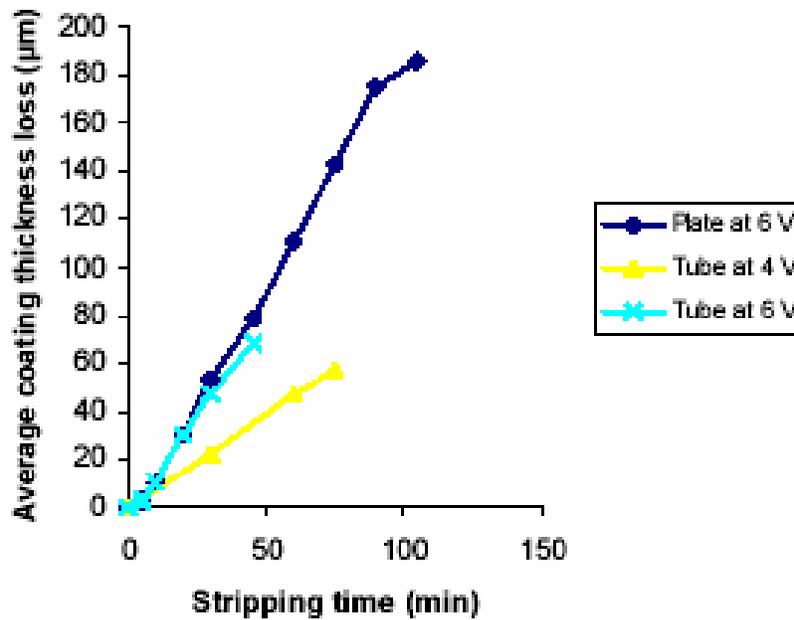
**Figure 6-4. Stripping Rate of WC/CoCr by Type S2-1, Rochelle Salt Stripper (Heroux Devtek )**

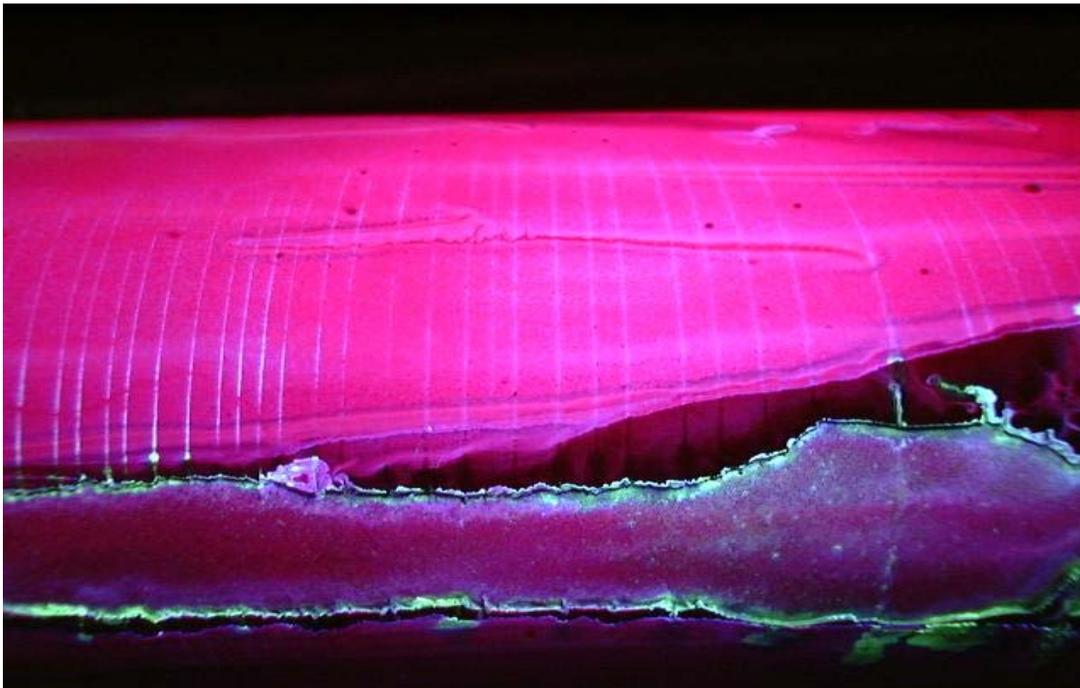
**Figure 6-7. FPI of HVOF-coated Landing Gear After Fatigue to Stress Sufficient to Cause Coating Delamination, Showing Circumferential Coating Cracks (C. Edwards, OO-ALC)**

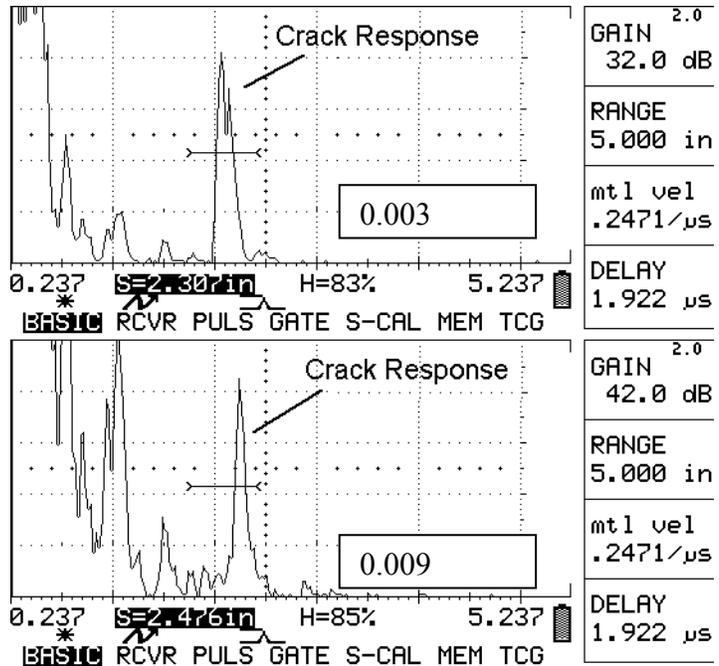
**Figure 6-8. Ultrasonic Detection of Crack Beneath HVOF WC/CoCr Coatings (Boeing)**

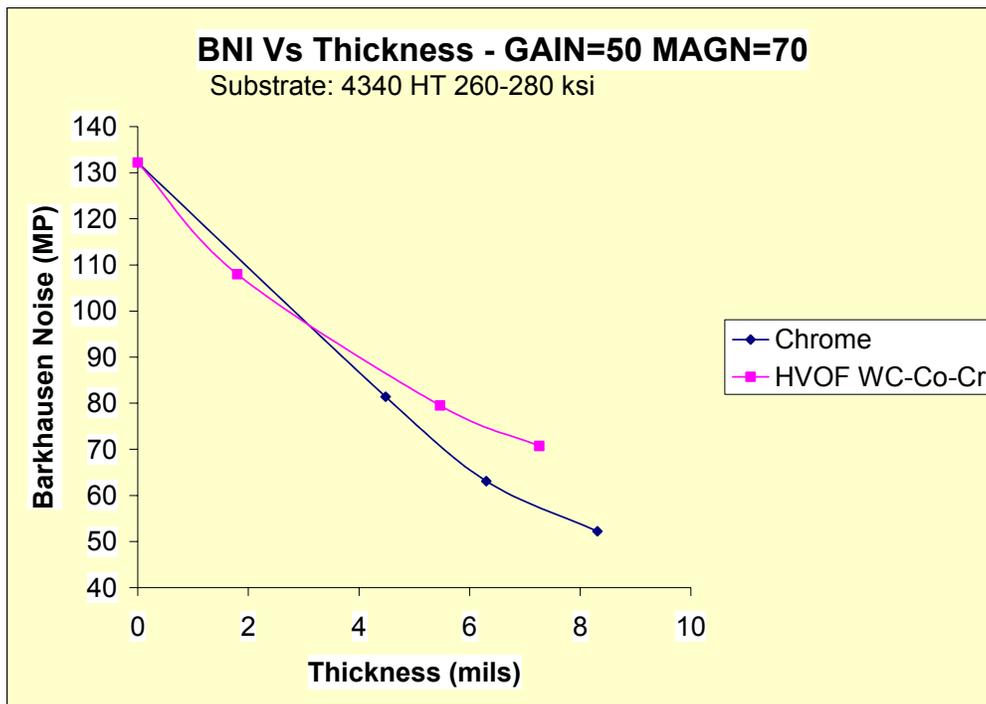
Figure 6-10. Barkhausen Noise Signal vs Coating Thickness (Heroux Devtek)

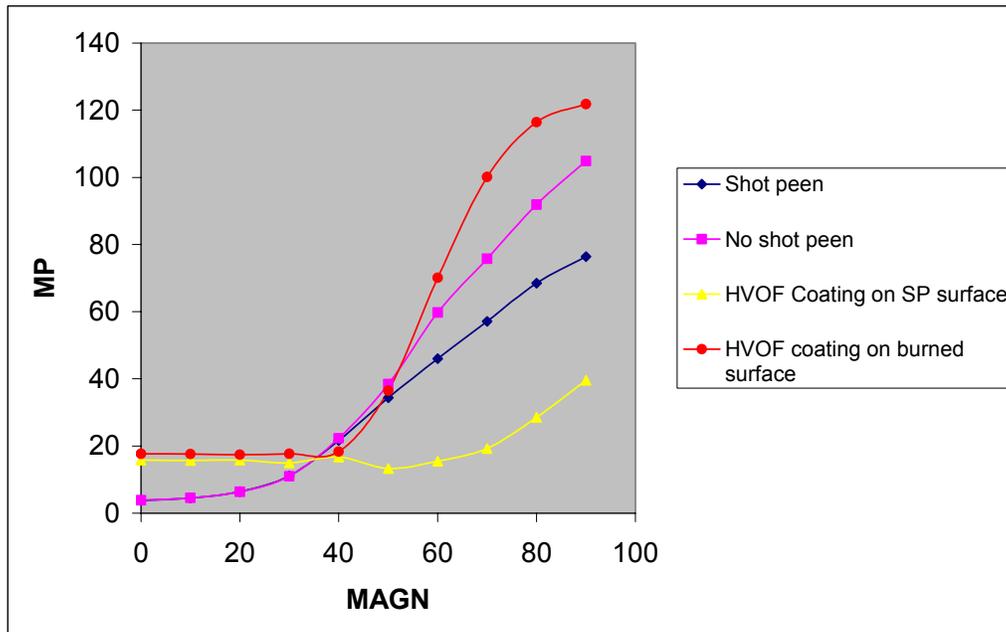
**Figure 6-11. Effect of Shot Peening and Grind Burning on Barkhausen Noise of HVOF WC/CoCr (Heroux Devtek)**

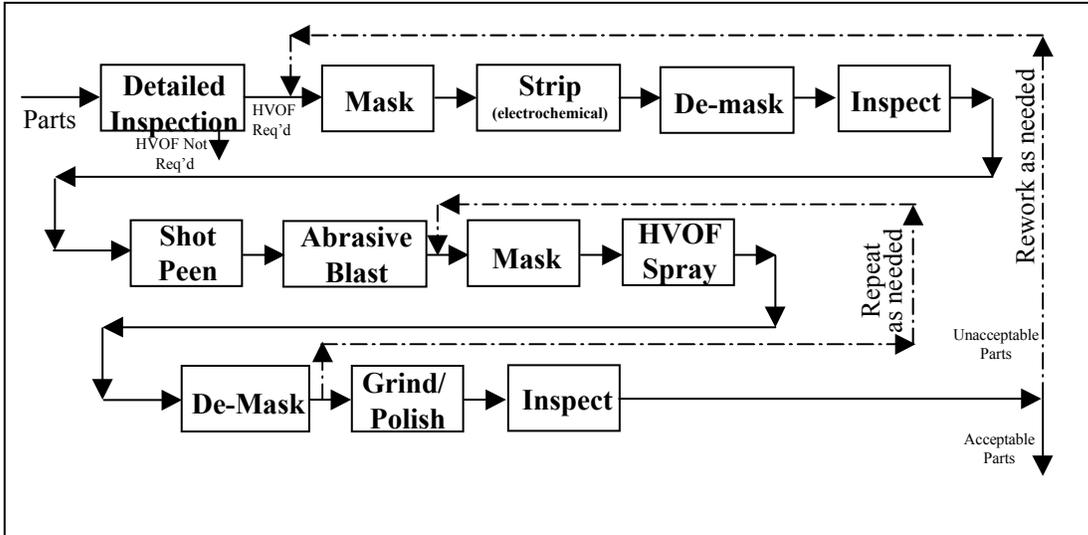
**Figure 7-2. Projected Process Flow of HVOF for Applying WC/Co or WC/CoCr**

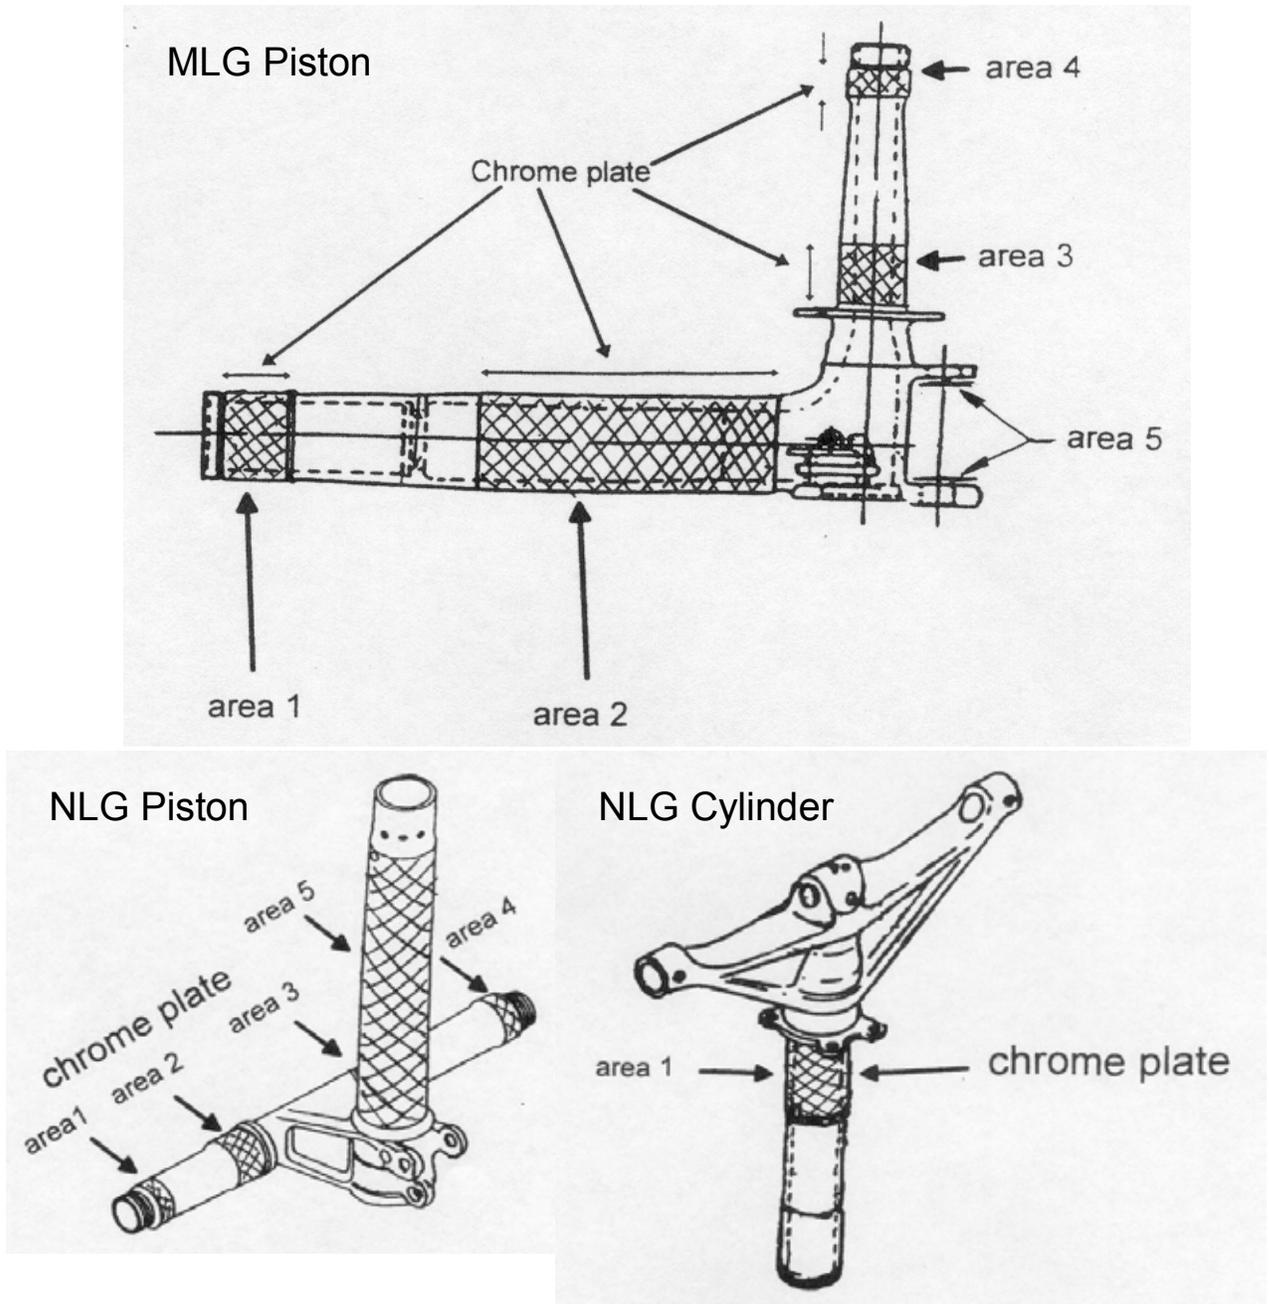
**Figure 7-3. Areas Expected to be Transitioned from Hard Chrome Electroplating to HVOF Thermal Spraying**
